## BGA TECHNICAL COMMITTEE

### TECHNICAL NEWSHEET (TNS) 1/2/95

#### PART 1 AIRWORTHINESS "AGGRO"

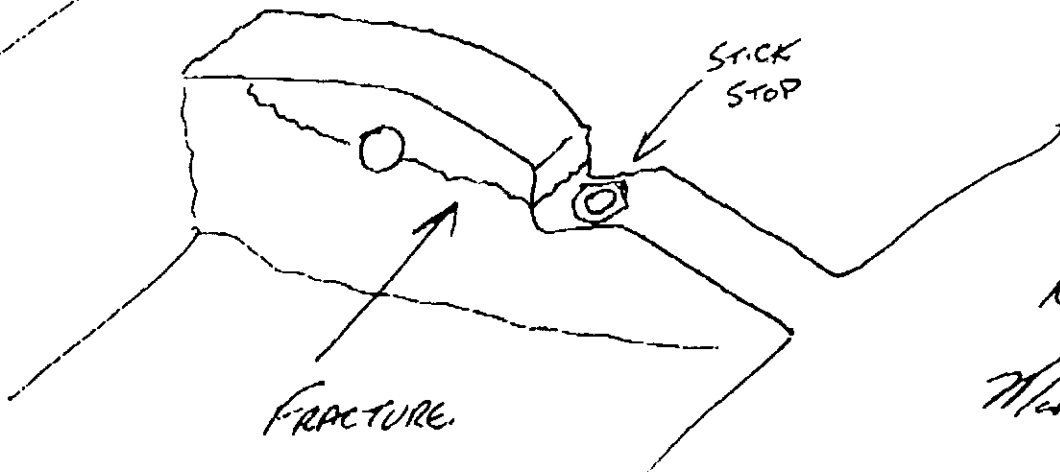
WHILE CARRYING OUT A COFA INSPECTION TO A NIMBUS 3DT (SER N°63) RECENTLY IT WAS NOTICED THAT THE FRONT STICK MOUNTING WAS SPLIT THROUGH.

THIS ITEM IS MADE OF GRP ROVINGING AND HAD FRACTURED ACROSS THE MOUNTING HOLE FOR THE INBOARD STICK MOUNTING POINT.

IN VIEW OF THE SERIOUS NATURE OF THIS FAILURE I FEEL IT OUGHT TO BE BROUGHT TO THE ATTN OF OTHER OWNERS AND POSSIBLY THE MANUFACTURER.

BELOW IS A ROUGH SKETCH OF THE AREA.

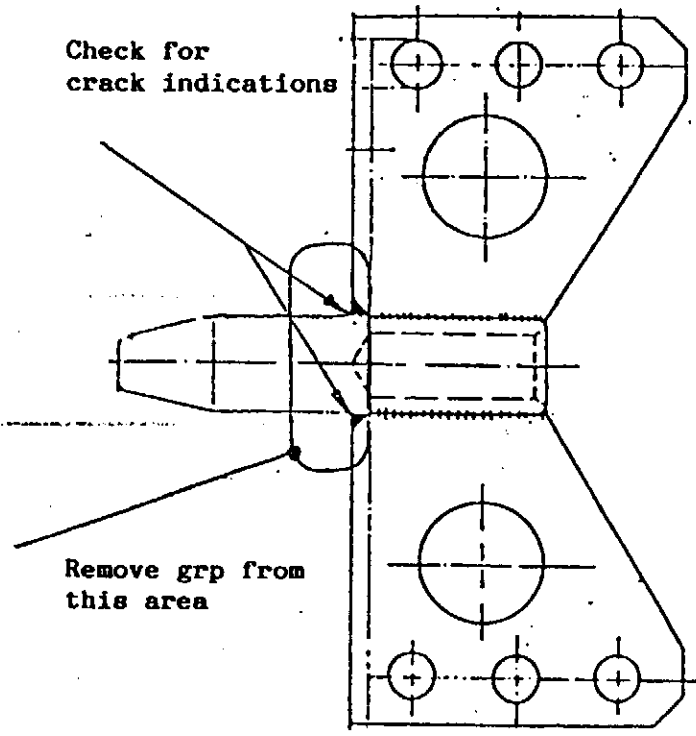
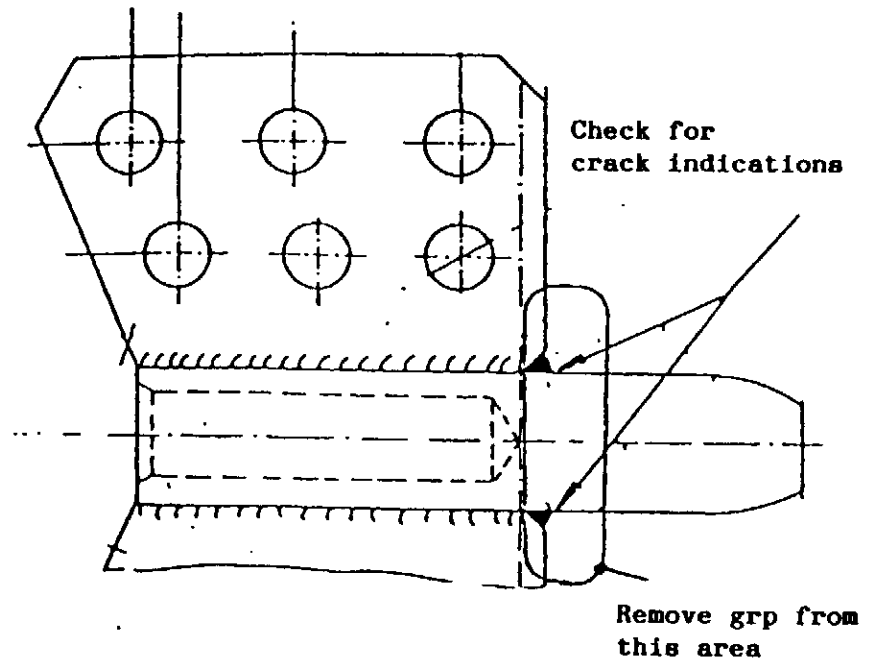
**FIGURE A**

Abrupt manoeuvres and/or high speeds are prohibited. If a crack is confirmed either in the weld only or in the spigot itself, rectification must be carried out to the manufacturer's approved repair scheme before further flight.

- (v) Where the spigots are found to be not cracked either after the actions of (iii) or (iv) above, reprotect the area where the grp has been removed, either with a lacquer or a brushed coat of epoxy resin. Refit the wings to the instructions in the Flight Manual. Repeat the instructions commencing at (i) above except that only the reprotection has now to be removed, at intervals not exceeding 300 flight hours.

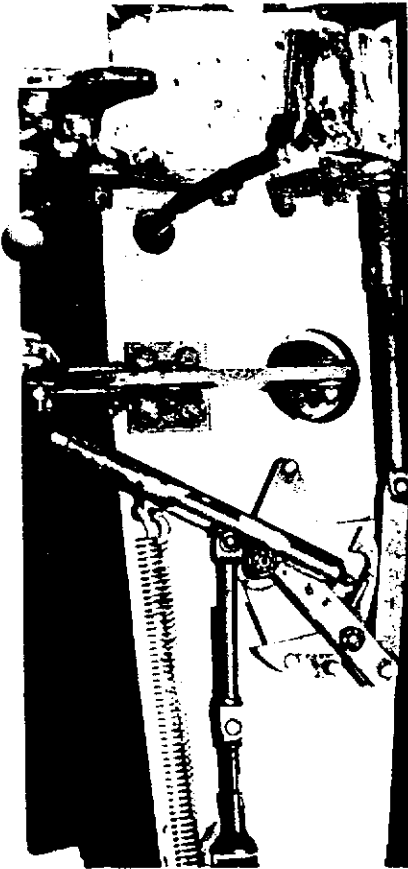
FIG.1 WING JOINT MECHANISM UNLOCKED

The pilot subsequently found that the right wingtip was unlocked. He had understood that it was not possible to fit the wing joint fairing in position if the locking mechanism was not fully in the locked position.
