BGA TECHNICAL COMMITTEE

TECHNICAL NEWSHEET (TNS) 3/4/95

PART 1 **AIRWORTHINESS "AGGRO"** - Please add to the BGA's 1995 Blue Pages.

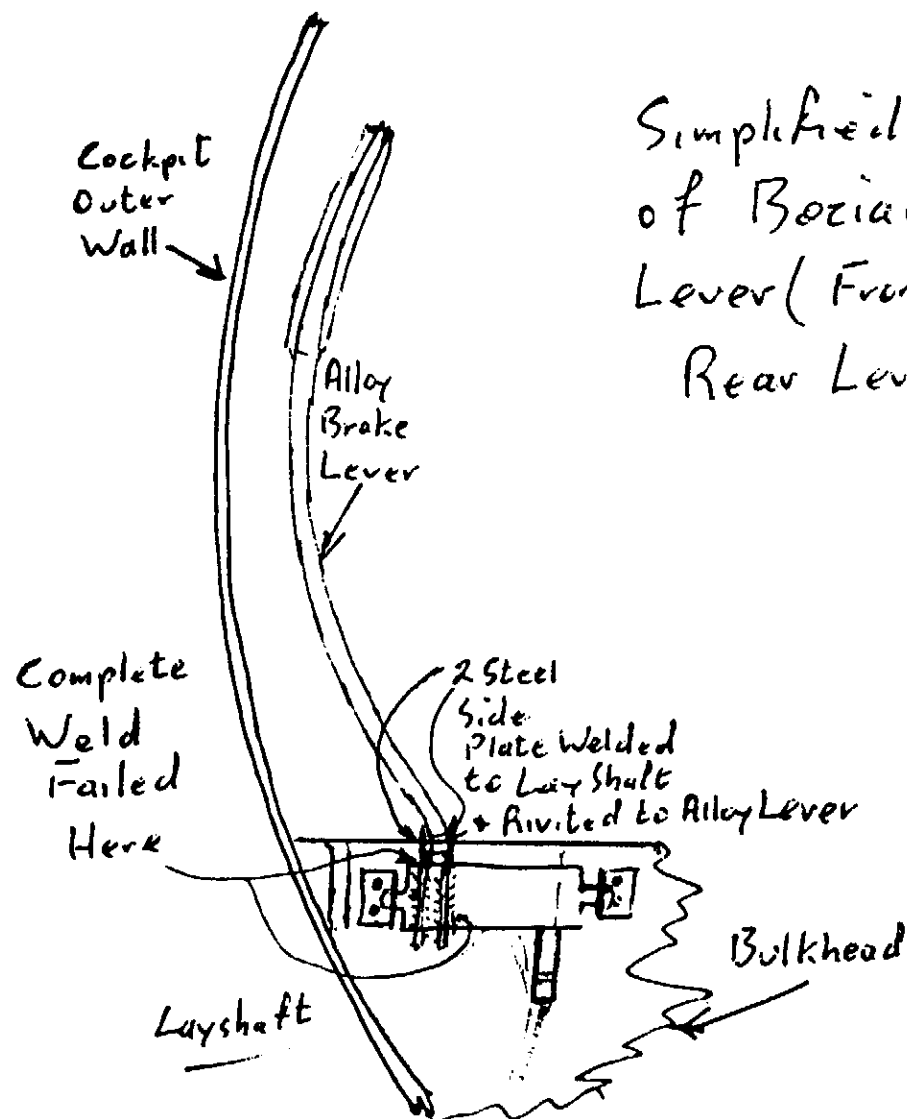
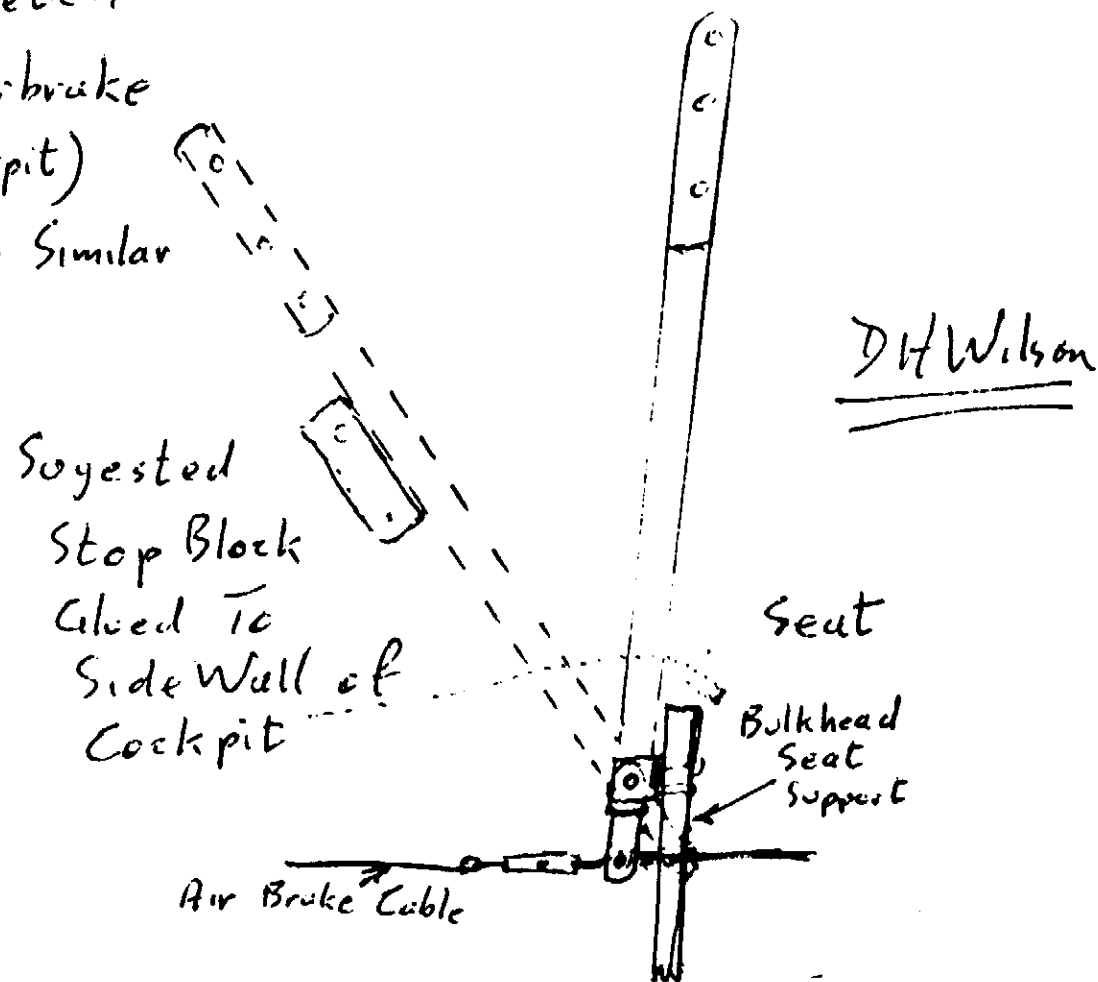
Simplified sketch
of Bozian Airbrake
Lever (Front Cockpit)
Rear Lever is Similar

- 1.2. Bocian - Speed-Brake (weld failure in cockpit - (Sketch from Dave Wilson).
- 1.3. Puchacz - Speed-Brake drive system failure at cross drive in the fuselage - (Sketch from Husband Bosworth).

BOZIAN AIRBRAKE LEVER. FAILURE (WELD).
