BGA TECHNICAL COMMITTEE

TECHNICAL NEWSHEET (TNS) 5/6/95

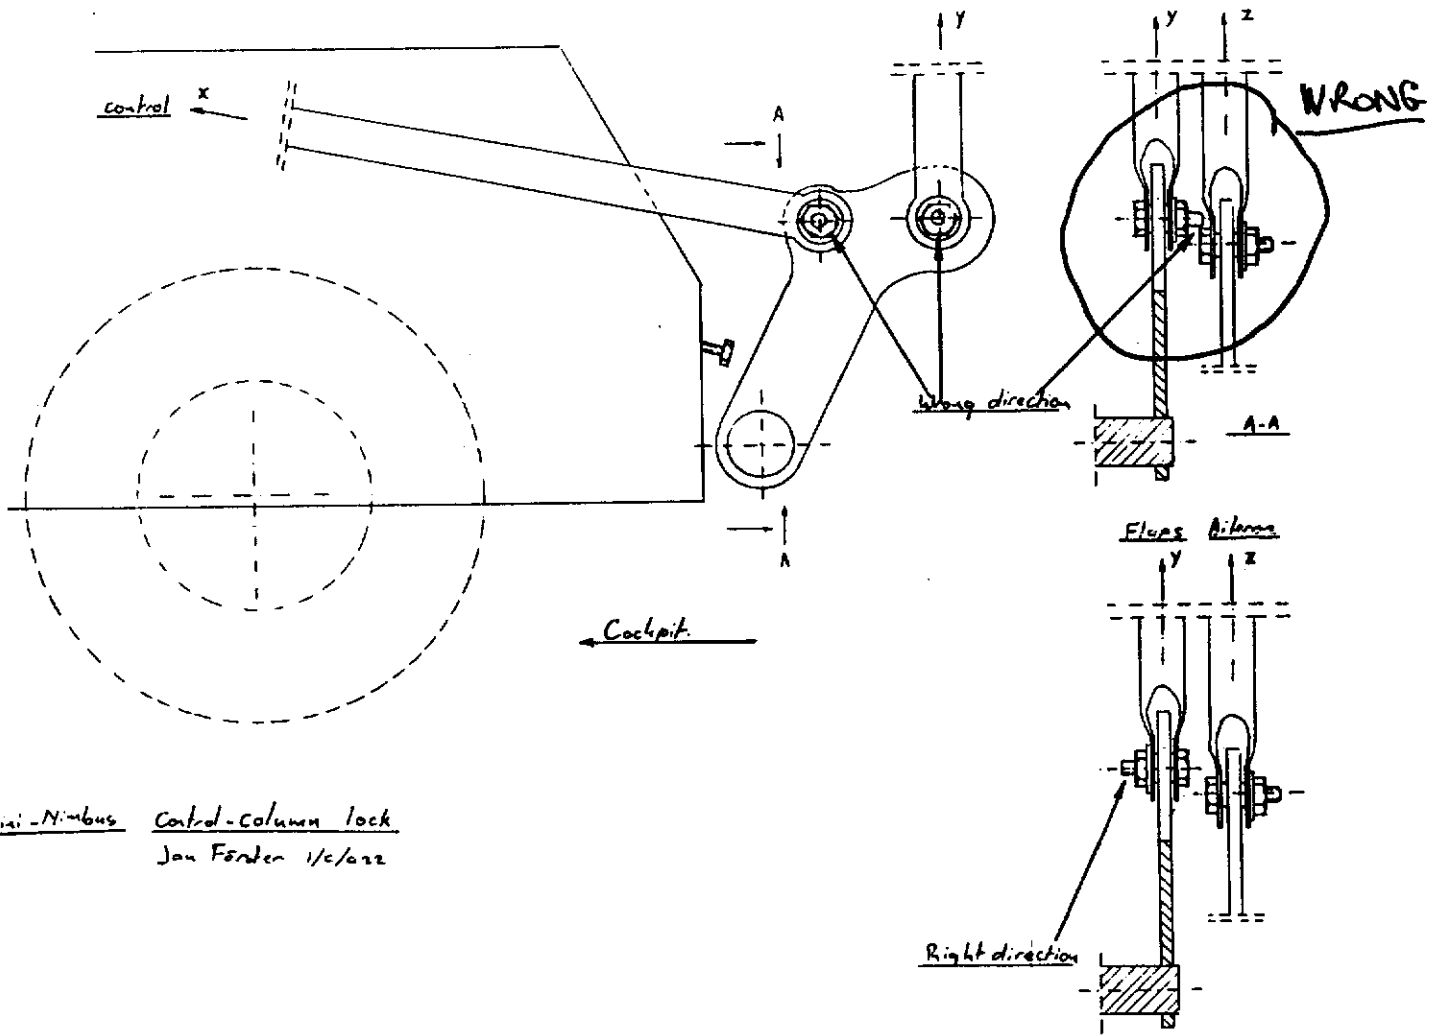
MINI-NIBBUS

- PART 1 AIRWORTHINESS "AGGRO" - Please add to the BGA's 1995 Blue Pages.
- 1.1. MINI-NIMBUS - Potential control system foul is illustrated in attached sketch. (Jan Forster).

Potential Control System Foul

Already Actioned By SB. 306-33 (1994)

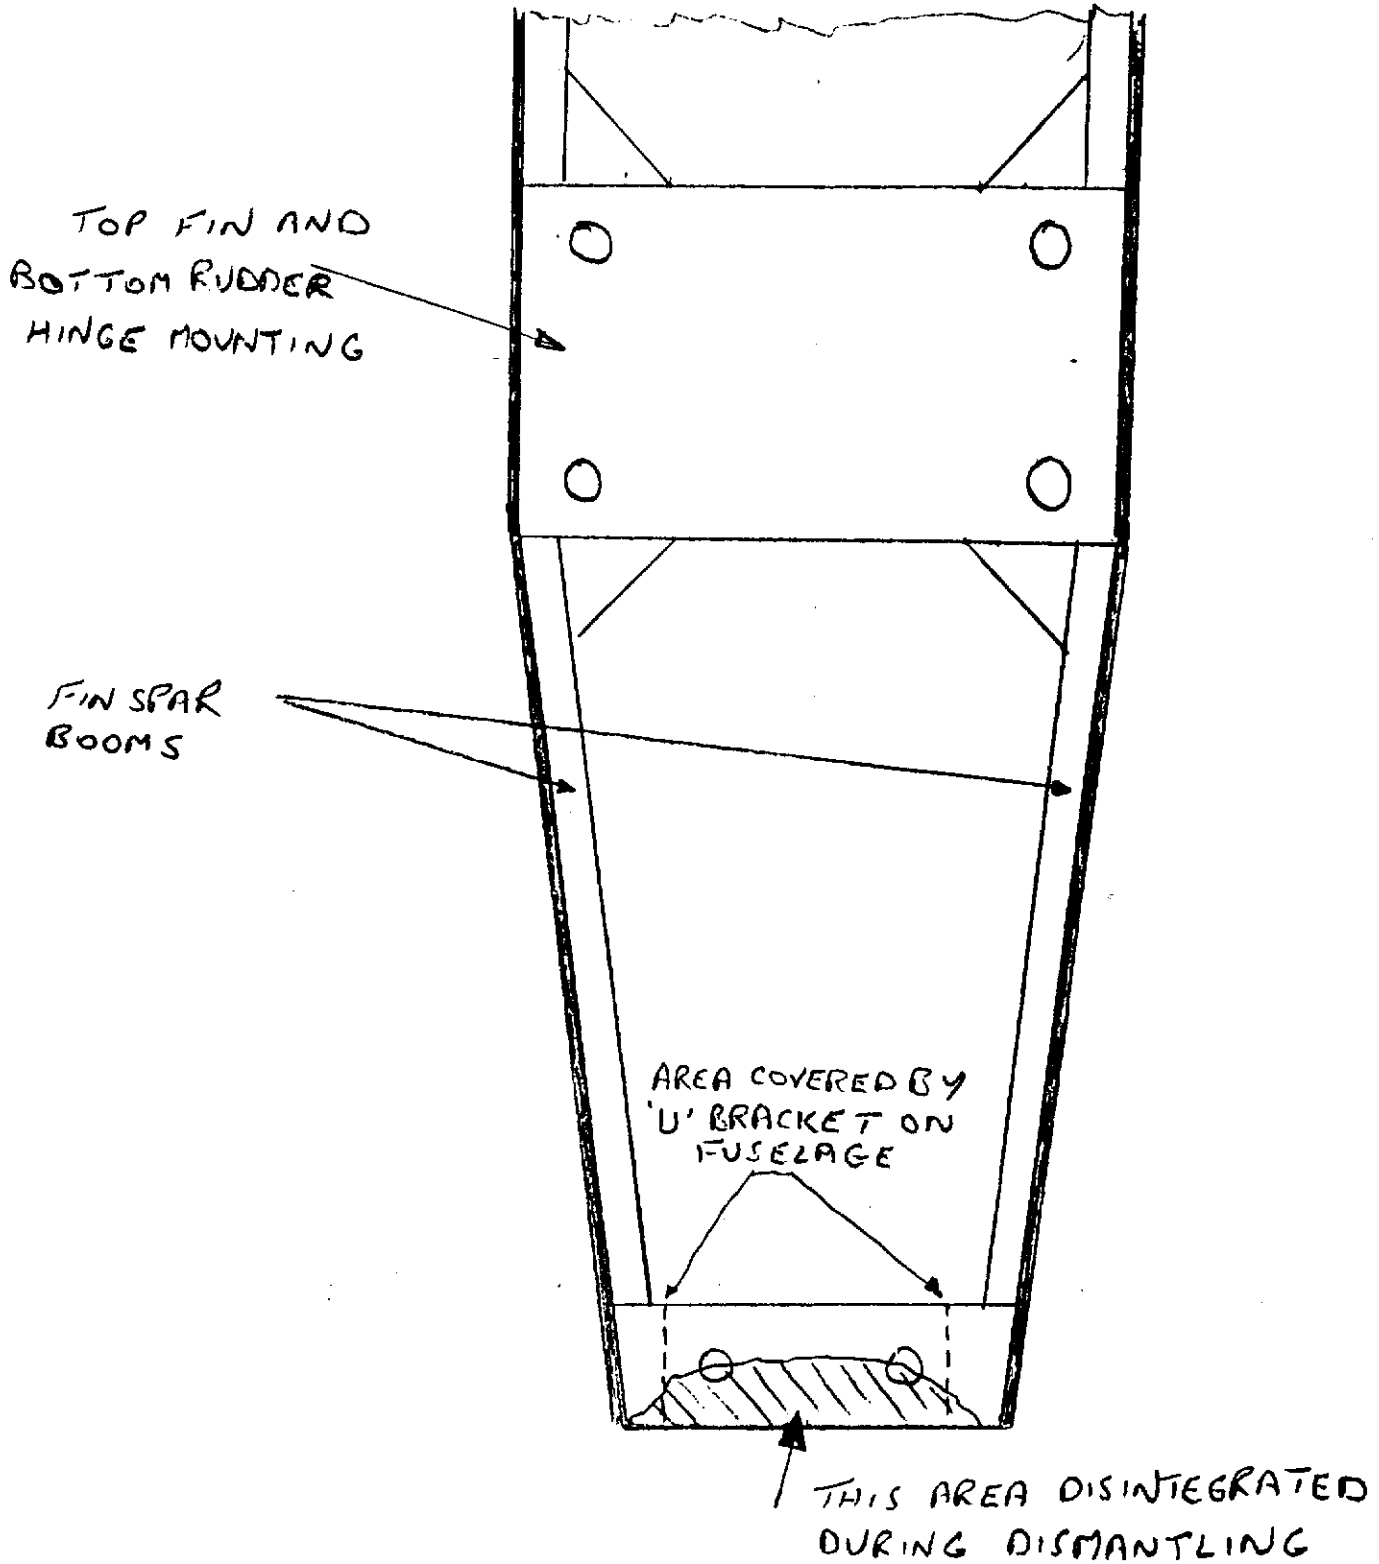
K6B BGA 1458 VIEW ON REAR OF FIN

- 1.5. OLY 460 Winch Launched with one Tailplane not secured - landed safely! (Portmoak).
- 1.6. KA6 (Series) Rotten Structure - below the paint at base of the fin. Sketch from R.W. Collins. Has been reported previously on KA7/13 etc. Look carefully by removing the paint!

Ka6 - ROT AT BASE OF FIN.

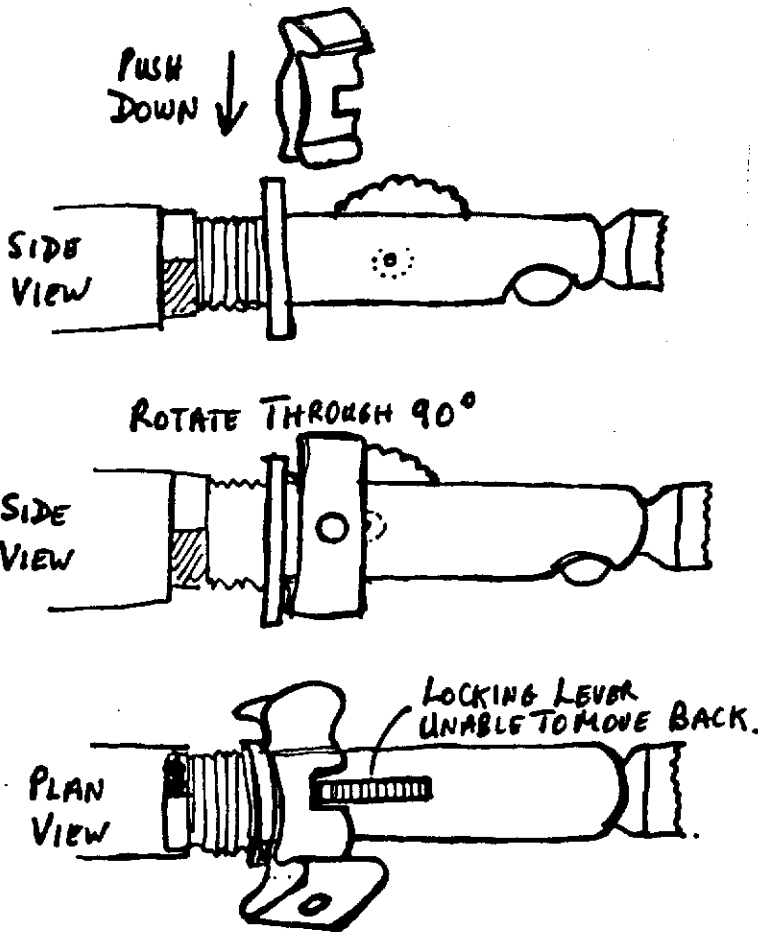
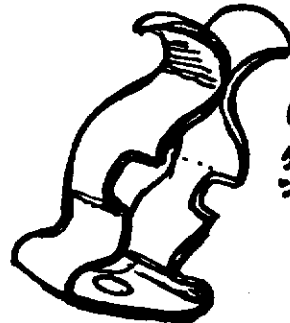
L'Hotelier Connection Alternative Locking Arrangement (Non-Wedge Type)

Connecting L'Hotelier on Standard Cirrus (and other types) is tricky since one is working blind, through a trap door, and over the main spar. Inserting "R" pins is well nigh impossible.

GROOVE FILED
3/4 WAY UP
"TERRY" TOOL CLIP

Adapted "Terry" tool clips make the job possible. The adaption is to file a slot as shown. The "Terry" clip is tethered via nylon cord to hollow rivet holes already present in the ends of the push rods.

Having made the connection, the "Terry" clip is pushed vertically down over the locking lever and then rotated through 90 degrees at which time the clip "clicks" into position over the lever. The depth of the groove is not critical, since even if the remaining body of the clip does not clear the lever, the serrations in the lever prevent any backward movement of the same. Removal is achieved by pushing the "Terry" clip forward.

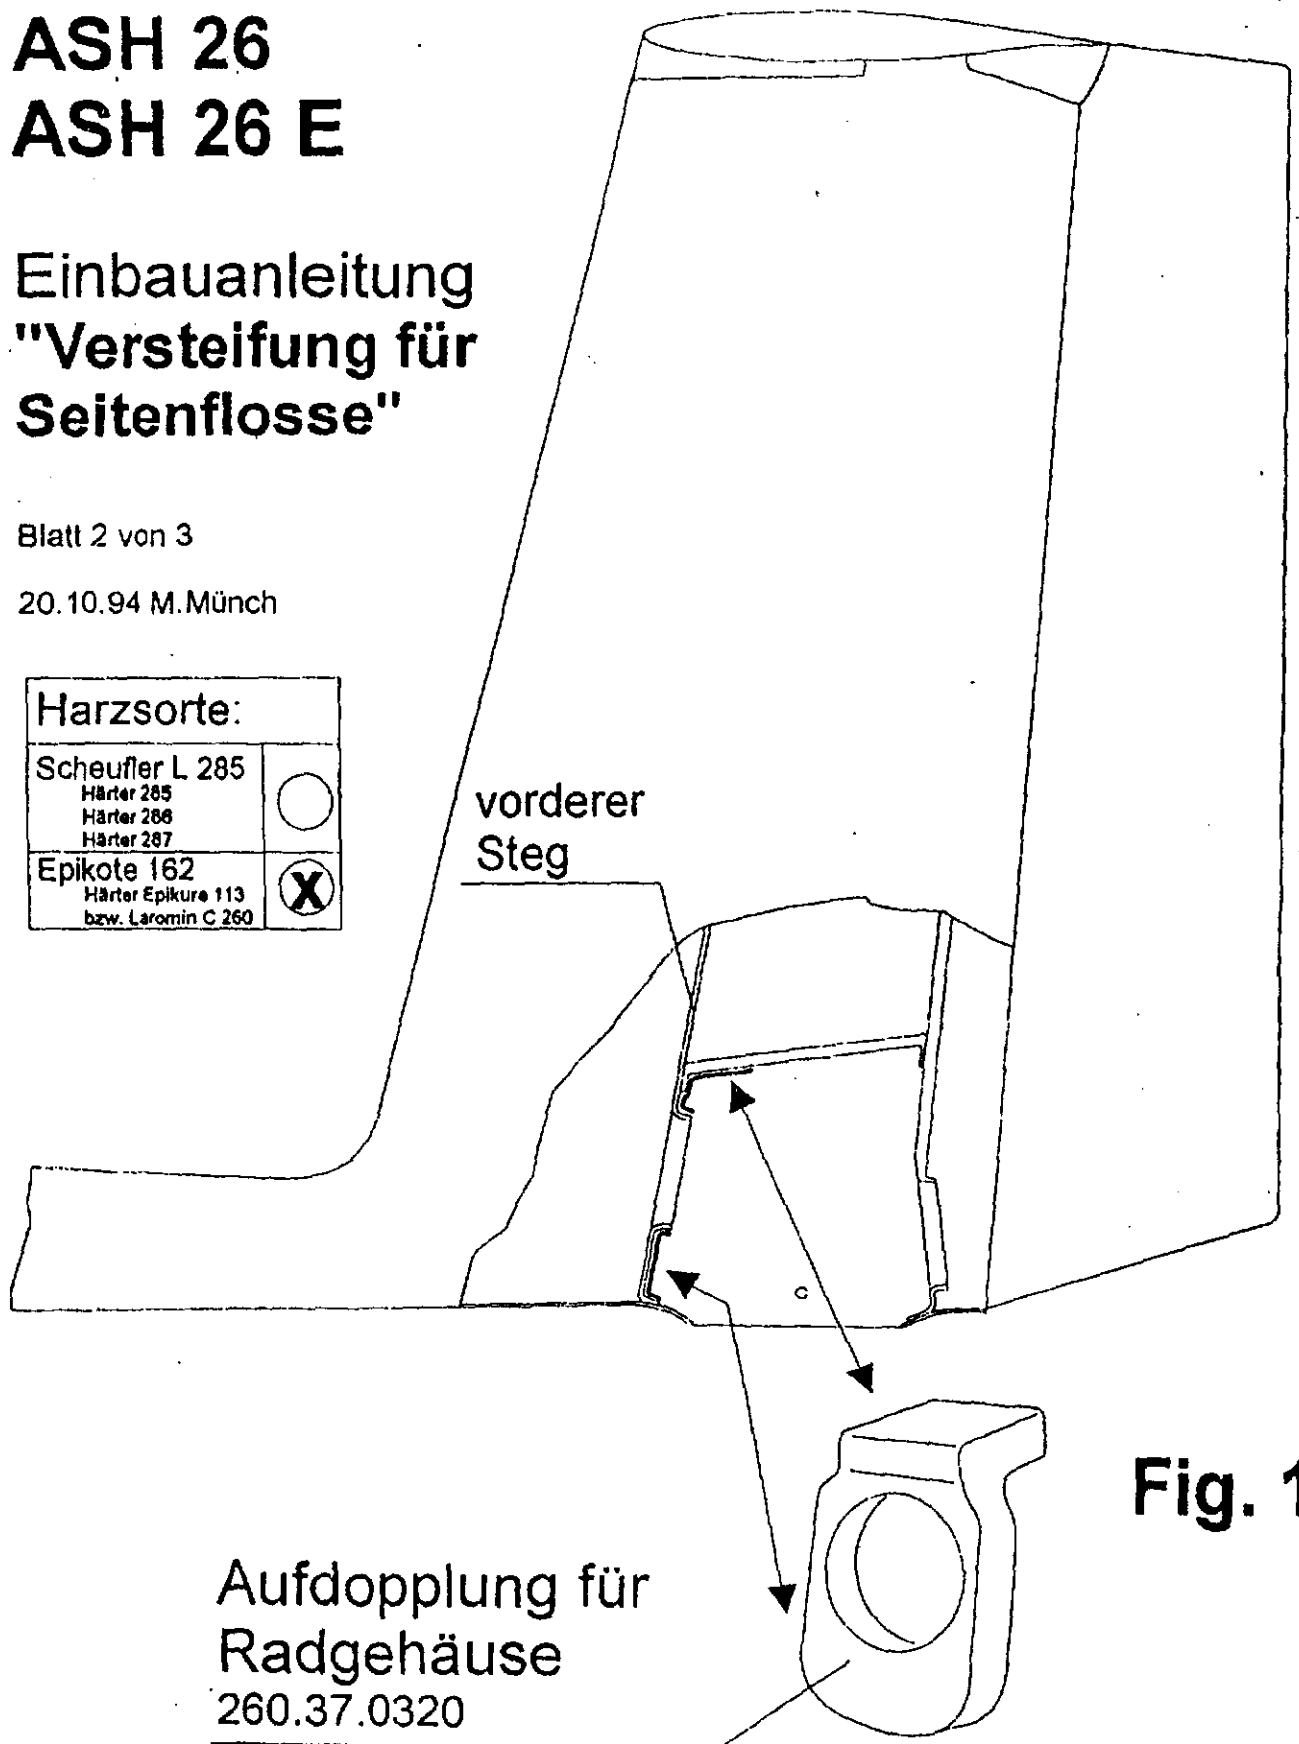
Blatt 2 von 3

Einbauanleitung "Versteifung für Seitenflosse"

- 1.12. STEMME S10 - V - LBA A/D 95-177 concerns propeller blade extension fork.
- 1.13. ASH 26/26E - Rear fuselage modification as required - ref attached sketches.
- 1.14. Centrair 201. A/D 95-0085(A) requires inspection of Elevator Control.

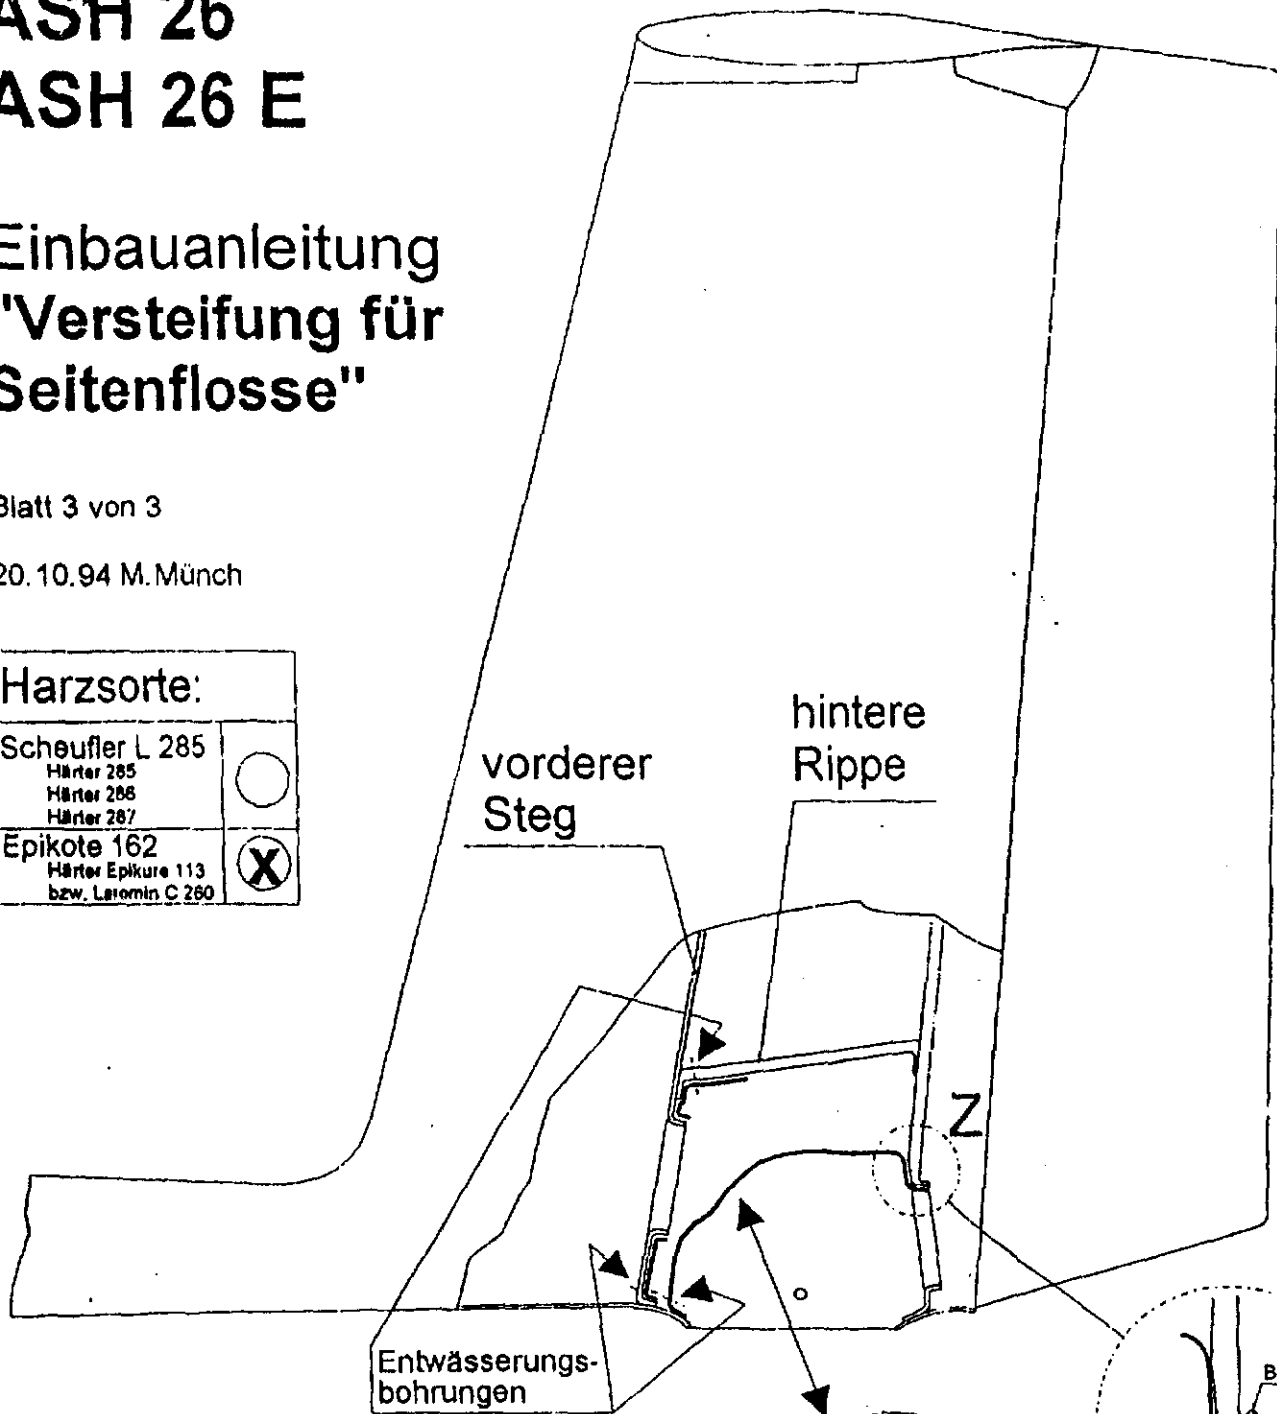
Blatt 3 von 3

Einbauanleitung "Versteifung für Seitenflosse"
