BRITISH GLIDING ASSOCIATION

TECHNICAL NEWSHEET

TNS 7/8/95

PART 1 Airworthiness "AGGRO". Please add to the 1995 Blue Pages.

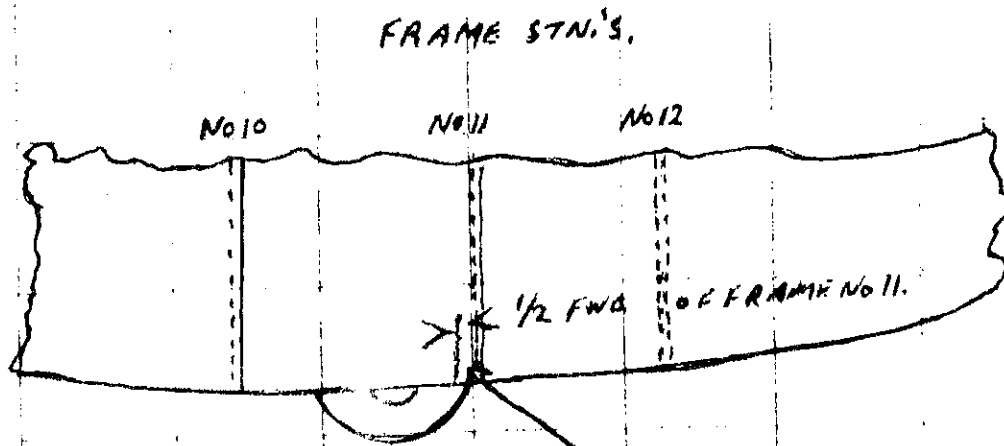
THESE FRACTURES FOUND ON D. L. OF GLIDERS
BY MENDIP GLIDING CLUB

FRACTURE LONG
PORT AND STBD SIDE ON BOCIAN IE
BCA No. 1804 AND PORT SIDE ONLY
ON BOCIAN IE BCA No 3529

BOCIAN IE BCA No. 1804 FRACTURES PORT AND STBD. SIDES.

BOCIAN IE BCA No 3529 FRACTURE PORT SIDE ONLY.

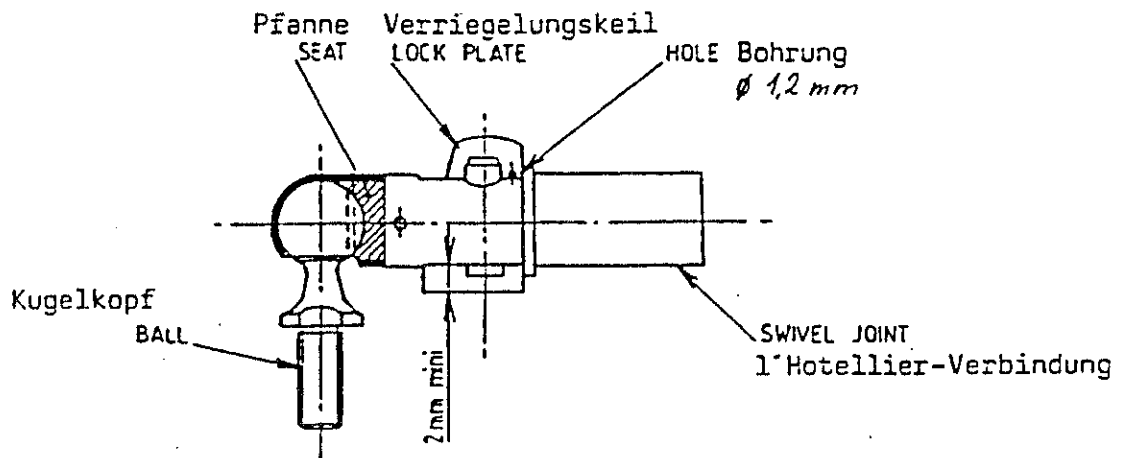
figure 1

The results have shown that the friction surfaces of the lock plates will be run in and smoothed after a relatively small number of operations. As has been demonstrated in the tests, in this case even normal operating conditions are sufficient under unfavourable circumstances to surmount the static friction (i.e. the lock plates open).

- 1) If the joints are not yet equipped with safety pins (e.g. L'H 140-31 made by Hotellier), these safety pins have to be retrofitted. In certain cases it may become necessary to rebores the hole in the lock plate, which is provided for visual inspection, to $\varnothing 1.2$ mm so that the safety pin can be inserted (see figure 1).
