BGA TECHNICAL COMMITTEE

TECHNICAL NEWSHEET 11/12/95

PART 1 Airworthiness "AGGRO"

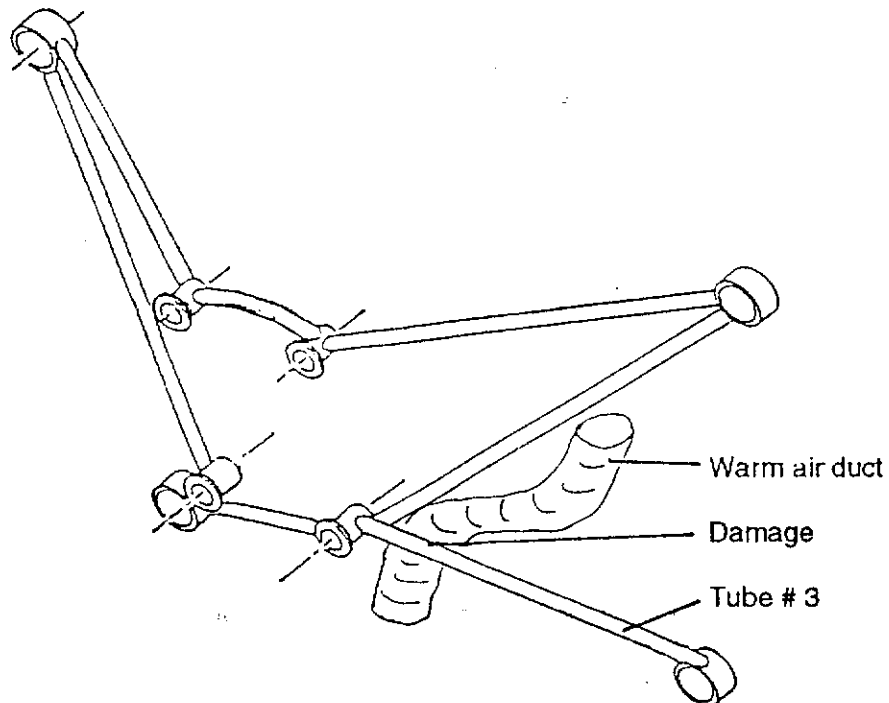
- Subject:** Inspection of the engine mounting frame for abraded areas
- Concerned:** G 109B, all serial numbers
- Urgency:** not later than 31. December 1995
- Procedure:** Some isolated cases have been reported to GROB of abraded areas on the engine mounting frame. The abrasion forms notches on tube # 3 of the engine mounting frame. These notches are parallel to the tube and are caused by the steel spiral of the warm air duct running from the heat exchanger to the LH carburetor rubbing on the mounting frame (see sketch).
In the cases which have come to our notice, the abrasion has arisen on privately maintained aircraft on which an excessively long warm air duct was installed.

- Action:**
1. Inspect tube # 3 of the engine mounting frame for abrasion.
 2. If abrasion is not detected, no further action is necessary.
 3. If abrasion is detected, proceed as follows:

- (a) If the abrasion is of a minor nature (paint scratched off), remove any corrosion from the area and remove dust. Degrease the tube and apply a protective anti-corrosion coat. Shorten the warm air duct or replace it, if damaged.
- (b) If the abrasion is more severe (up to a depth of 0.7 mm), provisionally protect the engine mounting frame as described in para. 3. (a) and perform final repairs in accordance with para. 4 not later than 31.12.1995.
- (c) If the abrasion is deeper than 0.7 mm, repair the engine mounting frame immediately in accordance with para. 4.

Because the repair must be performed in a welding jig, the engine mounting frame can only be repaired by GROB. Return the degreased mounting frame to GROB together with the attached form.

- 5. In addition, inspect all tubes of the engine mounting frame which may be subject to abrasion and protect where necessary with rubber tubes which have been cut open. Attach the rubber tubes to the mounting frame using Ty-raps.

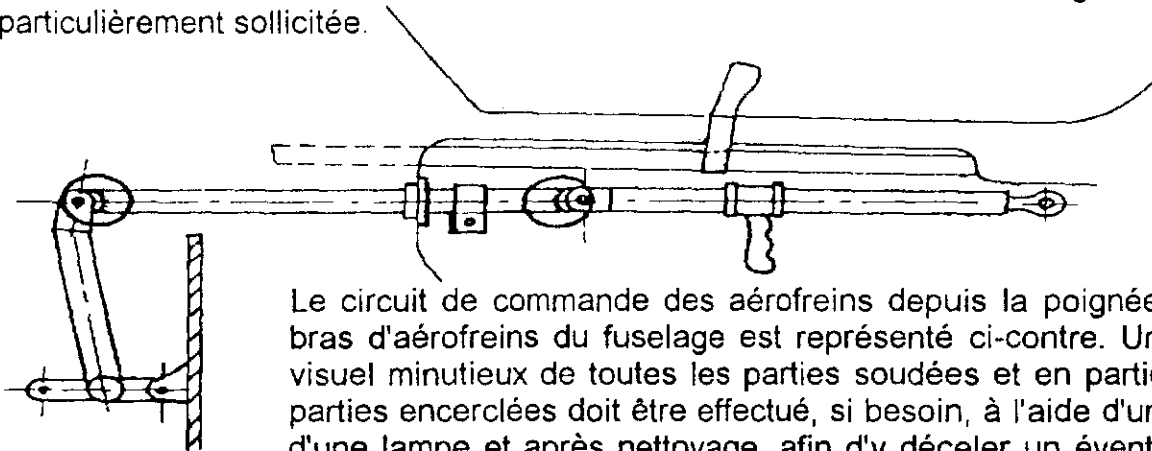
BUT : Détecter des éventuelles criques au niveau du circuit de commande d'aérofreins dans le fuselage.

Nous tenons à attirer l'attention des utilisateurs sur l'importance de ces inspections et notamment sur la chaîne de commande des aérofreins dans le fuselage laquelle est particulièrement sollicitée.

Le circuit de commande des aérofreins depuis la poignée jusqu'au bras d'aérofreins du fuselage est représenté ci-contre. Un contrôle visuel minutieux de toutes les parties soudées et en particulier des parties encerclées doit être effectué, si besoin, à l'aide d'un miroir et d'une lampe et après nettoyage, afin d'y déceler un éventuel début de crique.

En cas de constatation de crique, prendre contact avec S.N. CENTRAIR pour l'informer du défaut constaté. Une réparation du planeur doit alors être réalisée avant tout nouveau vol.

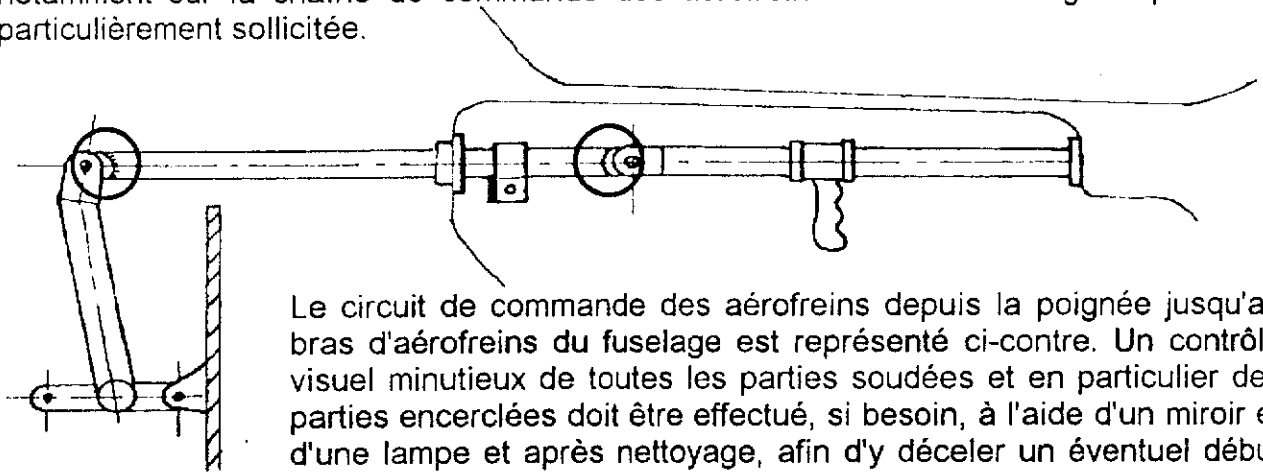
BUT : Détecter des éventuelles criques au niveau du circuit de commande d'aérofreins dans le fuselage.

Nous tenons à attirer l'attention des utilisateurs sur l'importance de ces inspections et notamment sur la chaîne de commande des aérofreins dans le fuselage laquelle est particulièrement sollicitée.

Le circuit de commande des aérofreins depuis la poignée jusqu'au bras d'aérofreins du fuselage est représenté ci-contre. Un contrôle visuel minutieux de toutes les parties soudées et en particulier des parties encerclées doit être effectué, si besoin, à l'aide d'un miroir et d'une lampe et après nettoyage, afin d'y déceler un éventuel début de crique.

En cas de constatation de crique, prendre contact avec S.N. CENTRAIR pour l'informer du défaut constaté. Une réparation du planeur doit alors être réalisée avant tout nouveau vol.

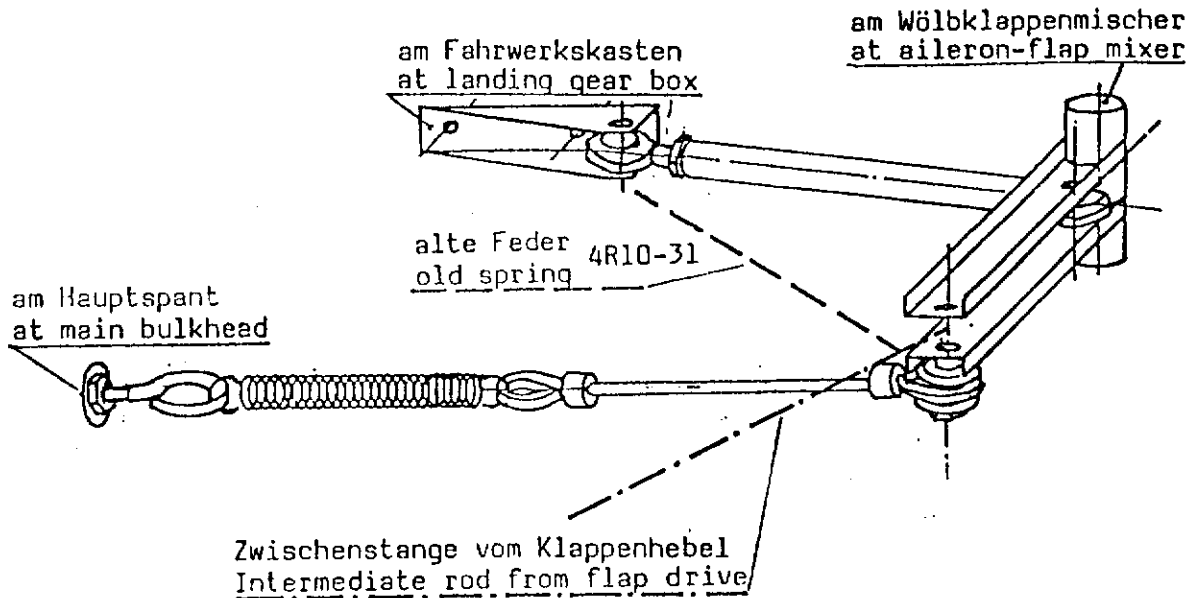
Drawing of flaperon drive in fuselage near landing gear box, parts list and exploded view for assembly.

Reason : The spring 4R10-31 (cadmium plated steel) in the flap drive may fracture due to fatigue, resulting in high flap control force at negative flap position.

Instructions : Spring 4R10-31 to be exchanged according to drawing 1BR-3b against longer spring (RZ 141 EI, corrosion resistant steel), also forward mounting of spring moved from landing gear box to main bulkhead. See pages 2 to 4 of this TB (excerpt of drawing 1BR-3b) for details, material and installation instructions.
