# BGA TECHNICAL COMMITTEE

## TECHNICAL NEWSHEET 1/2/96

### PART 1     Airworthiness "AGGRO"

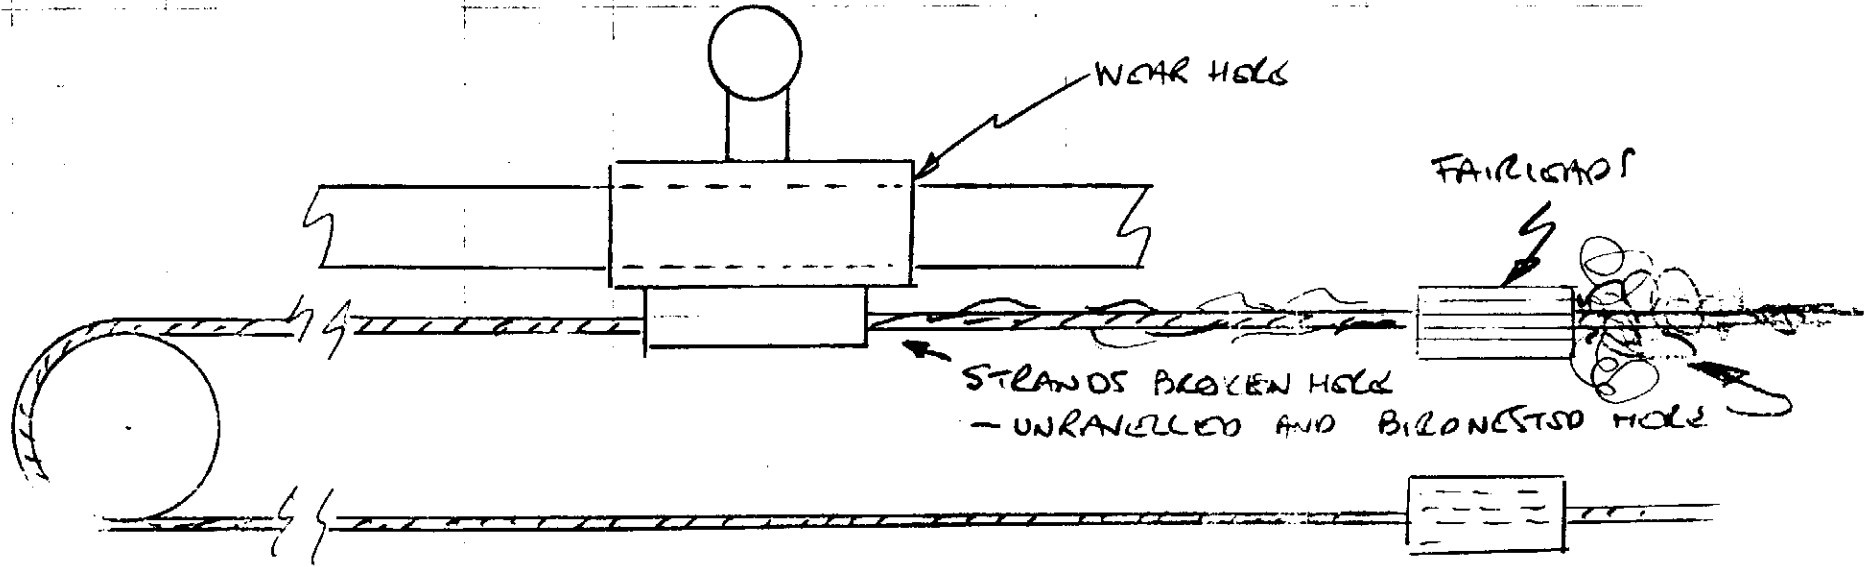
SHK TRIM CONTROL

- 1.4.     SHK - Trim System cable frayed - difficult to operate. Inspection hole cut in inner G.R.P. skin to gain access. (see diagram). Reported by P. Wells - Southdown G.C.

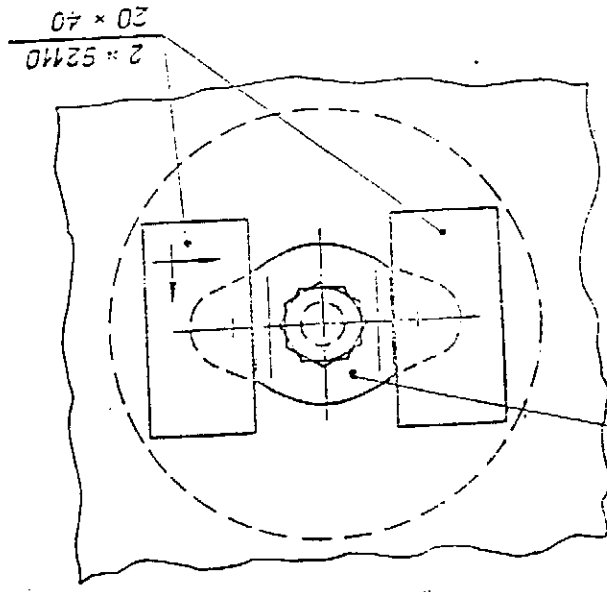
Fig. 3

Note: The case of loosening the screw fastening the distance sleeve on which the air brake plate arm rotates.

- 5.5. Glue-up onto the air brake boxes the degreased securing metal pads acc. to Fig. 3.
- 5.6. Cut the ring of  $\varnothing$  110 mm of 30-60 / 55 mm foam, cover with a composition with aerosil, glue the 2 x 92110 fabrics on these rings, glue into the coverings with a composition with aerosil, than press down till it is cured.
- 5.7. Sand-off the resin surplus.

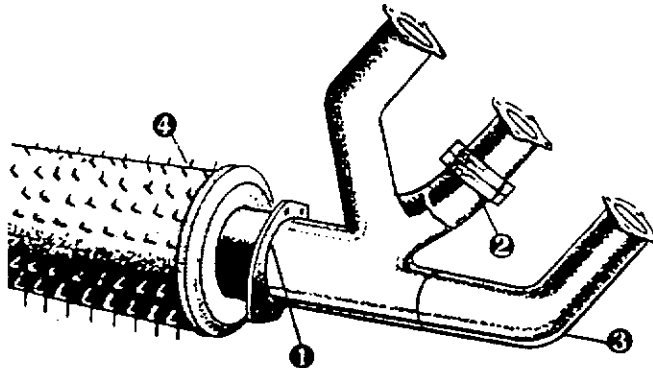
Examine surfaces adjacent to exhaust system components for telltale signs of exhaust soot. They reflect leakage points.

Look for gray, red or black gas stains at welds, clamps, flanges, etc. ❶
