## BGA TECHNICAL COMMITTEE

### TECHNICAL NEWSHEET 3/4/96

K 8  
Technical Note  
No. 24

Subject : Glass fiber laminate covering the spar stub fittings

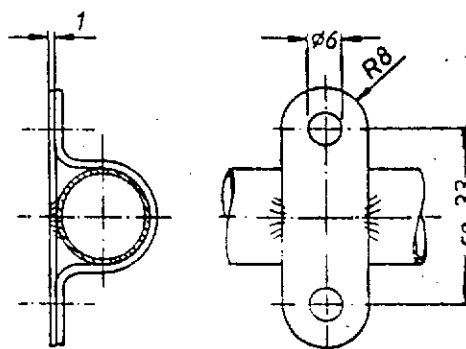
Fig. A2

- ad A2) In case of extreme overloading the rudder pedals the attach collars of the pedal boards may bend. As a result also the full deflection of the rudder can become restricted.

- ad A2) Checking the rudder pedals:  
With the rudder neutral the pedals left and right must be evenly adjusted. Check the pedal board angle versus the pedal dimensions (see drawing L-216.42-U01). The angle must meet the specified dimension.  
Engage the pedal adjustment into its foremost position and check full deflection of the rudder.  
Where pedals or attachment collars are bent, these can be either repaired or replaced by new ones.  
In order to impede the bending of the pedal boards it is optionally recommended to weld an additional butt strap onto the attachment collar (see Fig.A2).

Reinforcing the attachment collars for pedal boards at the pedal assembly. Material: 1.7734.4  
Welding procedure WIG to spec DIN 1912, welding wire material: 1.7734.2

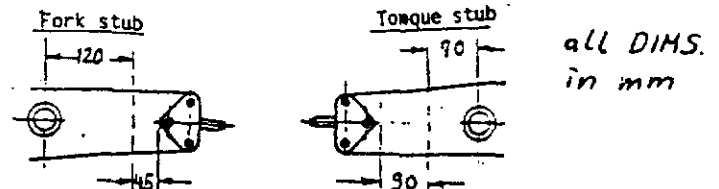
Reason : Separation of laminate from wing attachment fittings allowing the ingress of moisture which in turn may lead to corrosion

First remove gelcoat from spar stub (if such was applied by the manufacturer) and remove laminate as shown in the sketch (such preparing the area to be scarfed later on) -

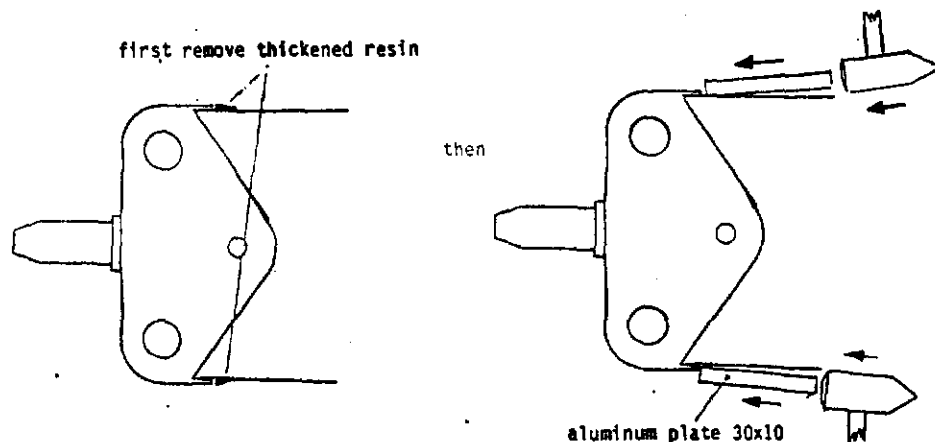
If there is suspicion that there is corrosion on the inner side of the fitting, it has to be removed as follows:

Drive out hollow rivets imbedded in the spar flanges - but make sure that a counter weight is held against the driving force, Thereafter, with rivets removed, carefully loosen and extract the fitting with the aid of an aluminum plate - see sketch.

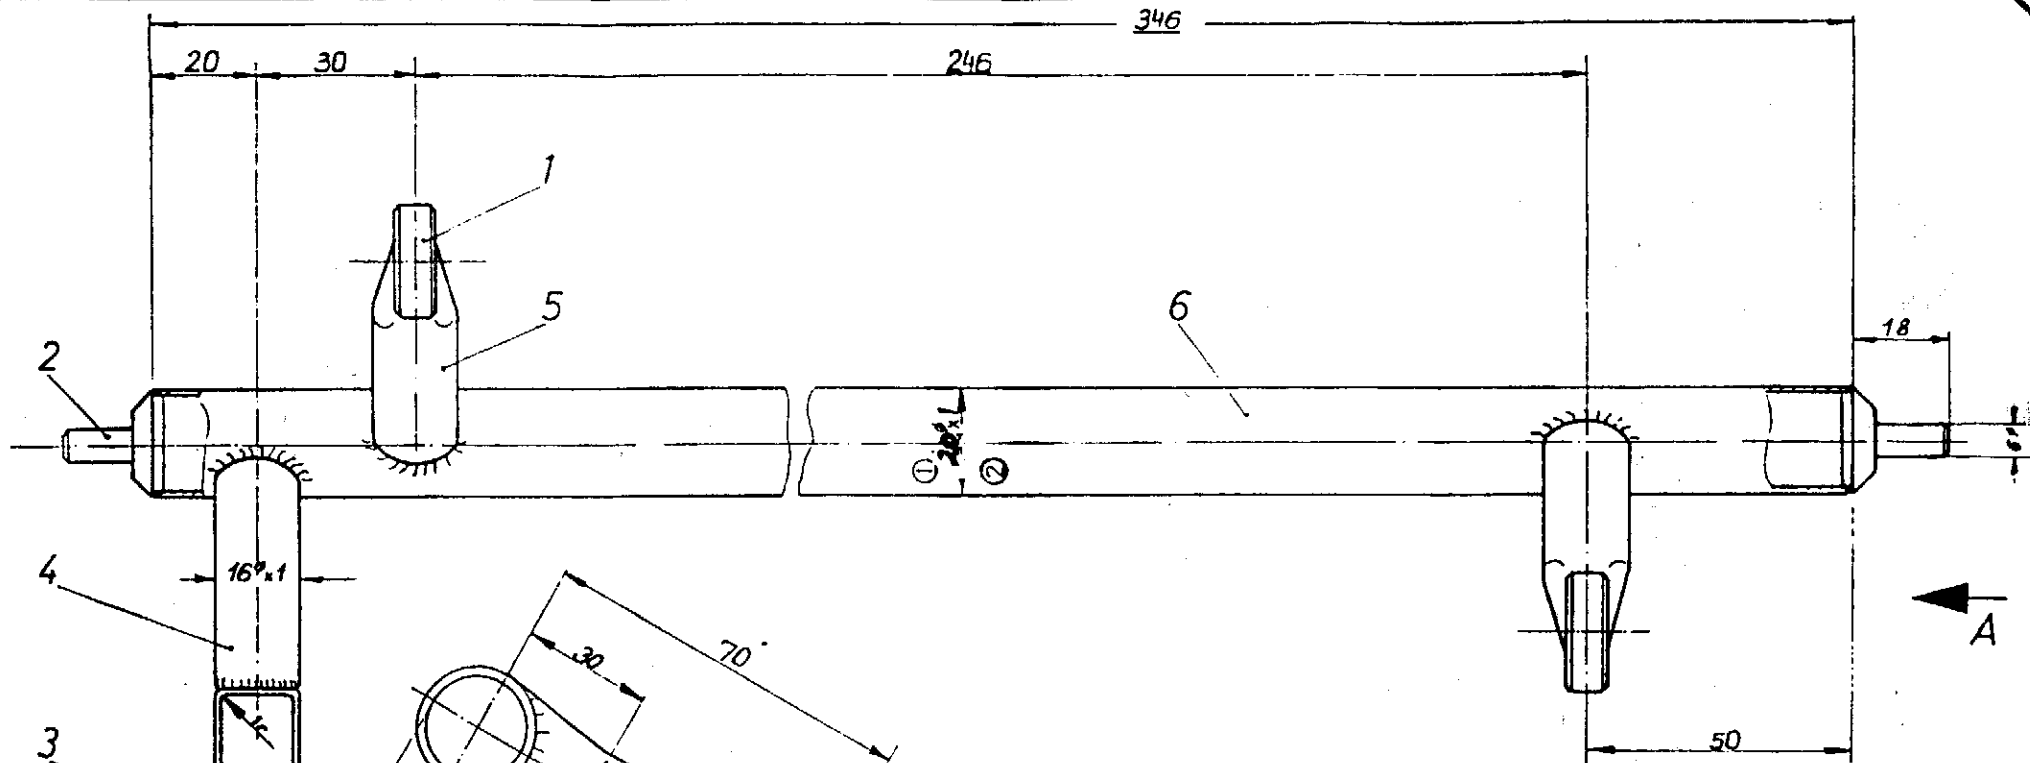
**Reason:** Cracks on aileron operating lever's welding seams due to overloading in case of derigging without disconnection of aileron controls.

**Method 3:** If method 2 was not accomplished the original actuating shaft can be replaced by a new and reinforced shaft according to drawing no. 201-47-3, Change "2".
