## BGA TECHNICAL COMMITTEE

### TECHNICAL NEWSHEET 5/6/96

TNS / S16196

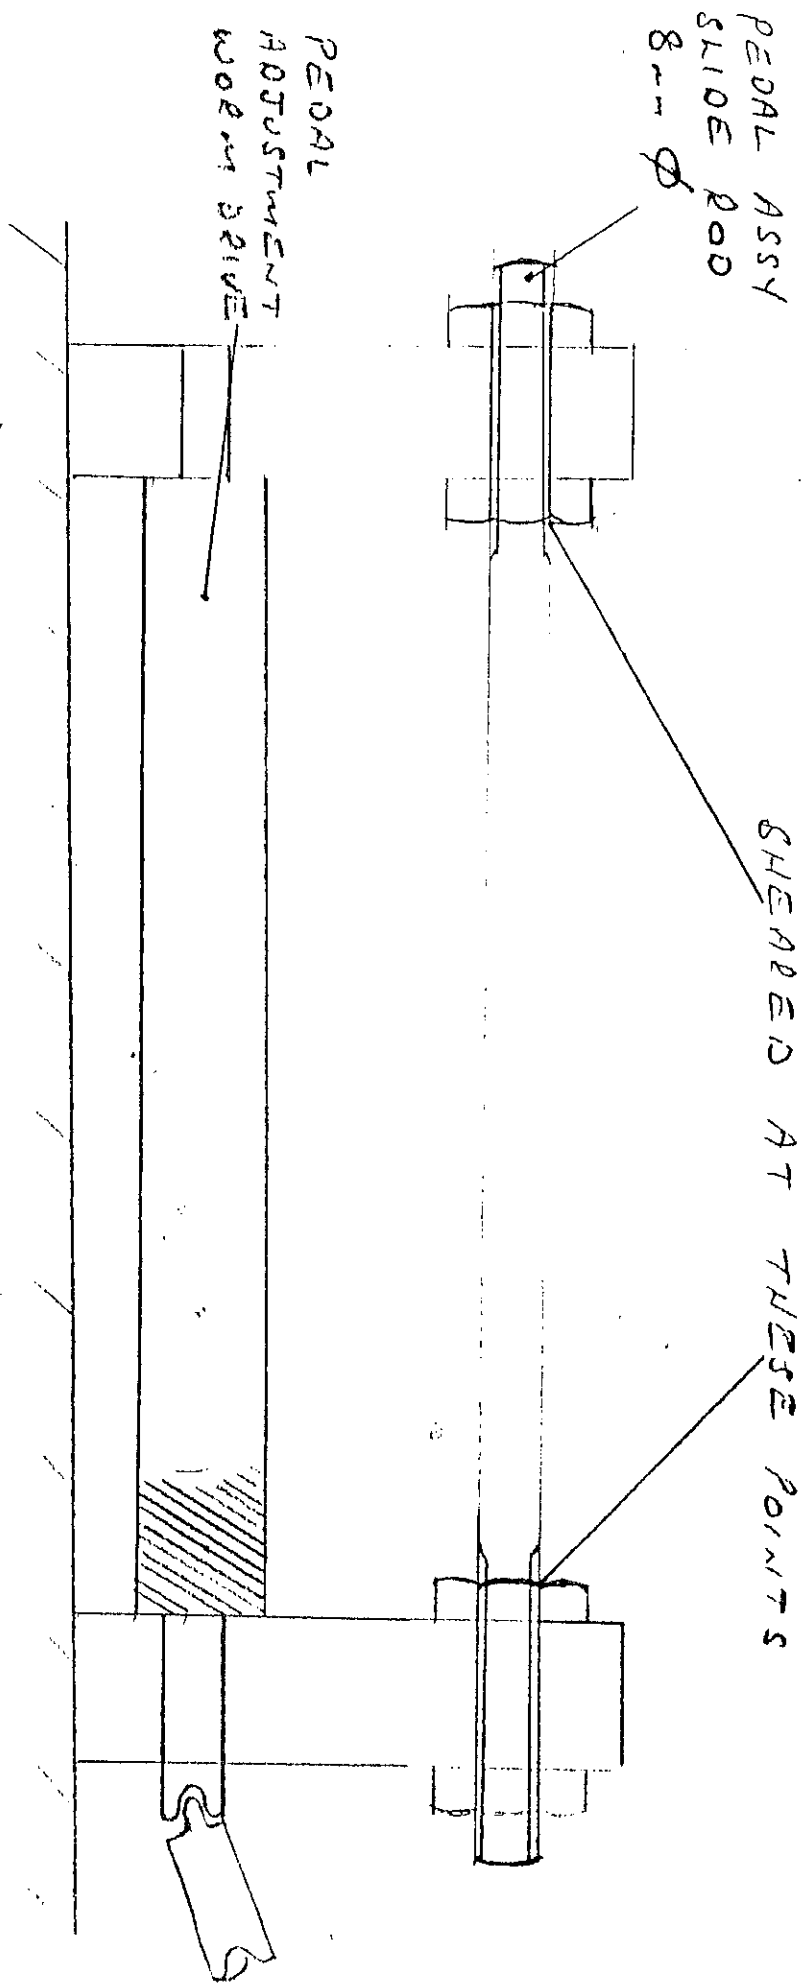
SIDE VIEW SKETCH OF FRONT RUDDER PEDAL MOUNTING ASSY.  
PEDALS OMITTED FOR CLARITY

May also apply to other Magneto installations.
  - 1.9.     G.103 Grob Accro II. Speed brake jammed by Gel-Coat repairs at brake cut-outs. Check for adequate clearances after such repairs. (Reported by Derby & Lancs G.C.).
  - 1.10.     G.103 Accro Twin 3 Rudder Pedal Assembly, Failure of Pedal Assembly Slide-Rod. Sketch from Lasham herewith.

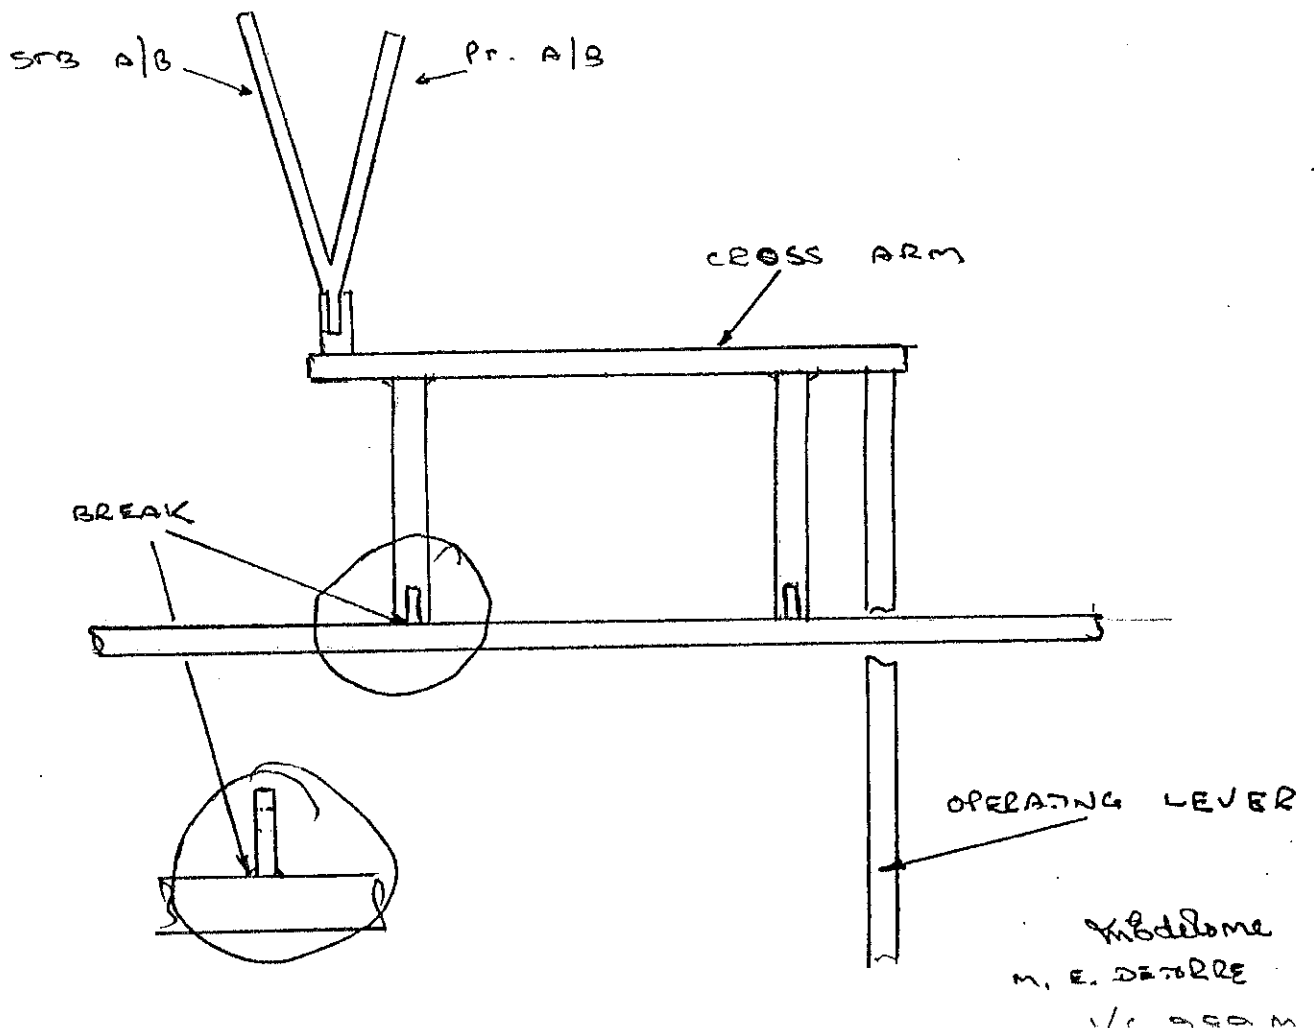
K8 BEAKE LEVER FAILURE REPORTED BY SHALBONKINE

K8 BGA. NO 3582.

54.  
After a flying incident at Garmston airfield  
(to be covered by a separate report) an inspection  
of the air brake control circuit revealed a broken  
link. This link is attached to the cross arm  
(normally) sketch shows details.

POINT OF FAILURE THROUGH  
LEVER AT BEARING  
HOLE, IN FLIGHT  
FAILURE UNDER NORMAL  
USE LEVER BROKE COMPLETELY  
OFF AT THIS POINT.

SECOND CLUB K8 INSPECTED  
AND FOUND TO HAVE A  
SMALL CRACK STARTING AT  
AN IDENTICAL POSITION.  
SUGGESTED THAT LEVERS ARE  
EMOVED ANY PAINT CLEANED  
OFF AND CAREFULLY INSPECTED.

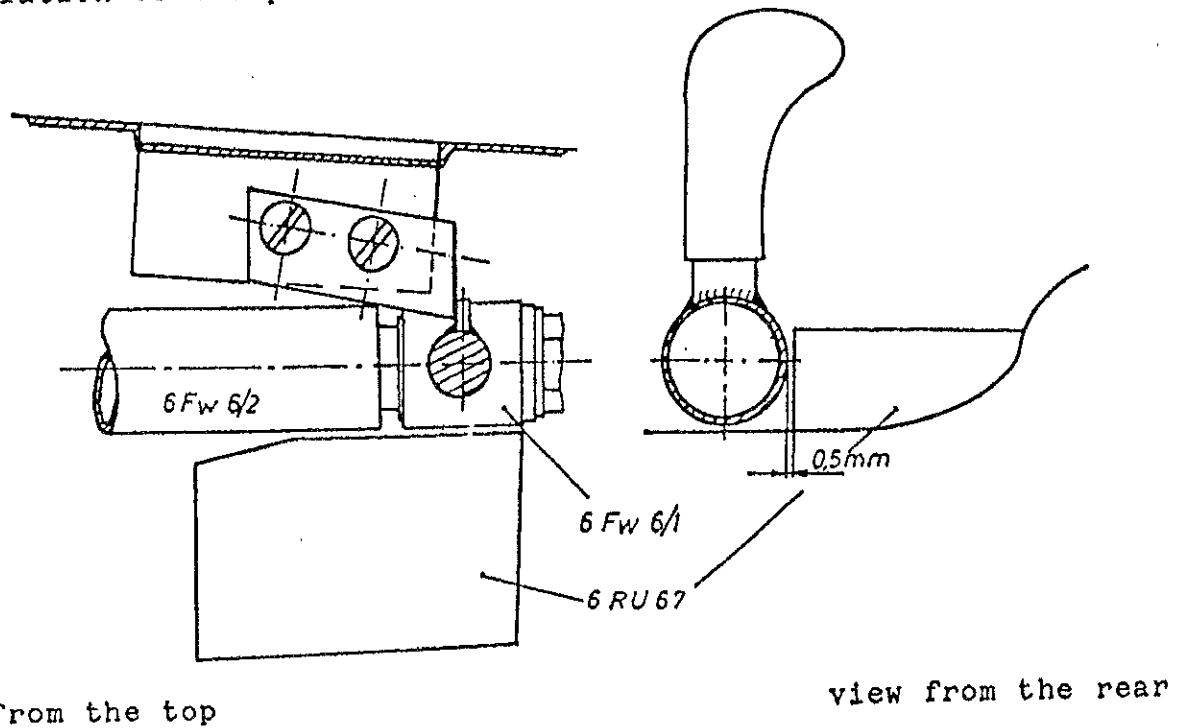
D.C. 400 Undercarriage Lock.

- 1.3.     D.G. 400. Inadvertent Undercarriage Retraction can be eliminated by the installation of a plastic block. Service Information 6-1 copied herewith.

Installation of the plastic block 6 RU 67.

1. Remove left cockpit side cover.
2. Roughen the seat shell in the area for block 6 RU 67 (see sketch) thoroughly with sandpaper.
3. Roughen the glue area of block 6 RU 67.
4. Glue block 6 RU 67 onto the seat shell.  
Therefore extend the landing gear and place a thin piece of cardboard between the landing gear control pushrod and the block to ensure the free play of appr. 0.5 mm.  
Press the block to the seat shell and secure it for curing with tape or with ballast.  
Remove excessive glue material.

Suitable glue material: Epoxyresin see repair manual or polyester resin both thickened with cotton flocks.

5. After curing.  
Function check of the landing gear control.
6. Reinstall the cockpit side cover.

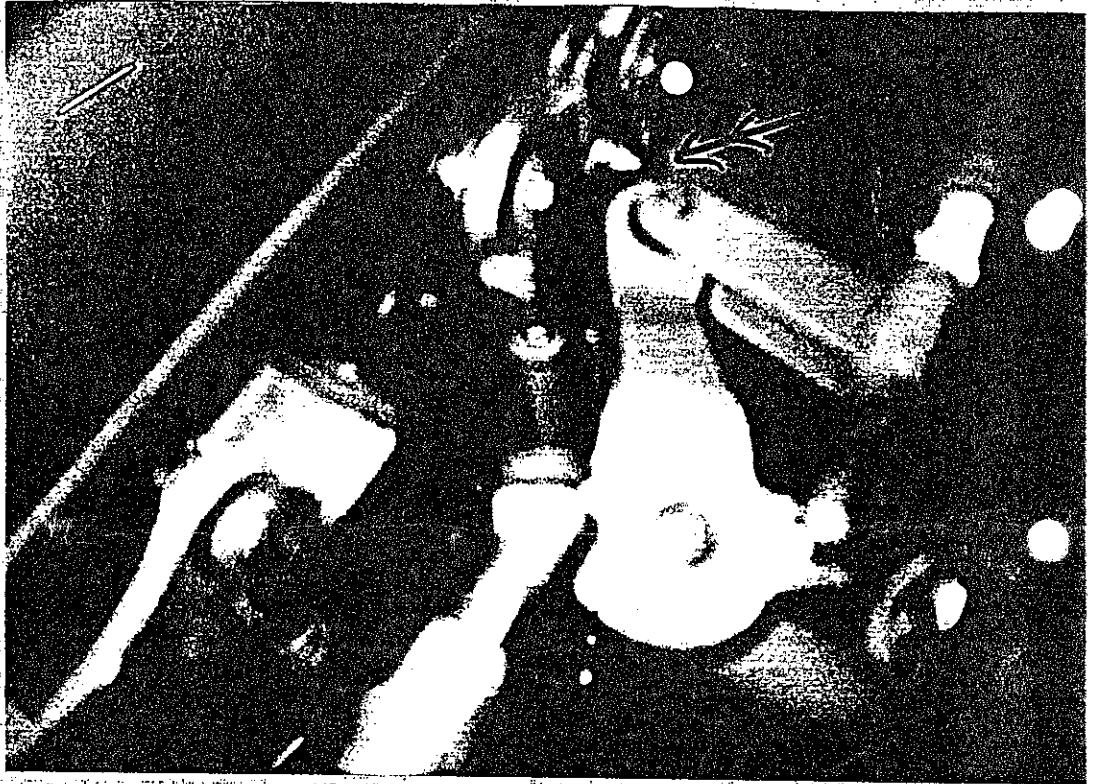
ASW 20 CONTROL JAM

- PART 1**     **Airworthiness "AGGRO"** Please add to the BGA's 1996 Compendium.
- 1.1.     ASW 20 - Elevator Control. Restricted by interference between bolts in the centre section control system. When full flap and speed-brake deployed. Check for correction insertion of bolts to provide clearance, after disassembly.

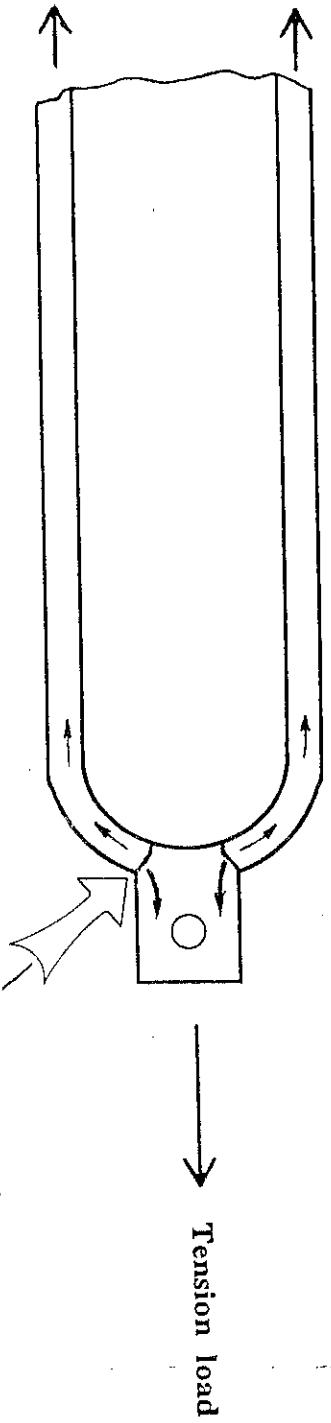
PA-18 Undercarriage Damper Body Failure, G-BALFF

Final overload region, mostly in shear

Fatigue region

Crack initiated at multiple sites

Note surface pitting corrosion and rough machining marks

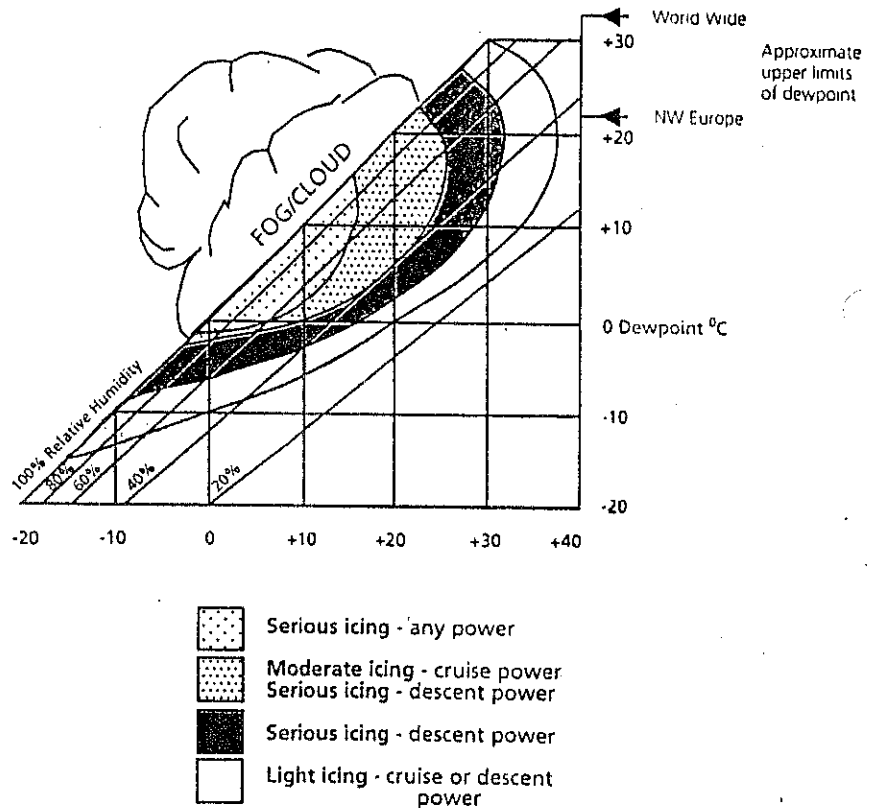
the icing ranges as shown in the chart shown.

It seems likely that the continuous use of carburettor heat caused the temperature in the venturi of the carburettor to rise such that it was now in one of
