BGA TECHNICAL COMMITTEE

TECHNICAL NEWSHEET 9/10/96

Airworthiness "AGGRO" - Please add to the 1996 Pink pages.

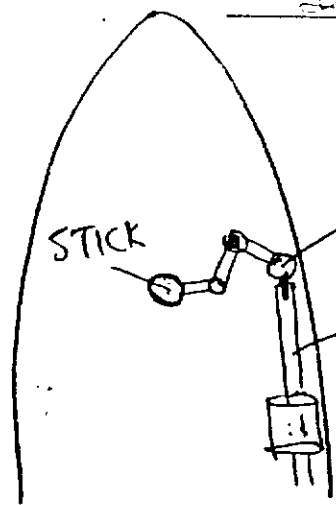
JANUS TAIL PLANE FITTING.

- 1.4. **Janus Tailplane** attachment fittings on the fin found cracked. (See photo). Reported by RAFGSA.
- 1.5. **KA21 - Safety Clips in Speed-Brake** Connectors attached by too long lanyards, were extracted from the L'hotelliers when the brakes were operated! (Southdown G.C.).

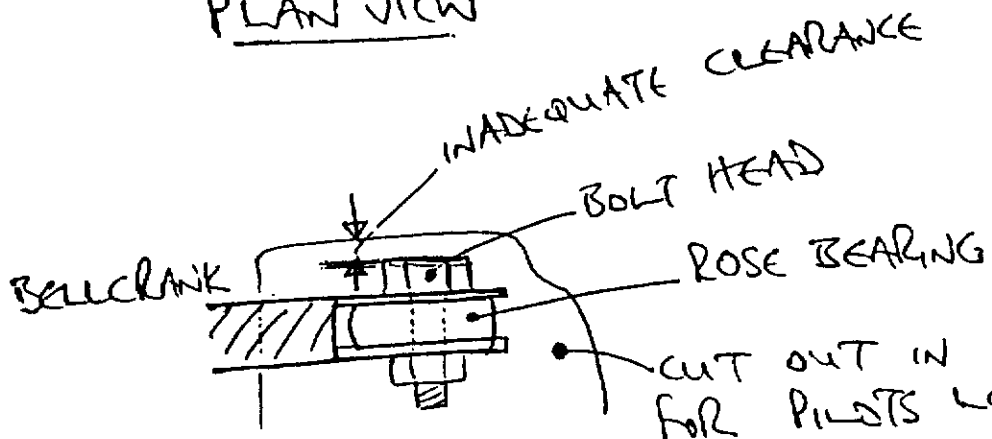
DETAIL VIEW FROM AFT

- 1.6. **Discus - Aileron Jammed In Flight** by bolt-head on the aileron bellcrank below the pilots seat, fouling on the clearance hole in the pilots leg support structure. (See sketch).

INADEQUATE CLEARANCE
BOLT HEAD
ROSE BEARING
CUT OUT IN SUPPORT STRUCTURE FOR PILOTS LEGS / INSTRUMENT PANEL

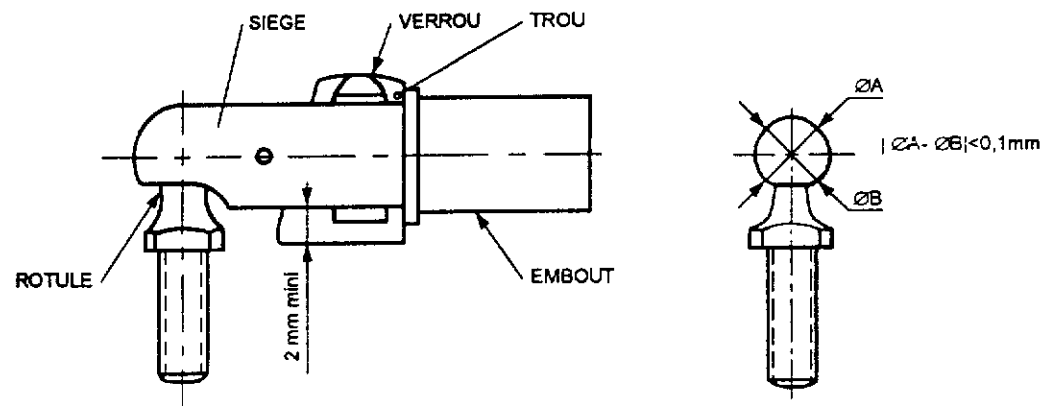
Afin de clarifier ces instructions dans le cadre de l'entretien des planeurs Pégase, les inspections de chaque ensemble rotule et embout à effectuer lors de chaque Visite Annuelle ou Grande Visite sont détaillées page suivante. Dans le cas où certaines opérations n'auraient pas été effectuées lors de la dernière visite, nous recommandons de les effectuer rapidement pour éviter tout risque de défaillance.

Dans le cas où l'une des vérifications ci-dessus (sauf **h**) n'est pas satisfaisante, il est impératif de remplacer le couple rotule+embout concerné.

Dans le cas où la vérification **h** n'est pas satisfaisante, effectuer le blocage correct avec le contre-écrou.

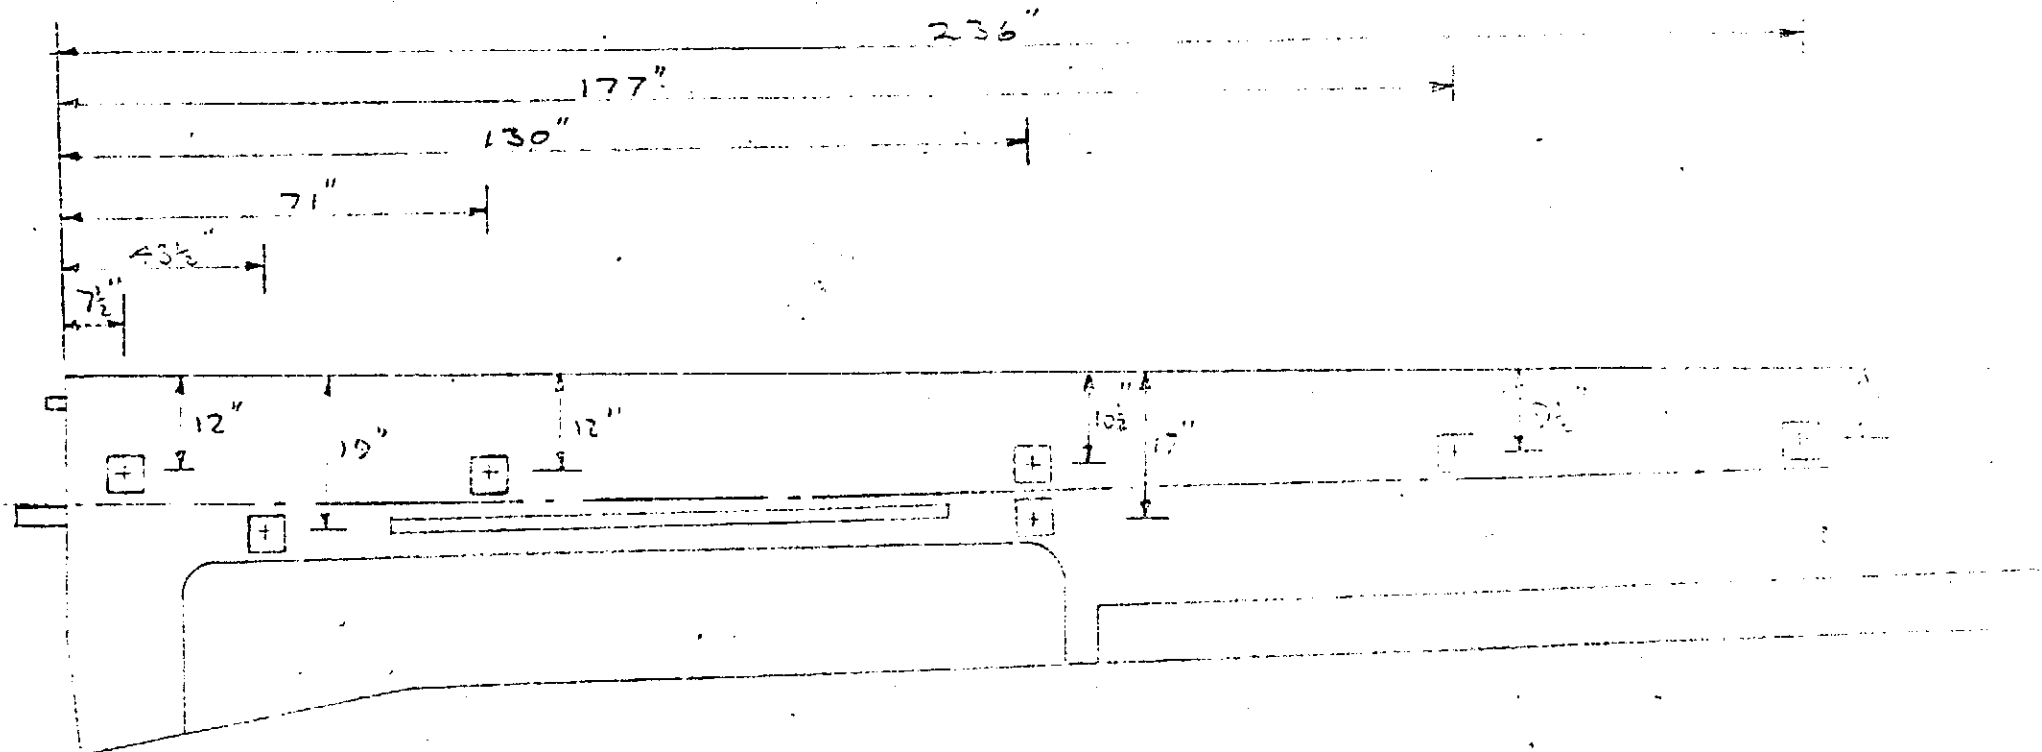
This inspection follows the discovery of severe metal corrosion in the spar of a Dart. Although the aircraft was clearly not in a good overall condition, there is no documented evidence of any severe environment being encountered.

1. Mark the hole centres as shown on the diagram, drill $\frac{1}{2}$ " dia. hole in the ply and gradually open up the holes to 3" - 4" square.
2. Thoroughly inspect the metal portion of the spar paying particular attention to bolted joints and rib attachment points.
3. If any significant corrosion exists, that is more than 0.007" in depth the aircraft will require repair action.
4. The holes in the wing should be repaired in accordance with standard practice and the results of the inspection sent to Slingsby Sailplanes.
5. After the results of the inspection have been analysed by Slingsby Sailplanes further action may be required on an annual basis.

CUT INSPECTION HOLES IN LOWER SURFACE OF BOTH WINGS AS SHOWN

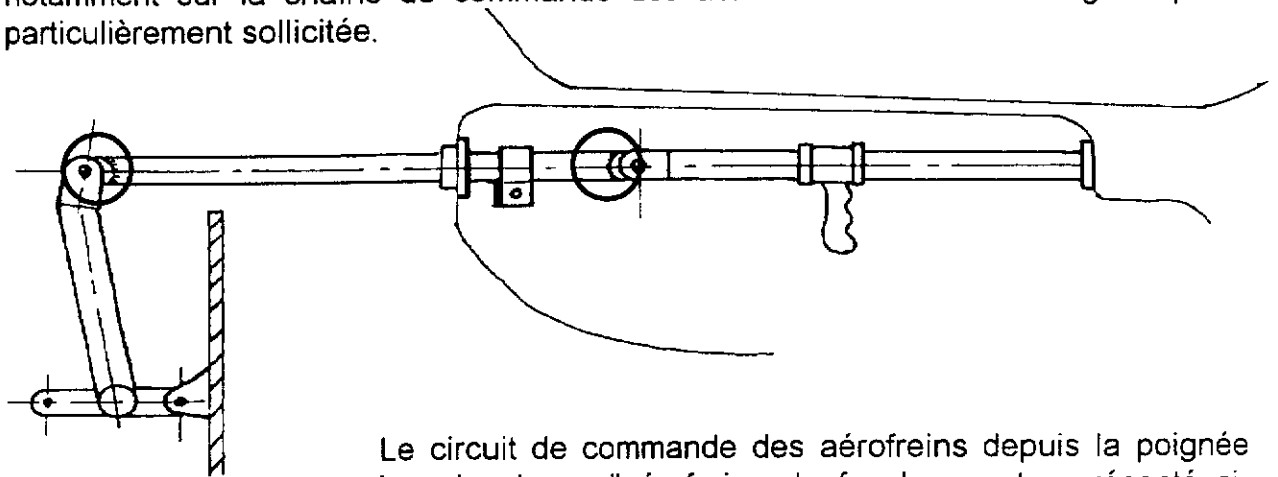
Bras d'aérofreins

Nous tenons à attirer l'attention des utilisateurs sur l'importance de ces inspections et notamment sur la chaîne de commande des aérofreins dans le fuselage laquelle est particulièrement sollicitée.

Le circuit de commande des aérofreins depuis la poignée jusqu'au bras d'aérofreins du fuselage est représenté ci-contre. Un contrôle visuel minutieux de toutes les parties soudées et en particulier des parties encadrées doit être effectué, si besoin, à l'aide d'un miroir et d'une lampe et après nettoyage, afin d'y déceler un éventuel début de crique.

En cas de constatation de crique, prendre contact avec S.N. CENTRAIR pour l'informer du défaut constaté. Une réparation du planeur doit alors être réalisée avant tout nouveau vol.

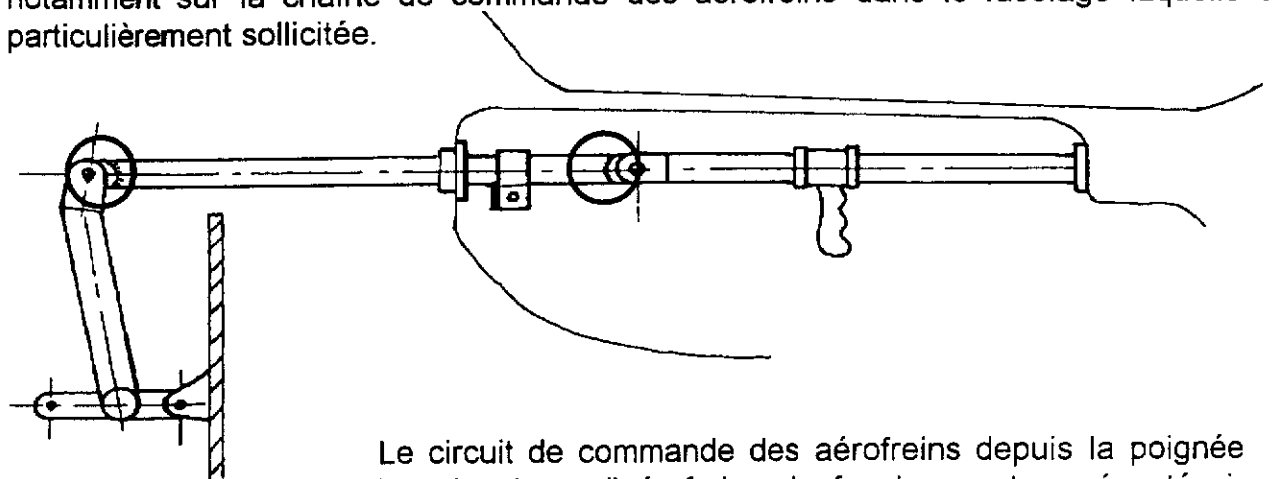
Bras d'aérofreins

Nous tenons à attirer l'attention des utilisateurs sur l'importance de ces inspections et notamment sur la chaîne de commande des aérofreins dans le fuselage laquelle est particulièrement sollicitée.

Le circuit de commande des aérofreins depuis la poignée jusqu'au bras d'aérofreins du fuselage est représenté ci-contre. Un contrôle visuel minutieux de toutes les parties soudées et en particulier des parties encadrées doit être effectué, si besoin, à l'aide d'un miroir et d'une lampe et après nettoyage, afin d'y déceler un éventuel début de craque.

En cas de constatation de crique, prendre contact avec S.N. CENTRAIR pour l'informer du défaut constaté. Une réparation du planeur doit alors être réalisée avant tout nouveau vol.
