BGA TECHNICAL COMMITTEE

TECHNICAL NEWSHEET 1/2/97

PART 1 Airworthiness "AGGRO"

Technical Note
No. 301/18
No. 323/9
No. 826/34

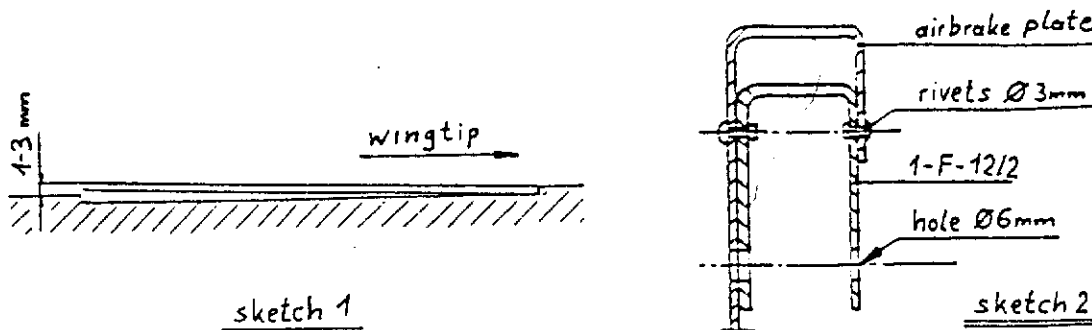
The airbrakes must retract at their outboard end first. When the airbrake cap is flush with the wing surface at the outboard end, the inboard end must be 1-3mm (0.039-0.118in) above the wing surface (s. sketch 1).

If not, modify as follows. With the modification a value of 1-3mm shall be adjusted.

1. Remove the bolt fixing the airbrake plate to the outboard bellcrank.
2. Drill out the 4 rivets which fasten the U-bracket 1F12/2 to the airbrake plate and remove bracket (s. sketch 2). Use a $\text{Ø}3\text{mm}$ (0.118 in) drill.

3. Enlarge the $\text{Ø}6\text{mm}$ hole at which the outboard bellcrank was screwed to the airbrake plate to $\text{Ø}7\text{mm}$ (0.276in).
4. Insert a new bracket 1F12/2 into the airbrake plate and screw it together with the airbrake plate and the bellcrank. Press bracket and bellcrank outboard when tightening the screw.

5. Retract the airbrake and measure the distance of the inboard edge of the airbrake cap to the wing surface. If the desired value of 1-3mm is not reached, you must repeat items 3 and 4. Enlarge the hole in steps from $\text{Ø}7\text{mm}$ to max. $\text{Ø}8\text{mm}$ (0.314in).

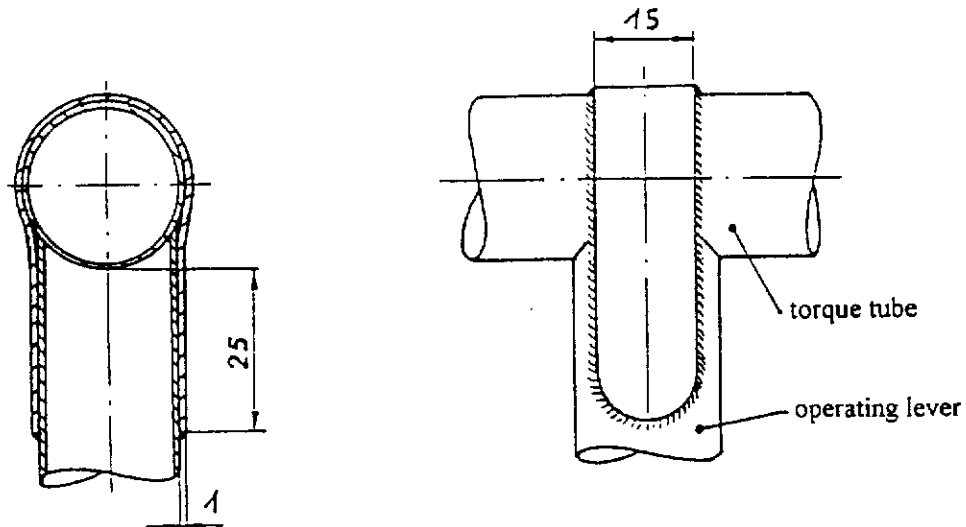
Prior to the next flight the airbrake torque tube in the fuselage must be inspected. Check the welded joint to the operating lever on cracks or deformation when locking and unlocking the airbrakes on the rigged airplane. The airbrake torque tube can be reached through the inspection hole in the fuselage. For inspection of the welding joint use a mirror and a magnifying glass (magnification min. 5x). In case of doubt remove torque tube for closer inspection.

If there are no defects flying operation can be continued until next inspection. If there is even a minor damage suspected instructions 3 must be accomplished prior to next flight.

If necessary the welded joint of torque tube and operating lever must be reinforced by welding an additional steel sheet 1-St-12/2 made of material 1.7734.4 (s. sketch). Visible cracks or other defects of the original joint must be repaired first. All welding must be done with the TIG-welding system (tungsten inert gas) using welding wire 1.7734.2. Where welding is to be done cadmium plating or painting must be removed first by sandblasting.

If the torque tube is damaged by deep cracks and due to this corrosion inside the torque tube or the lever is suspected, the complete part 1St12 must be exchanged.

After welding all metal surfaces must be protected against corrosion. This can be done by painting with suitable primer and paint.

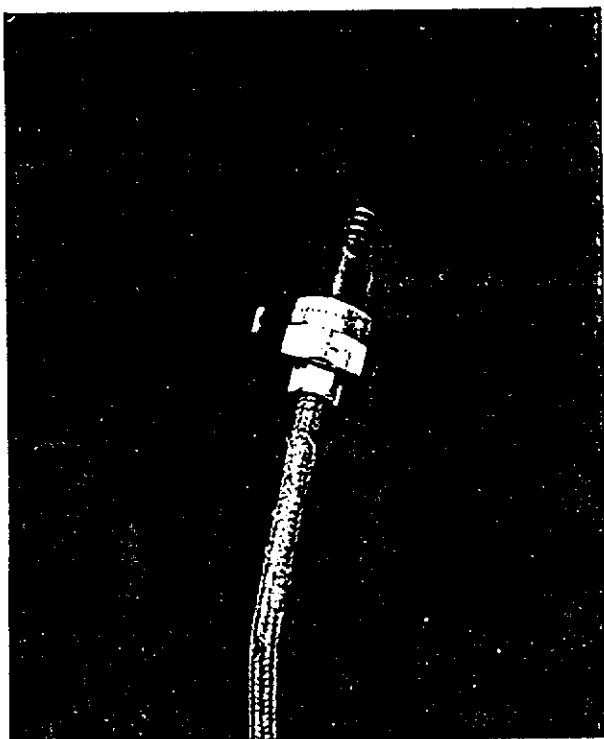
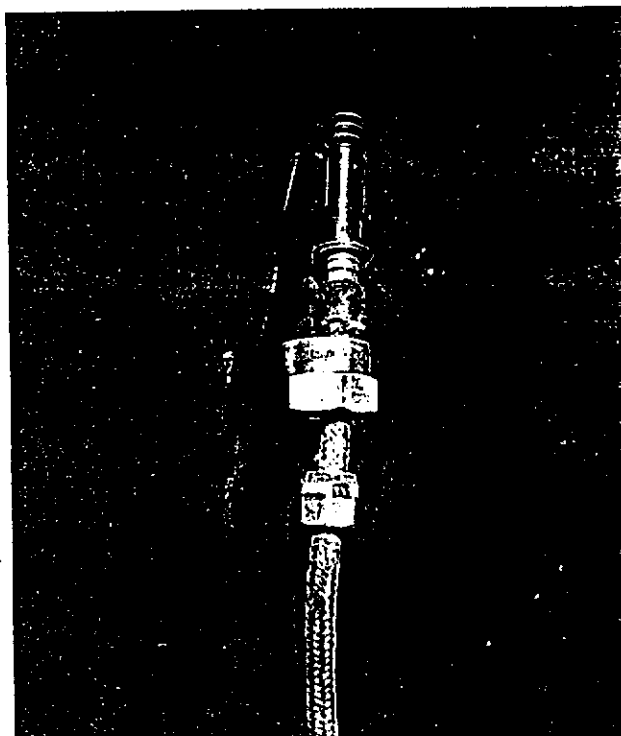
E1. MAGNETO LEADS

once and for all. Finally, removal of the magneto lead from the number 4 cylinder revealed the problem. As the first photograph on the left shows, it appears that the lead end is quite normal. However, upon tugging the lead, it can be seen that the smaller ferrule, which is

clamped in place by the large nut, had in fact failed and the clamping was non-existent. This allowed the outer sleeve of the plug lead to make only intermittent contact. A careful check of the entire harness found three other leads to be in similar condition. A new ignition harness solved the problem once and for all.
