B.G.A. TECHNICAL COMMITTEE

TECHNICAL NEWSHEET

TNS/5/6/87

PART 1 AIRWORTHINESS "AGGRO" (Please add to the 1987 Green Pages)

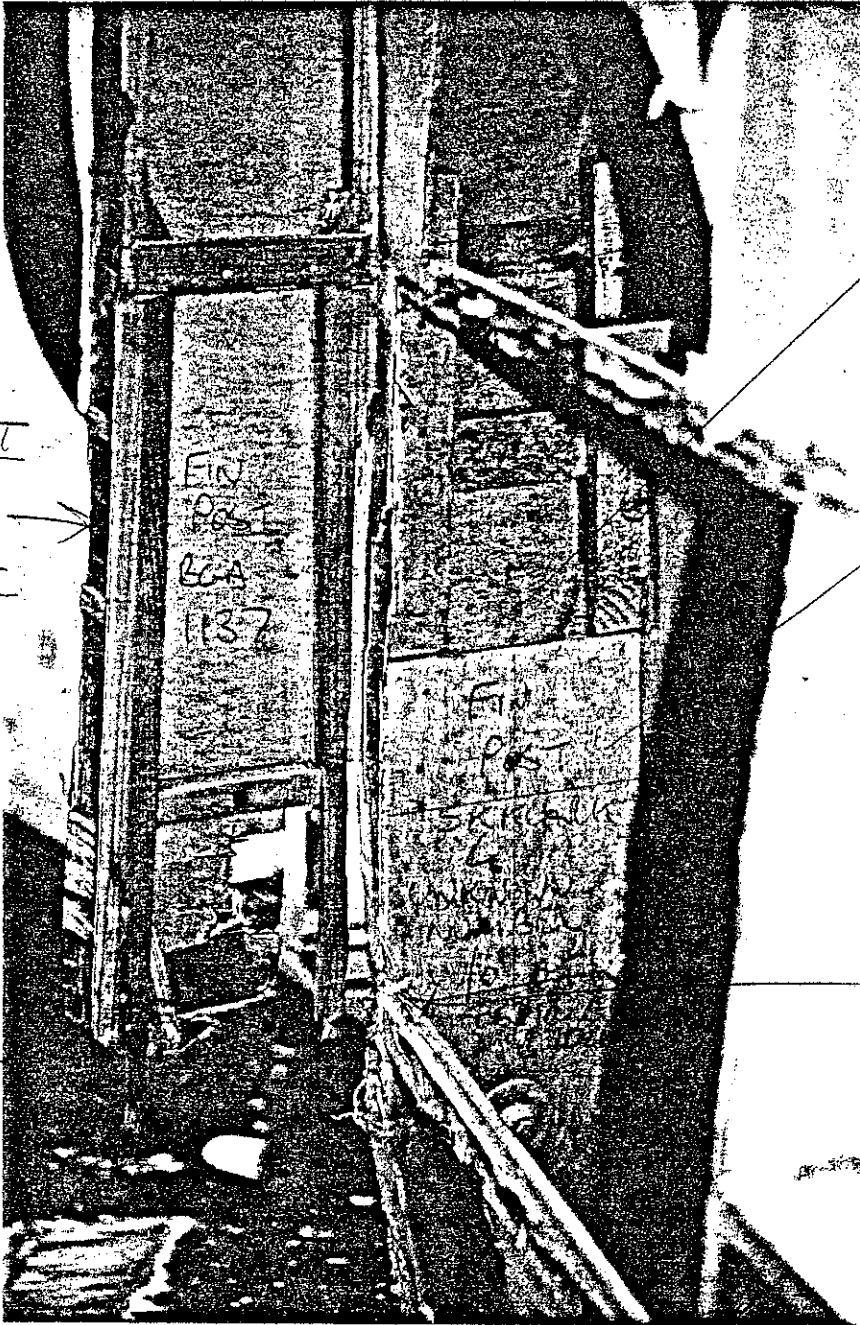
FIN FAILURE INSPECTION

indicated that the aft fin spars had failed where cutaways are provided for the longerons. The Sternpost, carrying the rudder, failed, followed by separation of the fin.

A Slingsby modification (No 50/1/2T/2 dated 9/5/62) deleted a plywood block from the area of the lower rudder hinge, on the front face of the Sternpost, because it was redundant. It had previously supported a pulley assembly, which formed part of the elevator drive. Later modifications re-positioned the elevator drive (see diagram).

Since it can be shown that there was no design, modification or construction deficiency in this area, it can only be assumed that some dormant damage had occurred.

It is possible that accumulated damage may have occurred over a prolonged period of operation in which repeated strikes by the tailskid may have induced compression shakes in the Sternpost. It is also possible that some damage may have occurred in this glider's one and only major accident. (With the deletion of the elevator drive pulley, the inspection facilities were also removed). (The B.G.A. have on record the separation of the rear fuselage of an OLY 1 - B.G.A. 512 due to a tail skid strike at Dunstable in 1961).

FIN
POST
BGA
1137

RE-ENFORCEMENT
Deleted
By Modification
9/5/62.

Failure
BGA 1137.

LONGERON
CUT-OUTS

Whereas Slingsby Aircraft (with the C.A.A.) will be issuing a Technical Instruction requiring inspections to be made to establish the continuing airworthiness of all effected sailplanes, the B.G.A. recommends the following interim checks.

- a) Apply a transverse load to the top of the fin and check for movement or noises in the affected areas.
- b) Inspect the Sternpost in the area of the lower rudder hinge, for signs of plywood separation, compression shakes, debonding, or damage inflicted by overtravel of the rudder.
- c) Check that the Rudder Stops limit the travel at full pedal deflections, such that the rudder does not transfer loads to the fin post.
- d) Inspect the forward fin structure in the area of the tailplane cut-away, for signs of plywood separation or compression shakes etc.
- e) Gain access to the forward face of the base of the Sternpost, to inspect for damage generally, and specifically where the longerons pass through the fin spars. (see diagram).
- f) Applicable also to Skylark 3s.

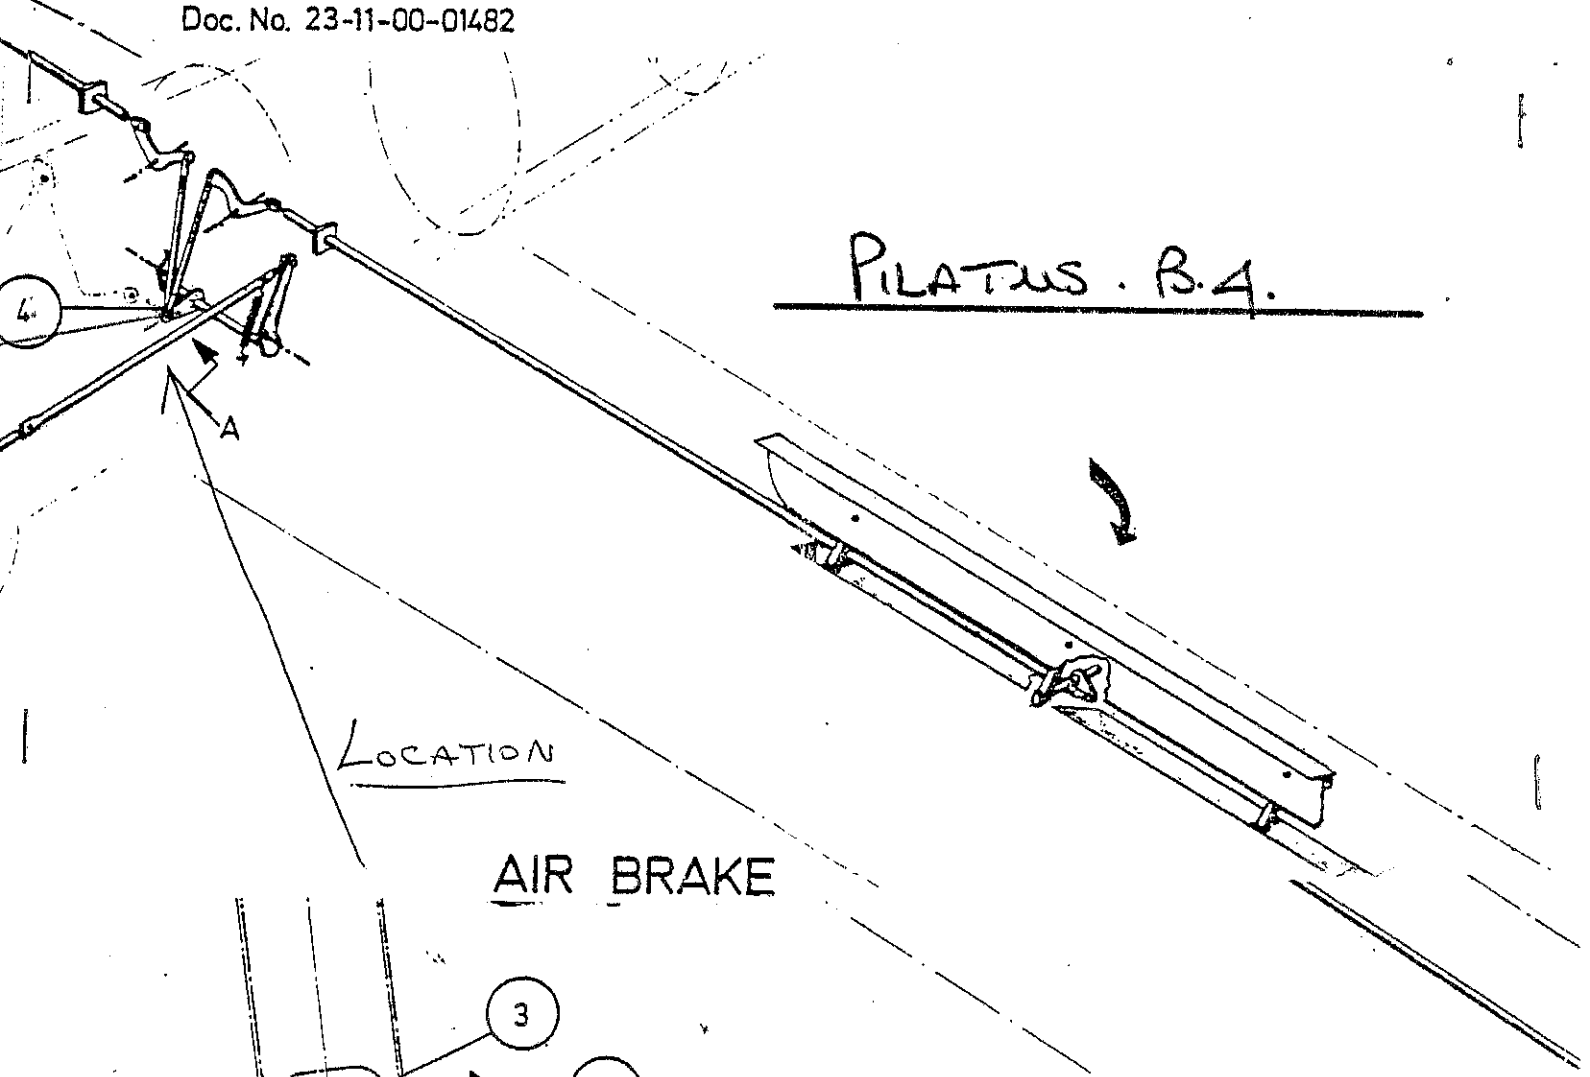
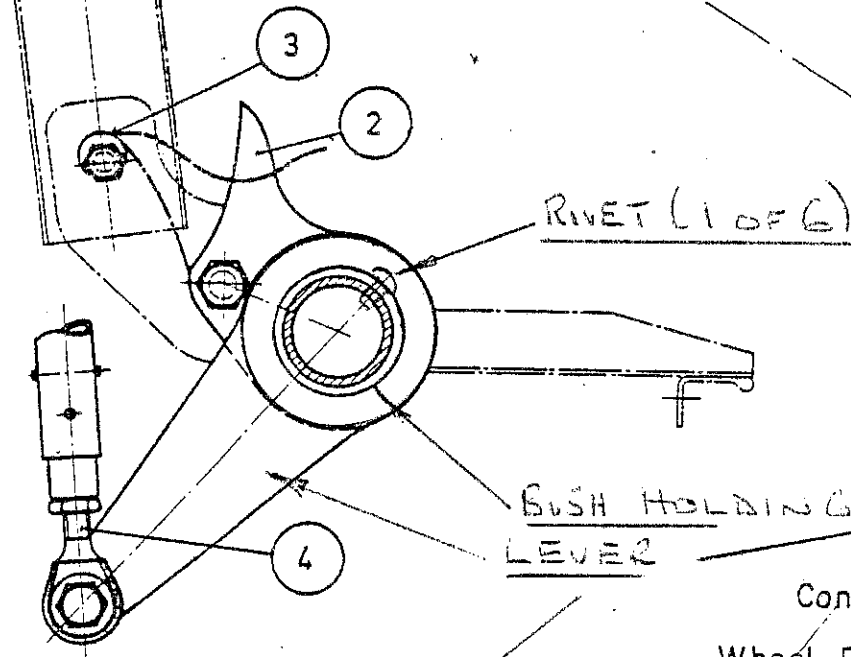
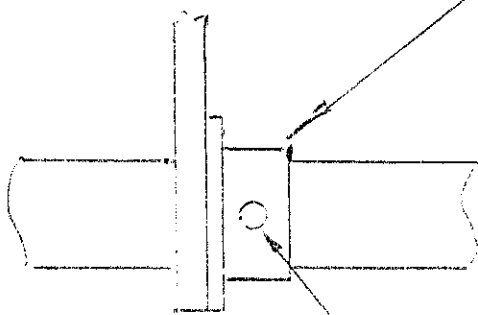
- 1.3. PILATUS B.4. Loose Rivets in the Air Brake lever in the centre-section. (Sketch attached).
- 1.4. MINI NIMBUS Release Hook Thin metal protective shroud partially compressed on to the hook by contact with the seat pan. (Reported by Ian Barnes). May cause hook malfunction.

LOOSE RIVETS

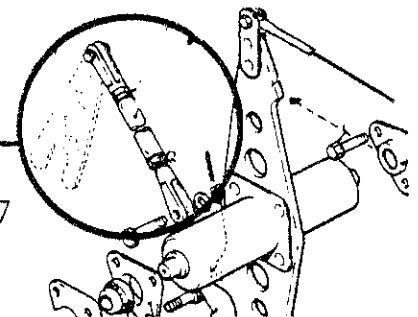
2. ELEVATOR CONTROL SYSTEM FAILURE

UNLOCKED TURNBUCKLE

Aircraft : Beagle Pup Series 2 Registration : G-AXES
Date : January 1987
Reportable Accident at Nairobi, Kenya.

During the approach to land all elevator control was lost, the aircraft struck the ground in a nose down attitude shearing off the nose leg and damaging the propeller. Subsequent investigation revealed that control tube, Part No BE-10047-1 of the elevator controls in the rear fuselage had come undone and one fork end had dropped out. It appears that both lock nuts had loosened off and the locking wire, which was still intact, was insufficient to prevent the centre barrel from rotating due to vibration, until one fork end dropped out. The aircraft had flown 1430 hours and had been maintained to the LAMS Schedule with 62 hours flown since the previous annual check in March 1986.

On aircraft with an "independent" trim system (i.e. not a spring bias system) it should be possible to land the aircraft without undue skill by use of the trimmer.

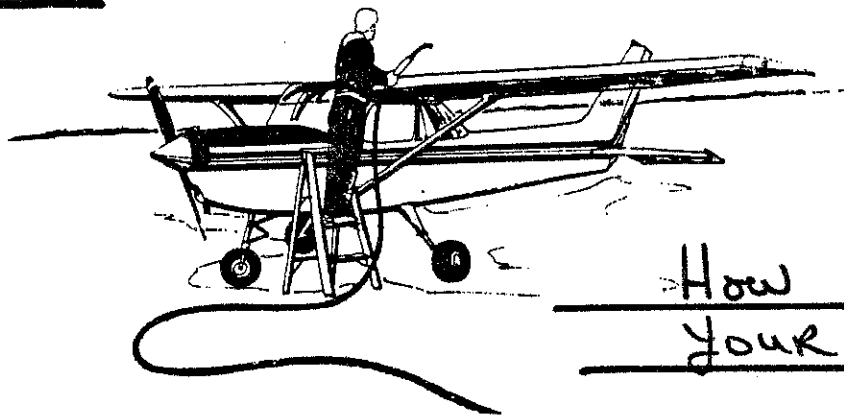
How Good ARE
YOUR GAUGES ?

Aircraft had been flying for 50 minutes in the local area and when 10 NM to the East of the airfield at 2000 ft, the engine misfired. The Pilot turned towards Andrewsfield and requested a straight in approach. When approach flap was selected and the descent initiated, the engine misfired again and then stopped. The Pilot stated that a distress call was made and the emergency checks completed, at which time the fuel gauges indicated half full. A gentle landing was made in a field about 1500 metres short of the runway. The aircraft came to rest with its nose in a hedge causing minor damage to one propeller blade and the underside of the fuselage.

Subsequent examination showed that the fuel tanks were empty of usable fuel and that the fuel gauges incorrectly over-read. The Pilot stated that a visual check of the fuel contents was not made during the pre-flight checks. The Pilot's flying experience was 202 hours, with 30 on the type.

All pilots should be aware of the need to visually check fuel before flight and to monitor during flight. Perhaps OUR Video (see Item 1) could be used to remind pilots.

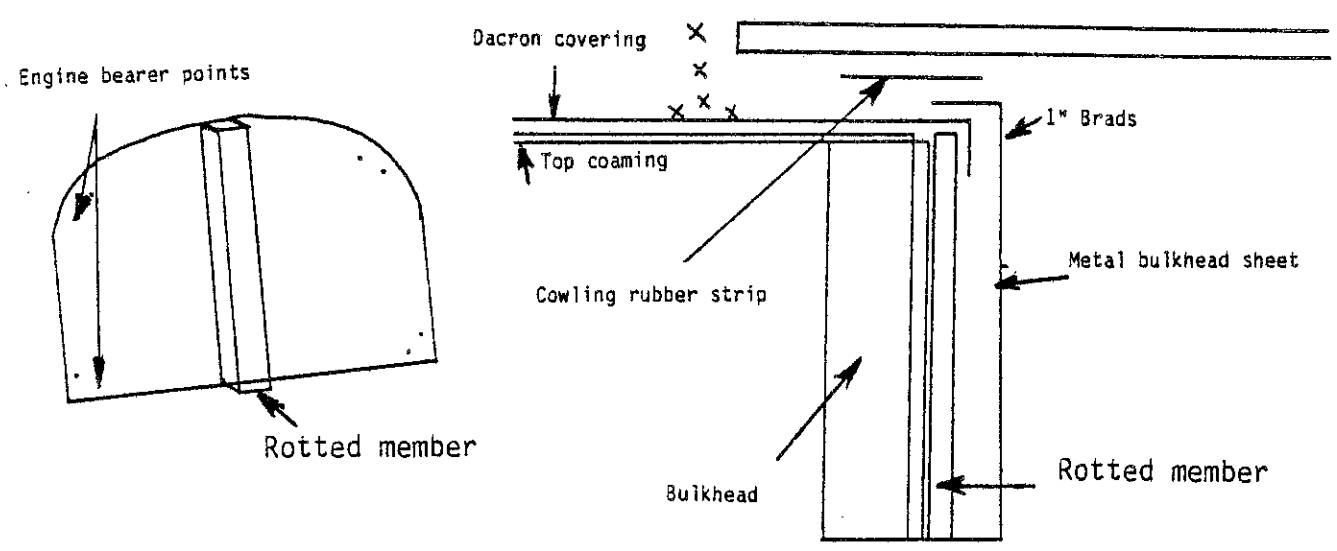
During maintenance the central vertical wooden member of the engine bulkhead was found to be completely useless due to rot caused by water ingress. The water had apparently run under the engine cowling and was trapped in this area. The damp had then been able to penetrate into the wooden structure via 1 inch metal brads that are used to hold the cowling rubbing strip in place.

The damage had been difficult to inspect due to the metal bulkhead sheet which covers the wooden structure. The aircraft has had to be completely rebuilt and recovered in this area. The 1975 aircraft had flown 7115 hours.

The reporter strongly suspects that the problem is not related to aircraft age but to whether the aircraft has been hangared or not. This particular aircraft had not. He also suggests that whenever the engine is removed, or at some more specific period, the metal bulkhead sheet should be removed and a complete inspection made.

Wooden aircraft should not be kept outside. Several have to be scrapped each year due to rot in the structure, others like this one, are lucky to require extensive only (i.e. expensive) rebuilding. The implications of undiscovered deterioration on an aircraft's structural integrity when subjected to flight loads, is obvious.
