## BGA TECHNICAL COMMITTEE

### TECHNICAL NEWSHEET 7/8/97

**DEFECT REPORT - Discus C.S. Airbrake/Aileron Interference**

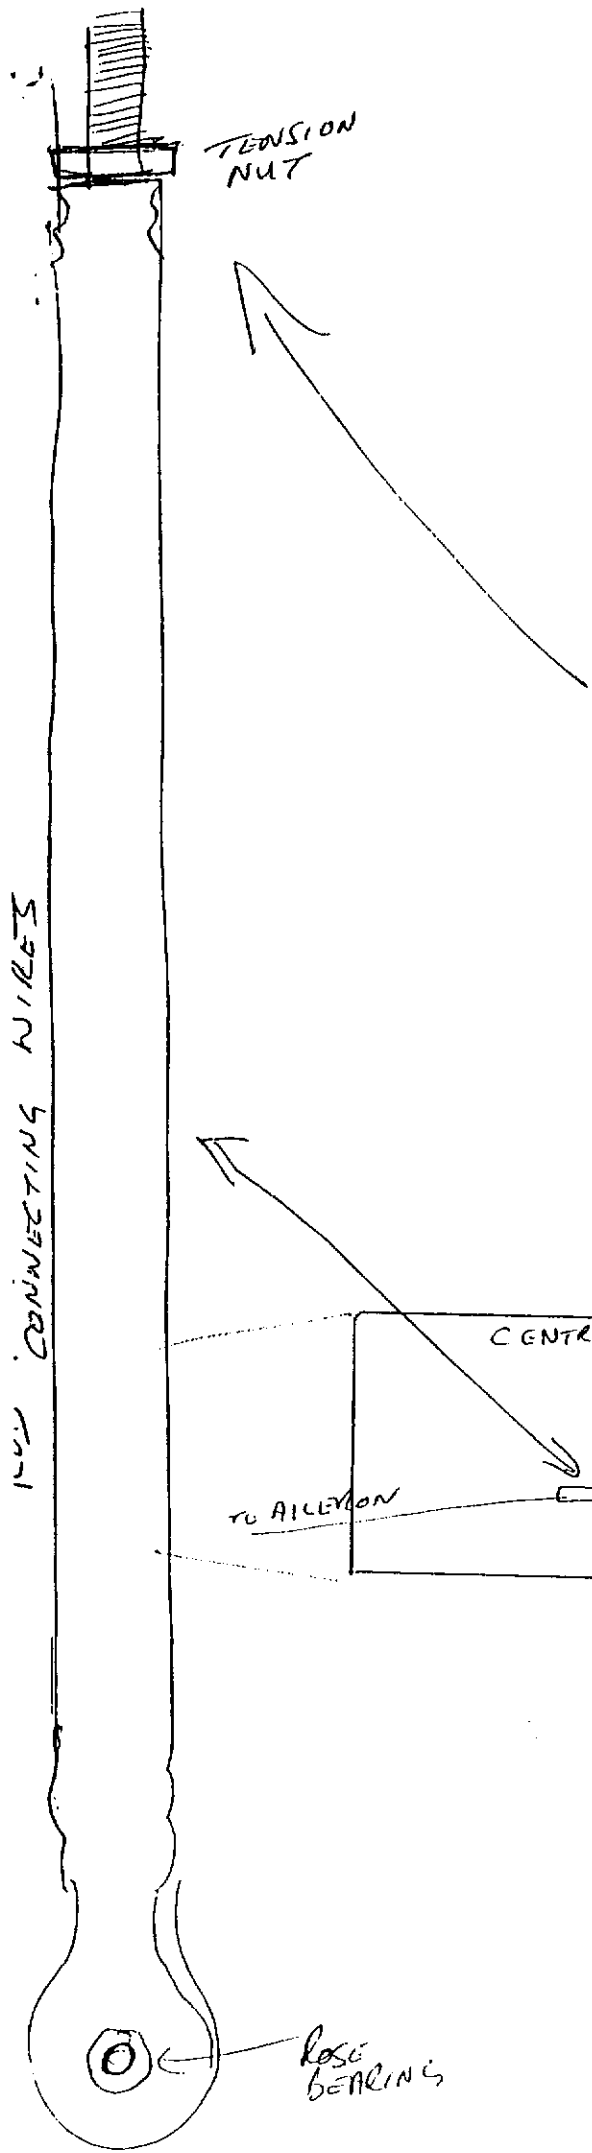
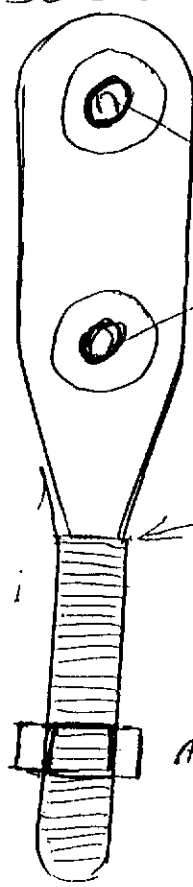
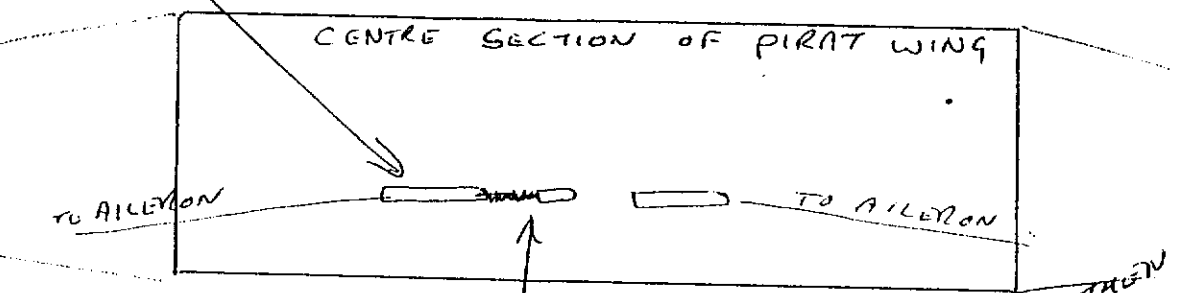
PIRAT S.Z.D. 30  
WORKS NO B 534  
BCA NO 1819.  
BUILT 13<sup>th</sup> FEBRUARY 1972

- 1.7.     PIRAT Aileron Connecting Rod damaged during rigging / de-rigging. (Sketch herewith).
  - 1.8.     LS4/LS4A Increase in Service Life to 12000 Hrs. Subject to multi-stage inspection at 3000 hrs. Tech Bulletin 4027 a enclosed.

STRESS FRACTURE  
(COMPLETE BREAK)  
CAUSED BY TURN BUCKLE  
BEING PUT UNDER STRESS  
WHEN LIFTING WING SECTION  
IT OFTEN GOT STUCK UNDER  
CONTROL ROD.

THIS PART OF WING  
IN CENTRE ~~CONNECTS~~ CONNECTS  
VIA ROSE BEARINGS TO ROD THEN  
TO THE STICK.

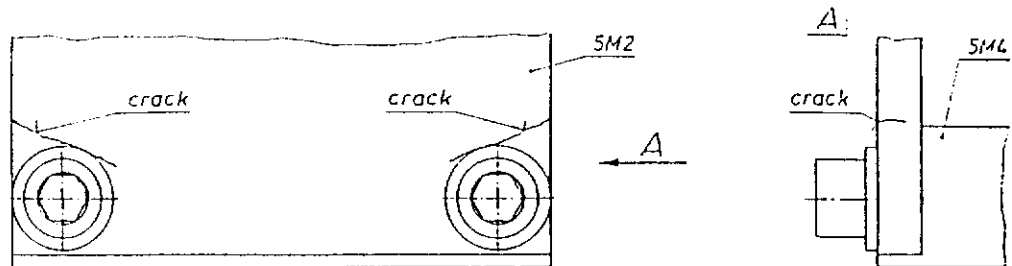
- Instructions:**
1. The critical areas (at the lower end) of the propeller mounting plate must be inspected for cracks. To accomplish this first remove the bolts at the front face of the propeller mounting plate including washers, then clean the plate with a cloth. Now have a close look at the surrounding of the fixing bolts and the edges (s. sketch) using a magnifying glass (magnification min. 5x). Due to remains of lubricant soaked into the cracks they are easy to detect.

Because cracks might also start from impressions of the washers check this area very carefully. If cracks are detected or only suspected the propeller mounting plate must be replaced by a new part SM2.

Moreover an aluminium plate SM75 must be inserted between propeller mounting plate and washers for better stress distribution. Use longer bolts M12x30 DIN912-8.8zn instead of existing bolts to fix the propeller mounting plate.
