BGA TECHNICAL COMMITTEE

TECHNICAL NEWSHEET 9/10/97

TI No. 109/T51 Issue No. 1

TITLE INSPECTION OF DART 15/17M DURAL SPARS

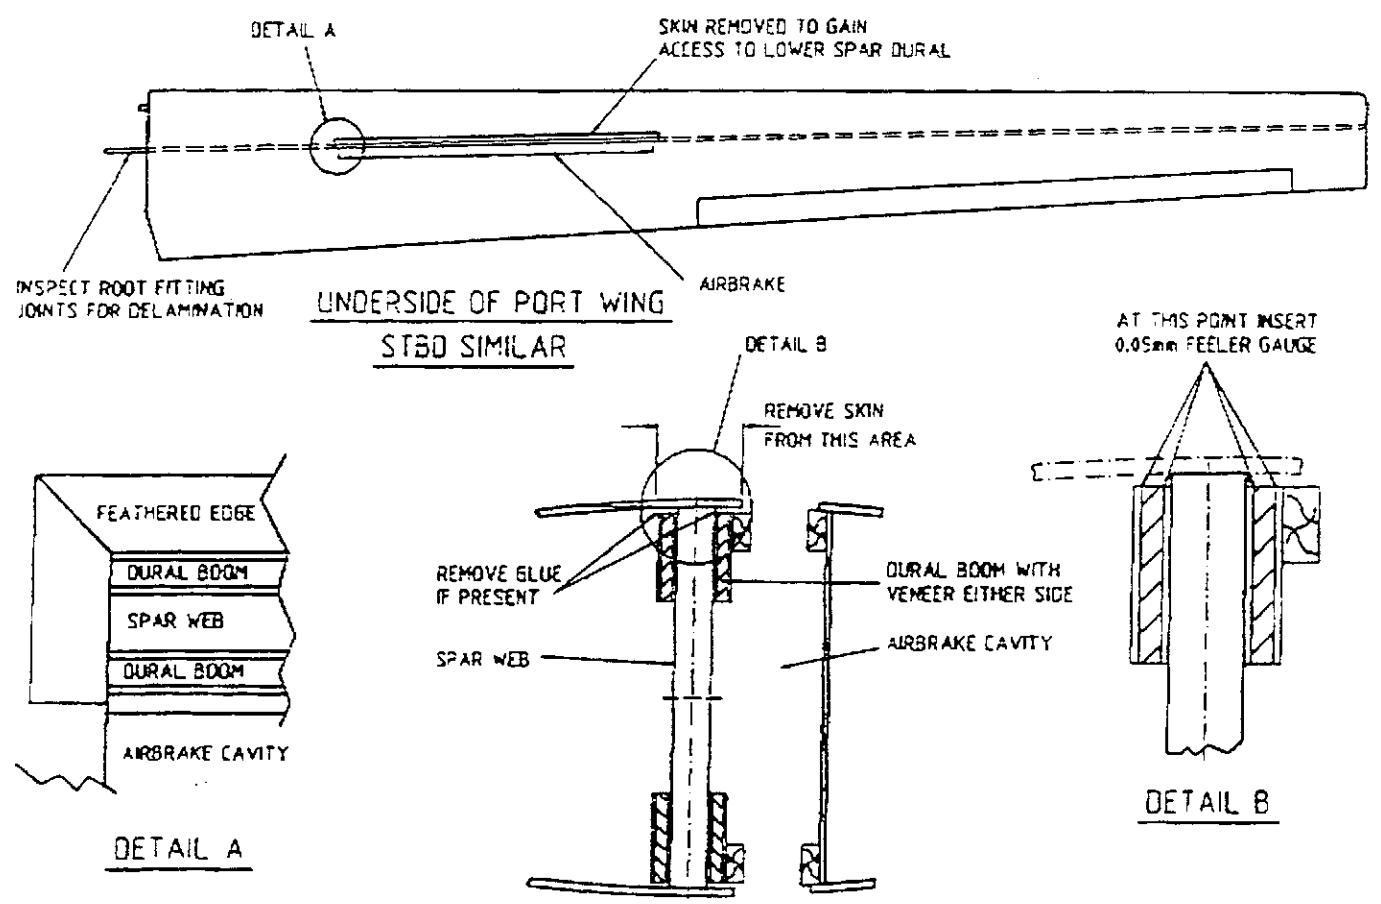
FIG. 1.
INITIAL INSPECTION AREA

This inspection has been prompted following the findings of an investigation into cracks on the stbd wing. These particular cracks were in the glue joint of the spar/skin interface. These were seen when looking into the airbrake box.

The skin over the spar area was removed locally to investigate the extent of the cracks. A feeler gauge, .002" (.05mm) thick, was then run along the dural boom lamination joints. This action highlighted a clean delamination to a depth of approximately 3" (80mm). Further delamination was then found.

The port wing was then investigated for completeness and this too revealed delamination and corrosion at the interface of the dural plates.

1.
 - i) Carefully remove the ply skin from both wings, over the lower spar for the length of the airbrake box. Refer to Fig. 1.
 - ii) Carefully remove paint to expose root fitting joints.
2. Ensuring dural booms are not damaged, carefully clean away any "Redux" that may have spilt from the joints during manufacture.
3. With the aid of a feeler gauge, .002" (.05mm) check for integrity of all exposed joints for delamination/exfoliation corrosion (white powdering on the metal).
4.
 - i) If delamination/corrosion found then inform SAL before proceeding with repairs.
