## BGA TECHNICAL COMMITTEE

### TECHNICAL NEWSHEET 11/12/97

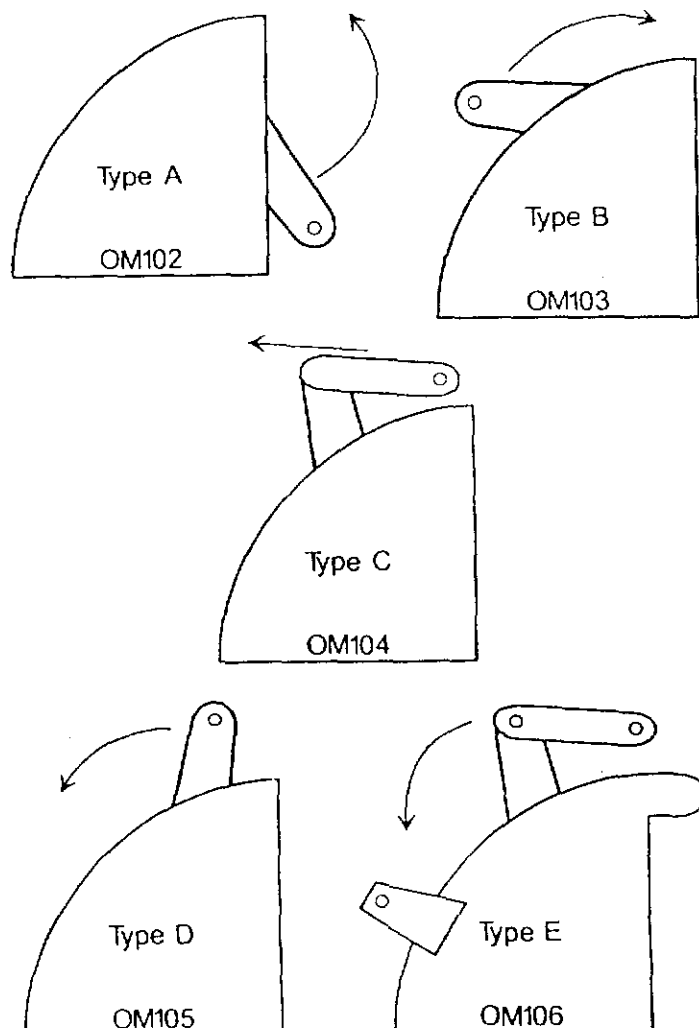
OTTFUR TYPES. (OM 100 SERIES)

An OM 100 OTTFUR hook has recently been returned which the pilot reported that he was physically unable to operate from the cockpit control during a very fast winch launch. The Back Release operated normally at the top of the launch.

Investigation has shown that the Unit had been made up of sub-assemblies from other units and a mis-match had occurred between the Casing and the Operating lever which resulted in the Over Dead Centre lock geometry being so far out that with a cable load of only 1.5 KN (337 lbs) the effort required to operate the release lever was 23 daN (51 lbs).

Once assembled, the Ottfur has NO ODC ADJUSTMENT and for types A and B (see below) the ODC geometry depends on the correct shim tubing being installed during assembly. For types C, D and E the Casing top strap acts as a stop for the release lever. The length and position of this top strap can vary.

It follows that that there is a potential risk of the ODC geometry being significantly incorrect when assembling any unit. It is also important to be aware that checking that the release lever of an unloaded hook can be operated by hand on completion of the assembly is no guarantee that the ODC adjustment is correct.

When servicing in the field the only sub-assemblies that should be changed are SPRINGS and, where applicable, that the shim tubing is installed as per the original.

DO NOT USE SUB-ASSEMBLIES FROM OTHER UNITS.

Carry out the simple Functional Test detailed below.

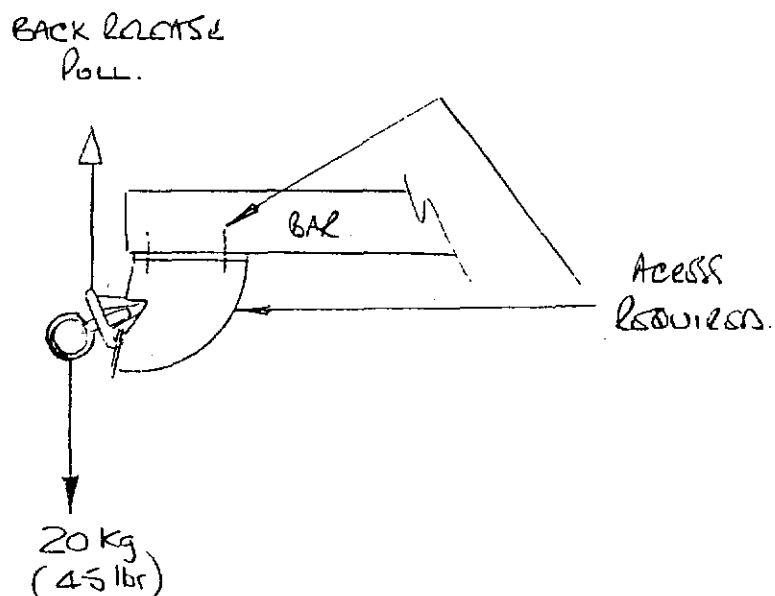
The release pull load should not be less than 2.7 daN (6 lbf) or more than 11 daN (25 lbf).

Full movement of the carriage should give a minimum of 3.0 daN (6.5 lbf) and not more than 11.5 daN (30 lbf); without the ring carriage reaching the casing stop. If the pull load is less than 3.0 daN the spring should be replaced. If the pull load is in excess of 11.5 daN, clean and lubricate the Unit. If this does not reduce the pull load the Unit should be rejected and returned for overhaul.

If the release pull load is less than 2.7 daN the release lever spring should be replaced. If the release pull load is higher than 11 daN, clean and lubricate the Unit. If this does not reduce the pull load the Unit should be rejected and returned for overhaul.

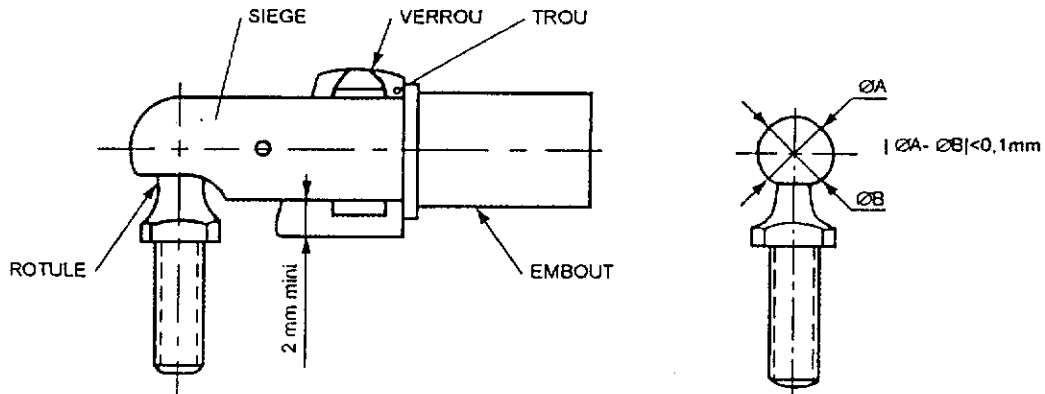
**OBJET :** INSPECTION DES EMBOUTS ET ROTULES L'HOTELLIER.

**BUT :** Vérifier l'absence d'endommagement ou d'usure excessive.

Afin de clarifier ces instructions dans le cadre de l'entretien des planeurs ASW20F et ASW20FL, les inspections de chaque ensemble rotule et embout à effectuer lors de chaque Visite Annuelle ou Grande Visite sont détaillées page suivante. Dans le cas où certaines opérations n'auraient pas été effectuées lors de la dernière visite, nous recommandons de les effectuer rapidement pour éviter tout risque de défaillance.

Dans le cas où l'une des vérifications ci-dessus (sauf **h**) n'est pas satisfaisante, il est impératif de remplacer le couple rotule+embout concerné.

Dans le cas où la vérification **h** n'est pas satisfaisante, effectuer le blocage correct avec le contre-écrou.
