## BGA TECHNICAL COMMITTEE

### TECHNICAL NEWSHEET 5/6/98

#### PART 1     Airworthiness "AGGRO"

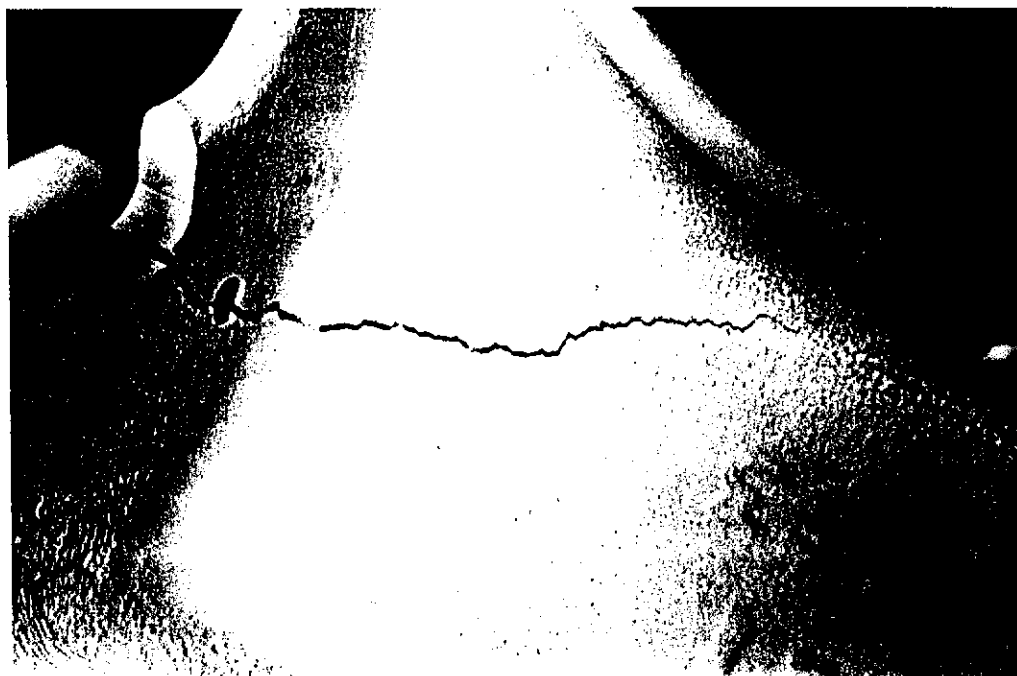
Following the item in Issue 5 of 1997 a reader has sent us details of problems with a very similar casting on an RF3. The main difference was that this one came miraculously close to failing but was still supporting the aircraft weight on an eighth of an inch of light alloy casting.

The first sign of the problem was that the wheel was seen to be leaning very slightly; closer inspection revealed that the bottom edge of the outer web had a small notch between the reinforcing plates, so it was decided to remove the landing gear as a complete assembly. It was only when the unit was removed into a good light that the amazing extent of the crack became apparent. It was estimated that the number of landings left, was between one and two before it collapsed. Once the fork was stripped down, it was possible to flex the ends back and forth manually and to see daylight through the gap.

The important detail is that this was an early casting and had curved reinforcing plates around the web between the two locking lugs and the web was therefore narrower. The plates are bolted on and all the cracks had propagated from these bolt holes as they run across the areas of stress concentration shown in the photo. The other side had also started to crack in two positions from the same bolt holes, although not as extensively. The problem is that, until they have been removed, the outer

plates cover up the worst of the cracks and the crack out to the arch was just a hairline. However, these plates do not in any way hold the casting together and would not prevent failure. The new castings have a thicker web, larger radius and have no outer plates and are less prone to cracking. It is worth noting that the earlier castings may have cracks hidden between the plates and even the crack shown in these pictures was not really apparent with the landing gear fully installed. It was very lucky that the defect was noticed while changing the oil during a minor inspection as it would probably have escaped even a thorough daily inspection.

View looking down on forward flange and inside edge of uplock notch. (Dye penetrant reveals crack continues into radius.

We are pleased to pass on the information given us by this Fournier owner and would recommend that other owners have a thorough look at their landing gear in order to avoid the possibility of what could be an expensive failure. Ironically the reader also informs us that, since the work described, he has landed the aircraft gear up. Perhaps even a cracked landing gear is better than none at all! BUMPH!
