## BGA TECHNICAL COMMITTEE

### TECHNICAL NEWSHEET 7/8/98

#### PART 1     Airworthiness "AGGRO"

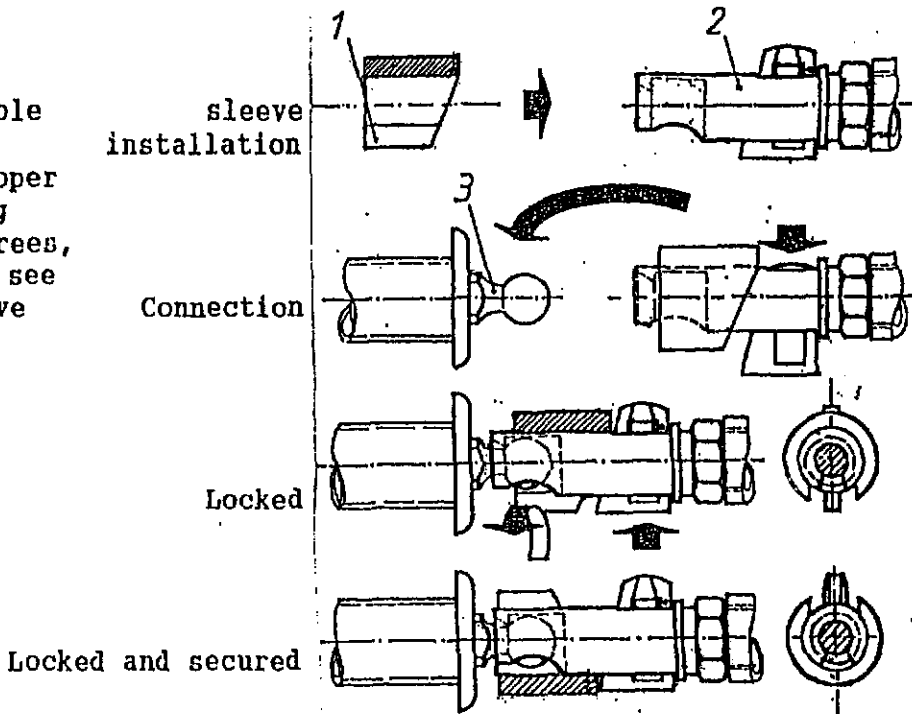
**Hotellier Control System Connectors**

Reason : These connectors may open during use when they are not correctly assembled.

Prior to assembly, everybody should be familiar with the functioning of the Hotellier control system connectors (a.k.a. ball snap joints or clip and ball coupling). With the locking plate fully pressed, each connector <2> must be engaged fully on the ball <3>. During securing, the locking plate moves slightly backwards. Using the securing sleeve <1>, installation is possible only with the slot facing down. After proper connection and turning the sleeve by 180 degrees, the joint is secured, see also sketch. The sleeve always stays on the connector!

**Warning:** With connectors unsecured, the locking plate may open under load temporarily ! The locking plate should never be greased !

Material and Instructions : Securing may be performed using sleeve "white" 4R10-188 according to specification SR10-188 dated 04.03.98. This sleeve replaces the securing pin according to LBA-AD 93-001. Slide the sleeve only axially onto the disassembled connector with the slot over the ball opening, from now on it should always stay on the connector. After assembly of ball and connector, rotate sleeve by 180 degrees to secure system.

Sleeve installation according to drawing 4BF-164. Insert page "Flight Manual LBA-AD 93-001/3" into Flight Manual, 3 pages "TB-AD-Accomplishment List for Periodical Inspections" into Maintenance Manual (Instructions for Continued Airworthiness) and update list of valid pages. Corresponding pages of both manuals with Edition May 93 must be removed.

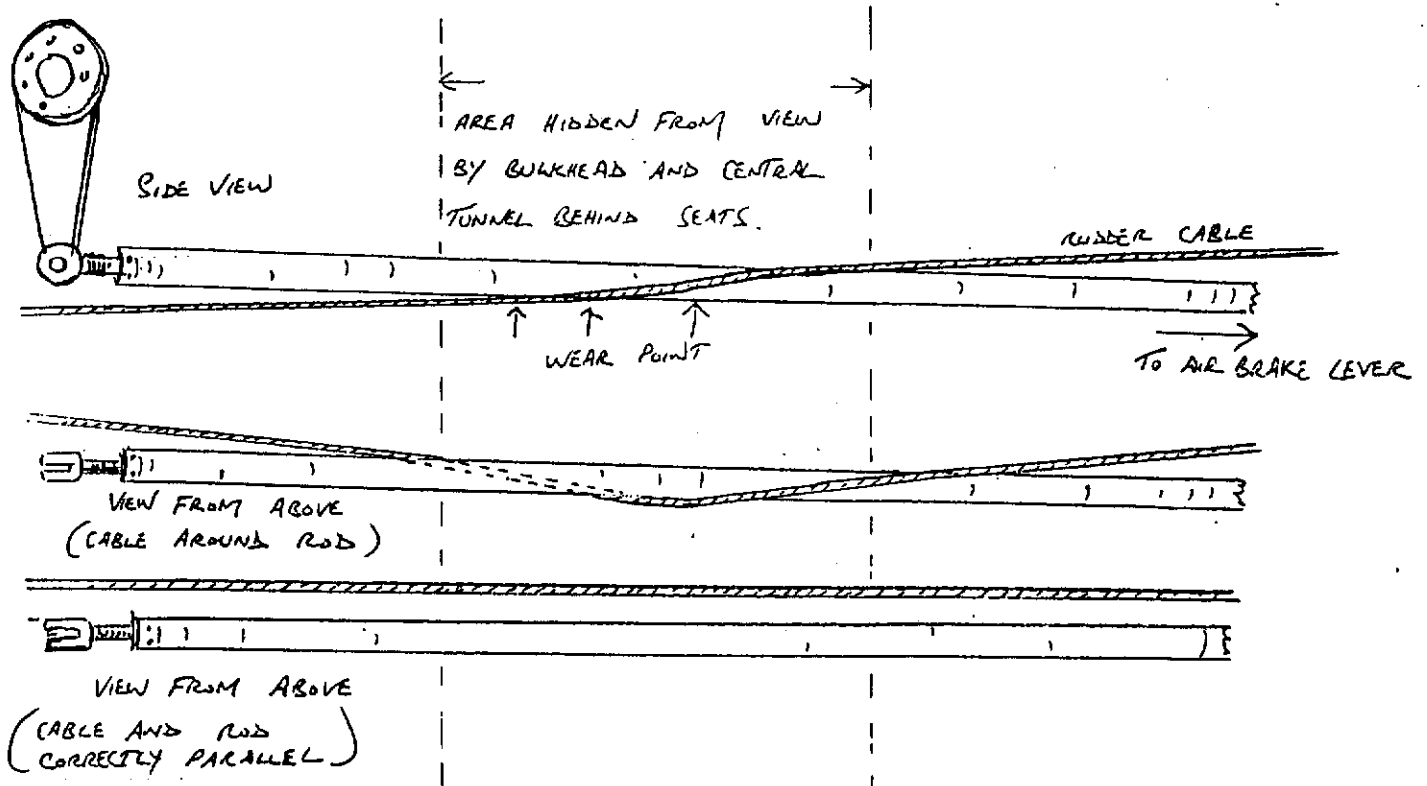
T49 CAPSTAN - STARBOARD RUDDER CABLE FOLLOWING  
AIRBRAKE CONNECTING ROD:

- 1.10.    CAPSTAN RUDDER CABLES Sketch from Ulster G.C. illustrates a possible problem.
- 1.11.    MT PROPELLERS. LBA Directives - the current list is attached.

WITH RUDDER CABLES DISCONNECTED AND LYING SLACK, IT IS POSSIBLE TO ASSEMBLE AIRBRAKE CONNECTING ROD WITH STARBOARD RUDDER CABLE LOOSELY DRAPED OVER ROD AND HIDDEN FROM VIEW AS PER SKETCH.
