BGA TECHNICAL COMMITTEE

TECHNICAL NEWSHEET 9/10/98

PART 1 Airworthiness "AGGRO"

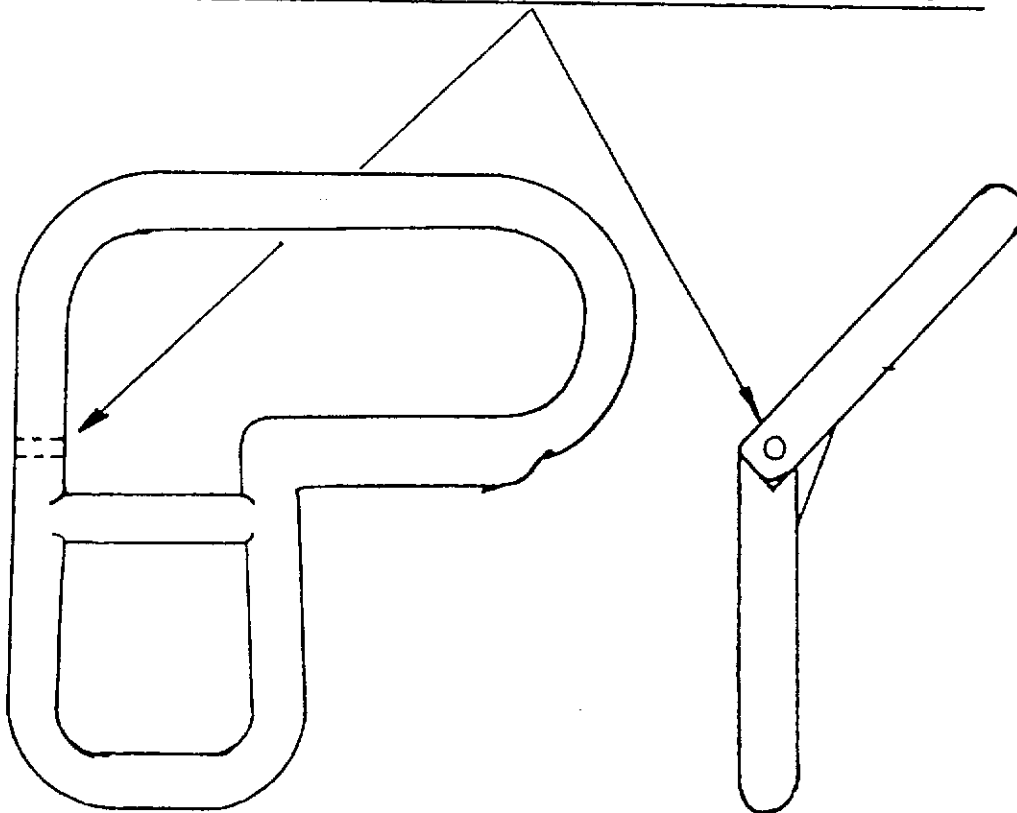
FIGURE 1

To prevent the possible nondeployment of a parachute canopy due to separation of the plastic handle from the ripcord cable when subjected to the deployment pull force, accomplish the following: replace the plastic handle shown in Figure 1 with a metal handle (P/N 1025) supplied by Strong Enterprises prior to the parachute being made available for any parachute jump.

PLASTIC RIPCORD HANDLE

REPLACE THIS HANDLE IF
RIPCORD CABLE ATTACHES HERE

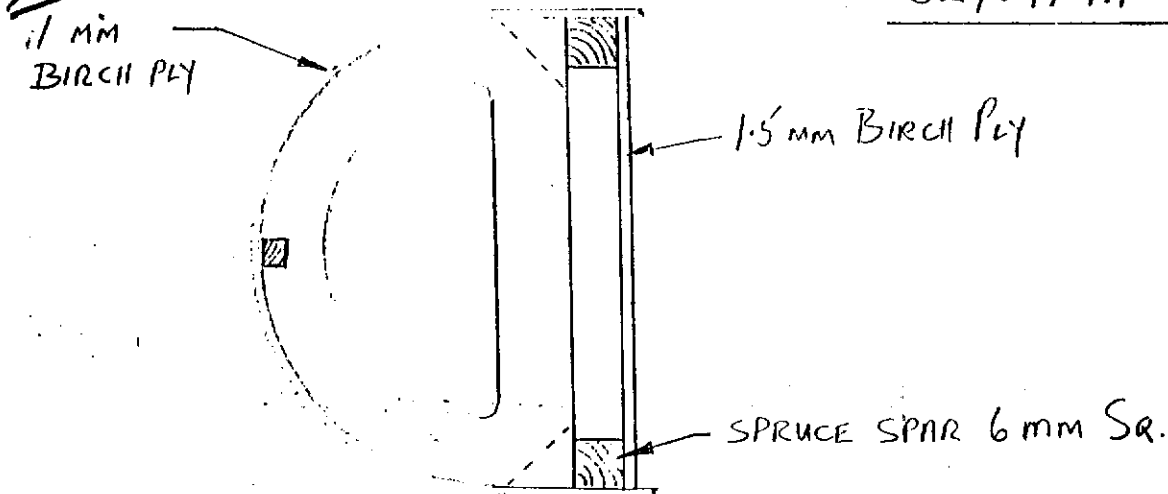
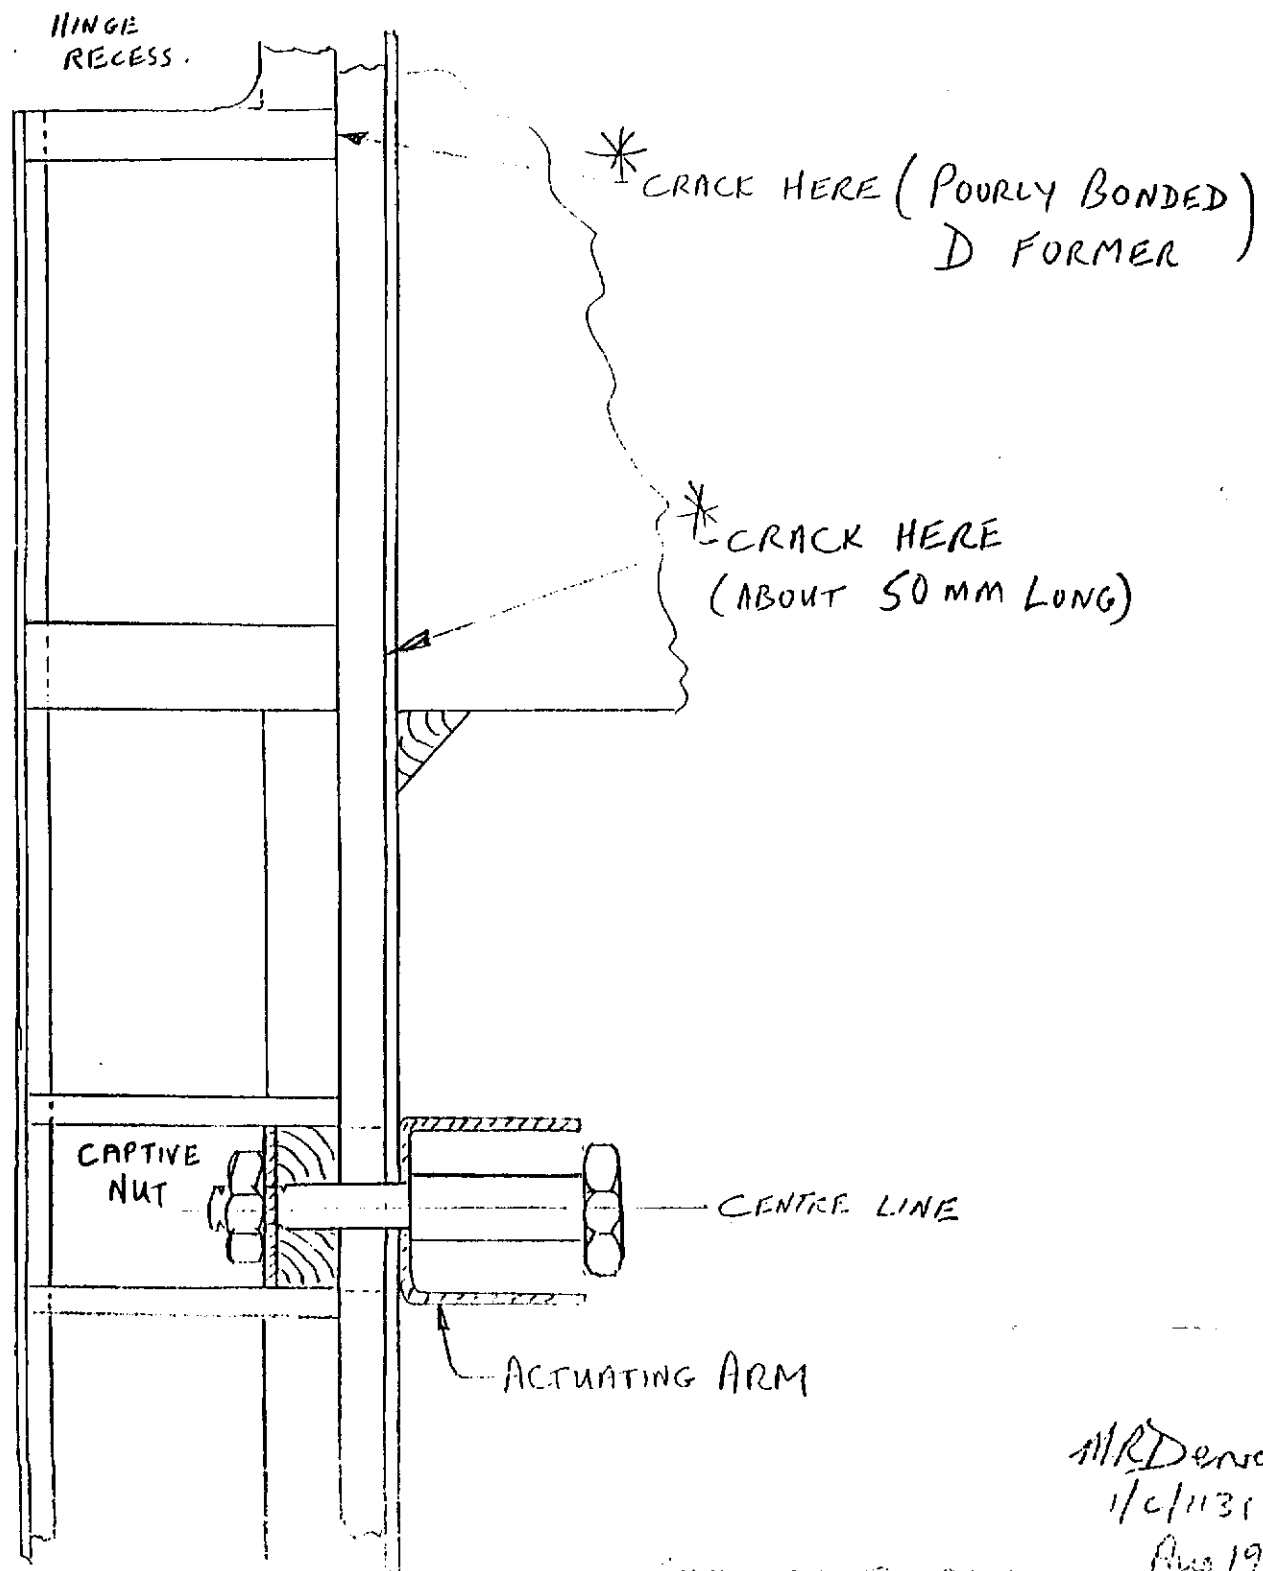
OLYMPIA 2B - ELEVATOR

- 1.4. OLYMPIA 2B - Cracks in the Elevator are illustrated in attached sketch from Mr. Derwent.
- 1.5. DART 17R - Elevator Flutter was caused by backlash between the two elevators. (Reported by Enstone Eagles G.C.).
