BGA TECHNICAL COMMITTEE

TECHNICAL NEWSHEET 11/12/98

PART 1 Airworthiness "AGGRO"

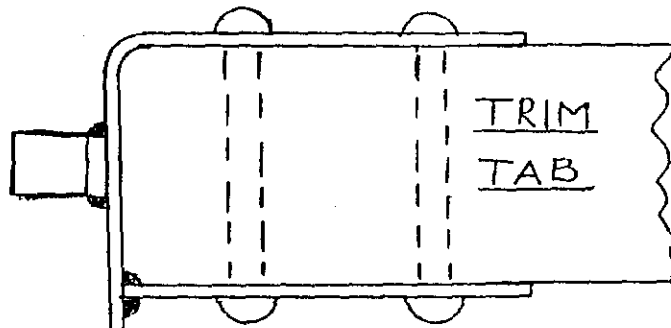
TRIM TAB LEVER CONNECTION

- 1.2. BOCIAN TRIM TAB DRIVE ATTACHMENT. A BGA Approved Modification has been produced by Mr. J.P. Fisher, copied herewith. (Drive failure has caused flutter Ref TNS 04/89 & 04/97).

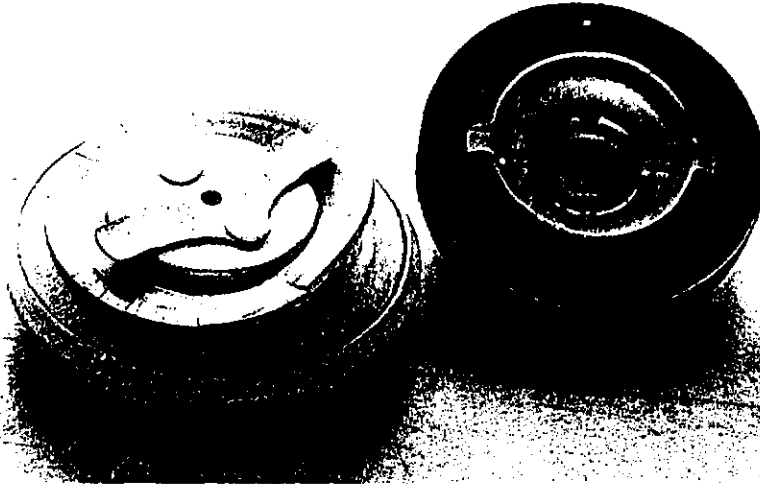
Investigation revealed that the right hand fuel tank contained water because the filler cap seal had perished. The aircraft had been left outside following its 50 hour check. All water was drained from the tank and 5 hours later was checked again. More water was found. The aircraft was parked in the hangar and checked yet again; even more water came to light. It was suspected that the water had been trapped by baffles in the tank and was slow to clear. A flight test was carried out using only the right hand tank after it had been ascertained that all

The consequences of worn or slack filler cap seals are very clear in this event, which fortunately had a happy ending. This is not an uncommon problem and where it is found that filler caps are easy to take off and on then it could be that the seal has deteriorated and a new one may need to be fitted. **If in doubt CHECK.**

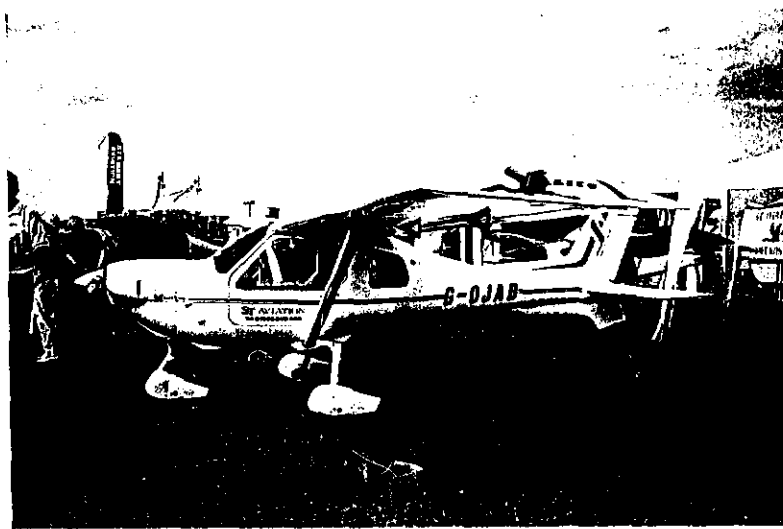
After take-off from Shobdon, the right hand side of the top engine cowl became loose and lifted off its seating, remaining attached by the left hand side pin and clip.

The engine top cowl is a one piece construction, secured on either side by an overcentre latch to which an 'R' clip is fitted as a safety device. The cowl had been opened before flight and although after the accident the latch had been found closed with the clip fitted, there is a strong possibility that the latch had not been engaged over the corresponding

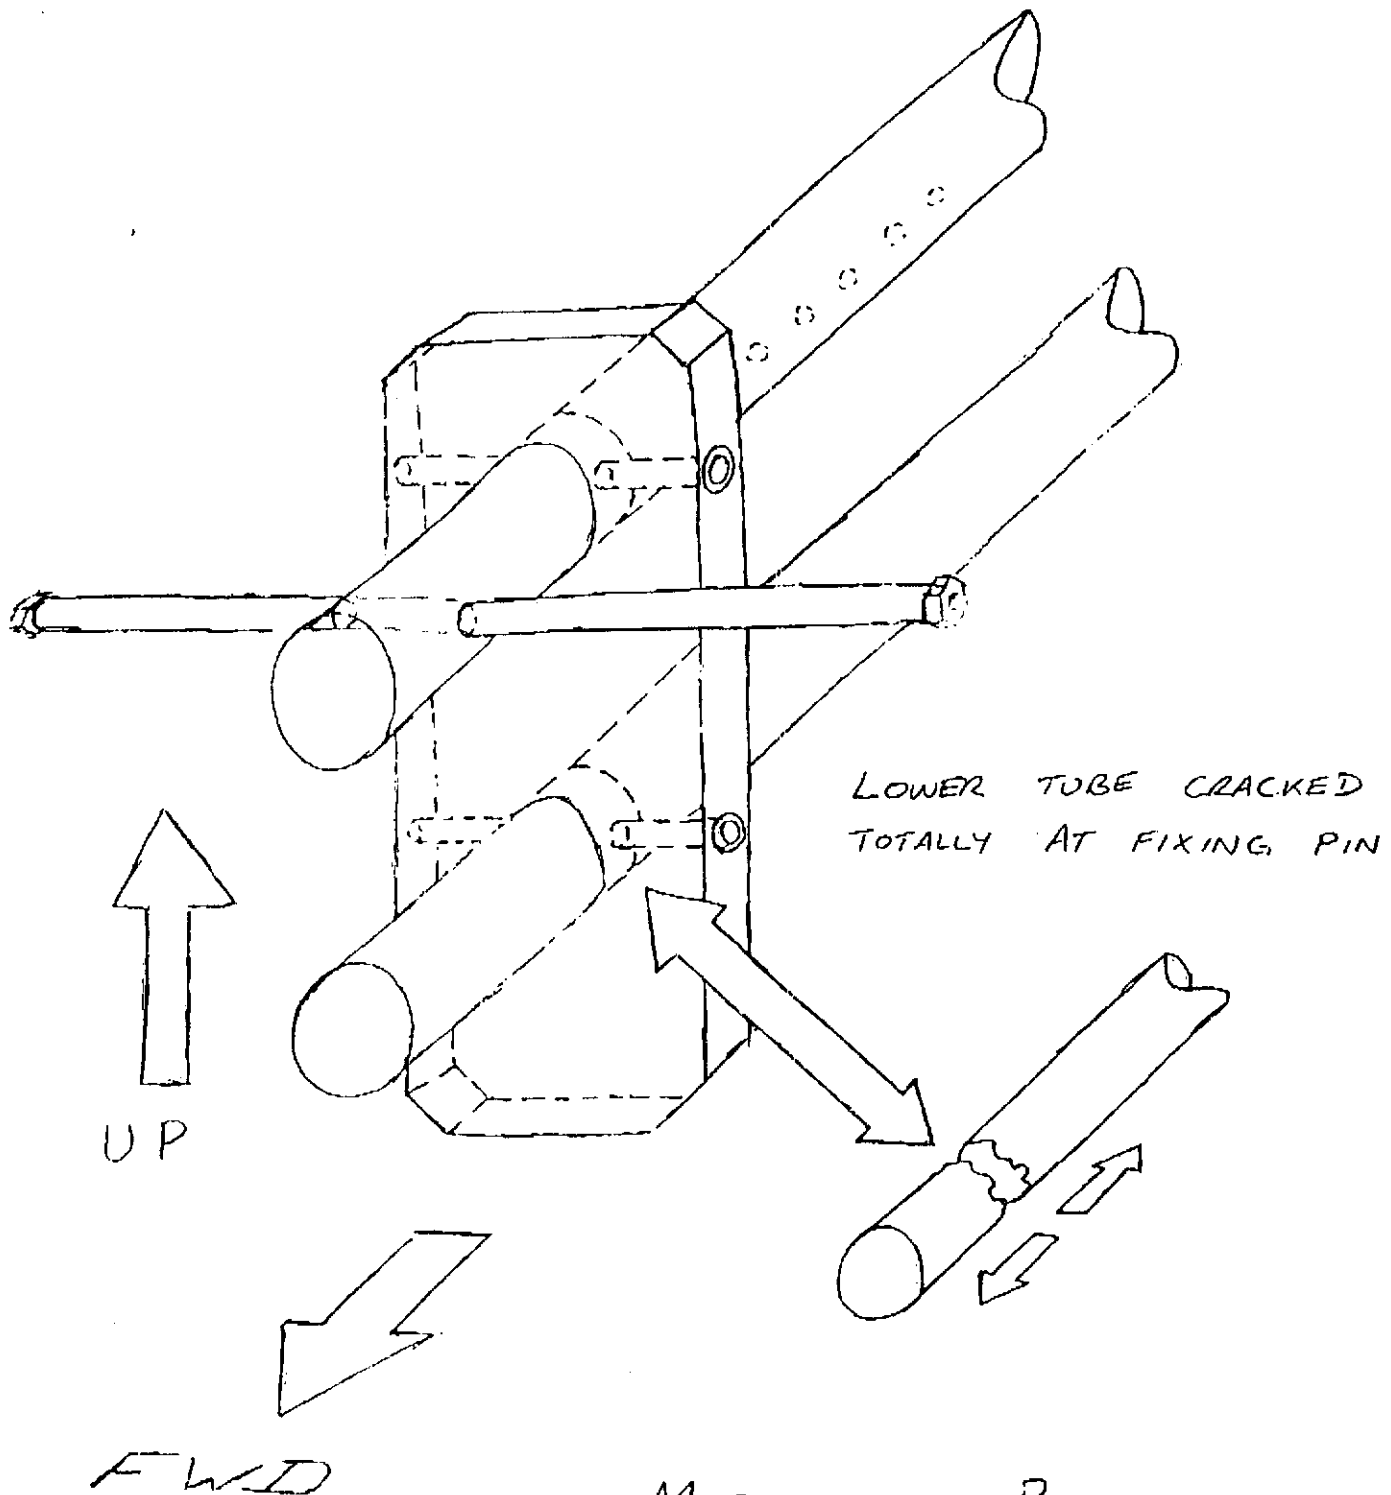
MOSQUITO B BGA 4054

FATIGUE FAILURE

- 1.6. MOSQUITO Rudder Assembly Failure. Sketch from Any Darlington requires inspection a.s.a.p.
- 1.7. ASTIR CS - Elevator Restriction (increase in friction) was caused by migration of the upper undercarriage pivot shaft. Washer and circlip required to locate the pivot shaft had become detached. Reported by Ian Tunstall - Syerston.

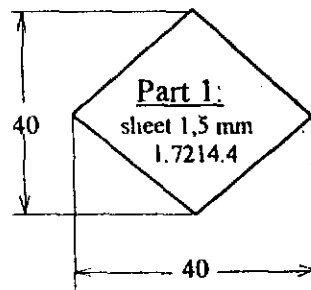
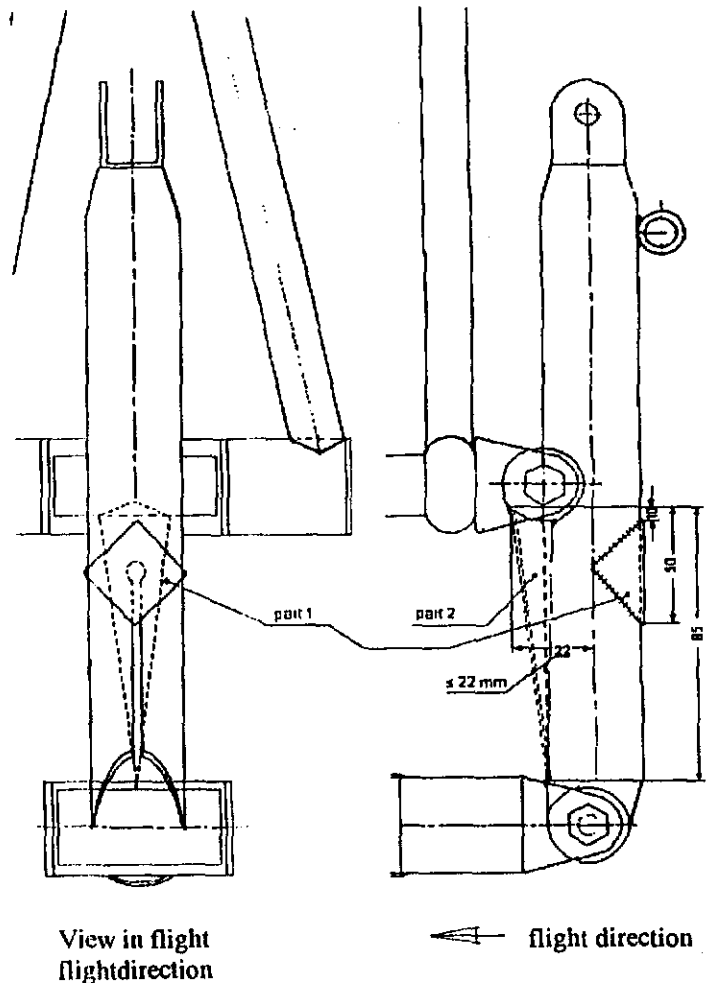
Part 2:
 Steel Pipe segment
 18x1 mm
 (Material ST 35 bk)

Part 1 and 2 are complete autogen- gas welded together with welding wire 1.7324.0 or WIG welded (DIN 1912) together with welding wire 1.7734.2.

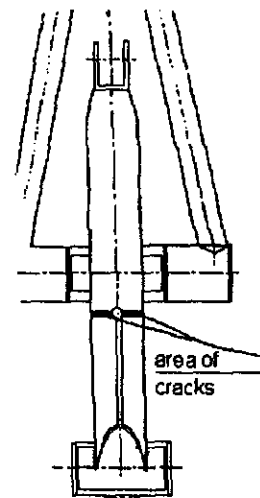
Reason: At some inspections of the controls cracks on the combined bellcrank like the following sketch must be stated. Probably one reason for the detected cracks are defective ball bearings of the controls in the fuselage and also not tightened controlsticks while aircraft is taxiing on the ground.
 In case of inflight malfunction of aileron and elevator -- if this bellcrank is complete cracked -- urgent actions are necessary.

- Actions:**
1. **Before next Flight** a thorough crack inspection of the bellcrank is to carry out. Cracks are possible in the area of the hole and slit on the backside of the bellcrank. (see sketch on the right side). If the bellcrank is installed cracks are very hard to see if they arise. The bellcrank is located under the rear seat of the motorglider behind the fuselage mainframe. Therefore it is necessary to disassemble the bellcrank. The bellcrank is to depaint and to inspect for possible cracks with a 10- times magnifier. The crack inspection is also possible by Dy- check penetration.

3. **Before next flight** a reinforcement of the combined bellcrank like the additional sketch on page 2 is to carry out.
 4. If the complete controls in the fuselage are installed after repair all deflections of aileron and elevator must be checked, if necessary they must be adjusted (see page 16 of the „SF 28 A Flight- and Maintenance handbook“). All connecting points of push rods with control sticks or bellcranks in connection with ball bearings could be protected for opening with DIN 985 self secure hex nuts.
