## BGA TECHNICAL COMMITTEE

### TECHNICAL NEWSHEET 1/2/99

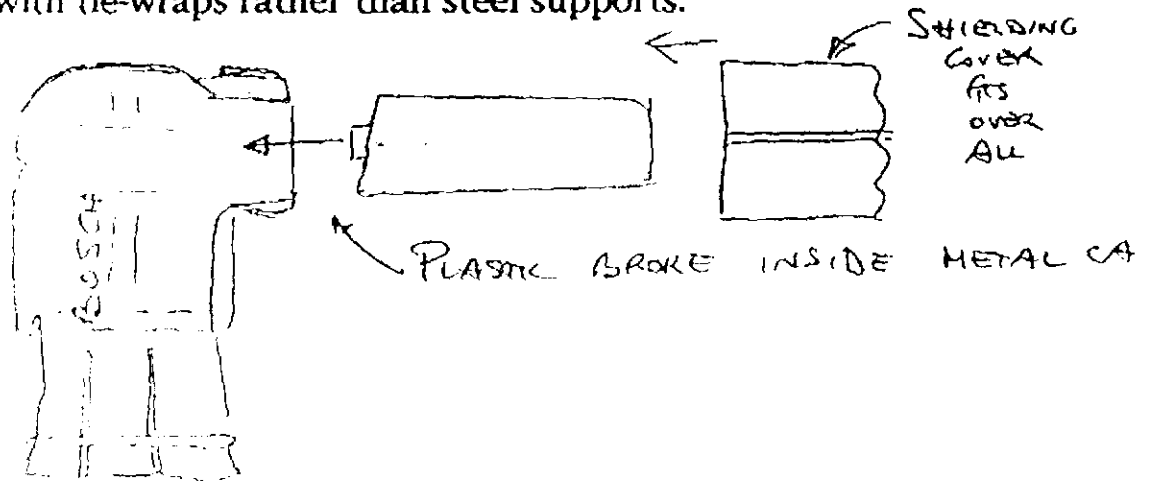
PIK. 20E

SPARKPLUG CAP FAILURES

An intermittent failure of one cylinder when restarting the engine in the air was eventually traced to a break in the 'bakelite' type brown plastic plug lead arm of a 90° BOSCH Spark Plug Cap marked 0 356 351 032. Tracking burns confirmed it had been leaking HT to earth over a period of time.

The cap was metal-shielded and the break was invisible until exposed by the extreme action of removing the steel clips and covers and dismantling the shielding.

Brittle plastic is not the best material to rely on in the spark plug caps of vibrating SLMG engines.

Use a simpler, rubber insulated spark plug cap and secure it in place with tie-wraps rather than steel supports.
