BGA TECHNICAL COMMITTEE

TECHNICAL NEWSHEET 3/4/99

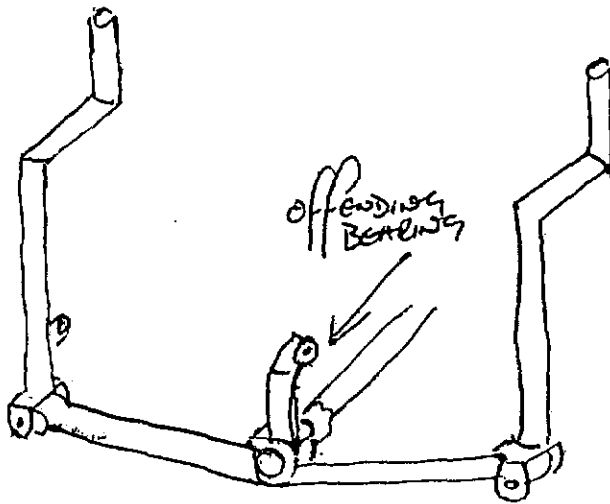
SF 25E - AILERON RESTRICTION.

- PART 1 AIRWORTHINESS "AGGRO" Please refer to the BGA 1999 Red Pages Compendium .
- 1.1. SCHEIBE SF25E - AILERON CONTROL restriction in flight was attributed to failure of the upper Rose bearing, supporting the central hangar for the Pilot's' dual control assembly. (Diagram by Martin Carolan).

CONTROL STICK LAYOUT ON SCHEIBE
SF 25E - G-KDEY SN^o 14325

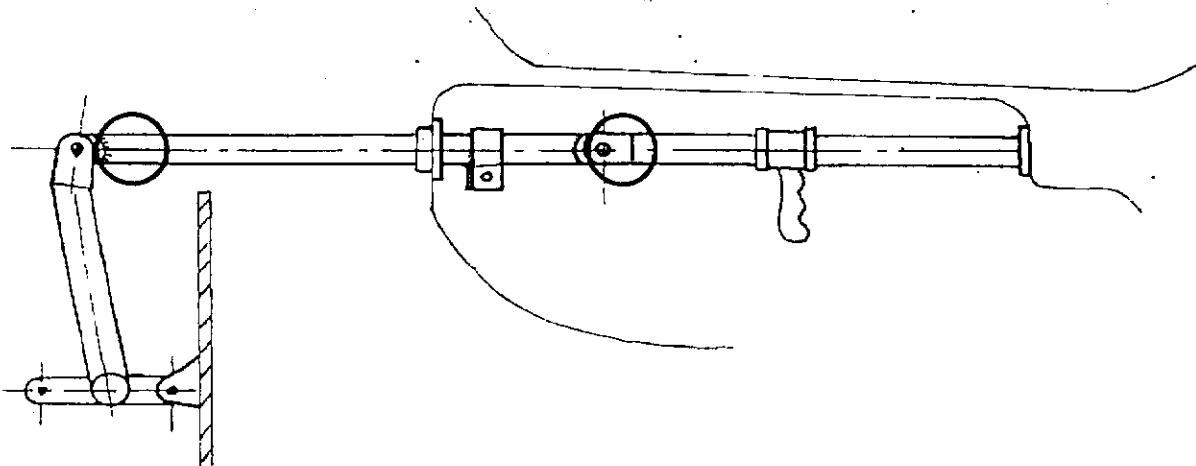
PURPOSE :
To detect eventual cracks in the airbrakes control system in the fuselage.
To replace the airbrake control system in the fuselage for gliders non equipped with the latest version of the part

The diagram above represents the airbrakes control system from the handle to the arm of the airbrakes in the fuselage. All welded parts and especially all above encircled parts should be very carefully eye-checked. If necessary and after cleaning, use a mirror or a lamp to check if there is any crack starts.

In case of cracks, please contact S.N. CENTRAIR in order to inform them about the problem. A repair of the glider must be done imperatively before any new flight.

N.B. : According to the eventual difficulty of analysis of the welded parts of airbrake arm (see diagram above) by people who are not used to perform such inspections, we require as a preventive measure to replace this airbrake control by the the following parts :

- Part number \$Y057D for gliders equipped with manual ailerons and airbrakes control system.
- Part number \$Y818E for gliders equipped with automatic ailerons and airbrakes control system.

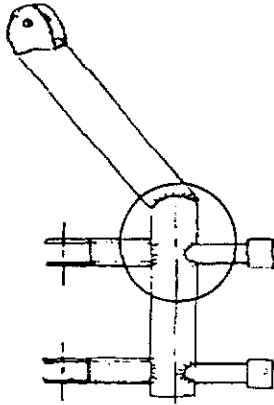
Le circuit de commande des aérofreins depuis la poignée jusqu'au bras d'aérofreins du fuselage est représenté ci-dessus. Un contrôle visuel minutieux de toutes les parties soudées et en particulier des parties encerclées doit être effectué, si besoin, à l'aide d'un miroir et d'une lampe et après nettoyage, afin d'y déceler un éventuel début de crique.

En cas de constatation de crique, prendre contact avec S.N. CENTRAIR pour l'informer du défaut constaté. Une réparation du planeur doit alors être réalisée avant tout nouveau vol.

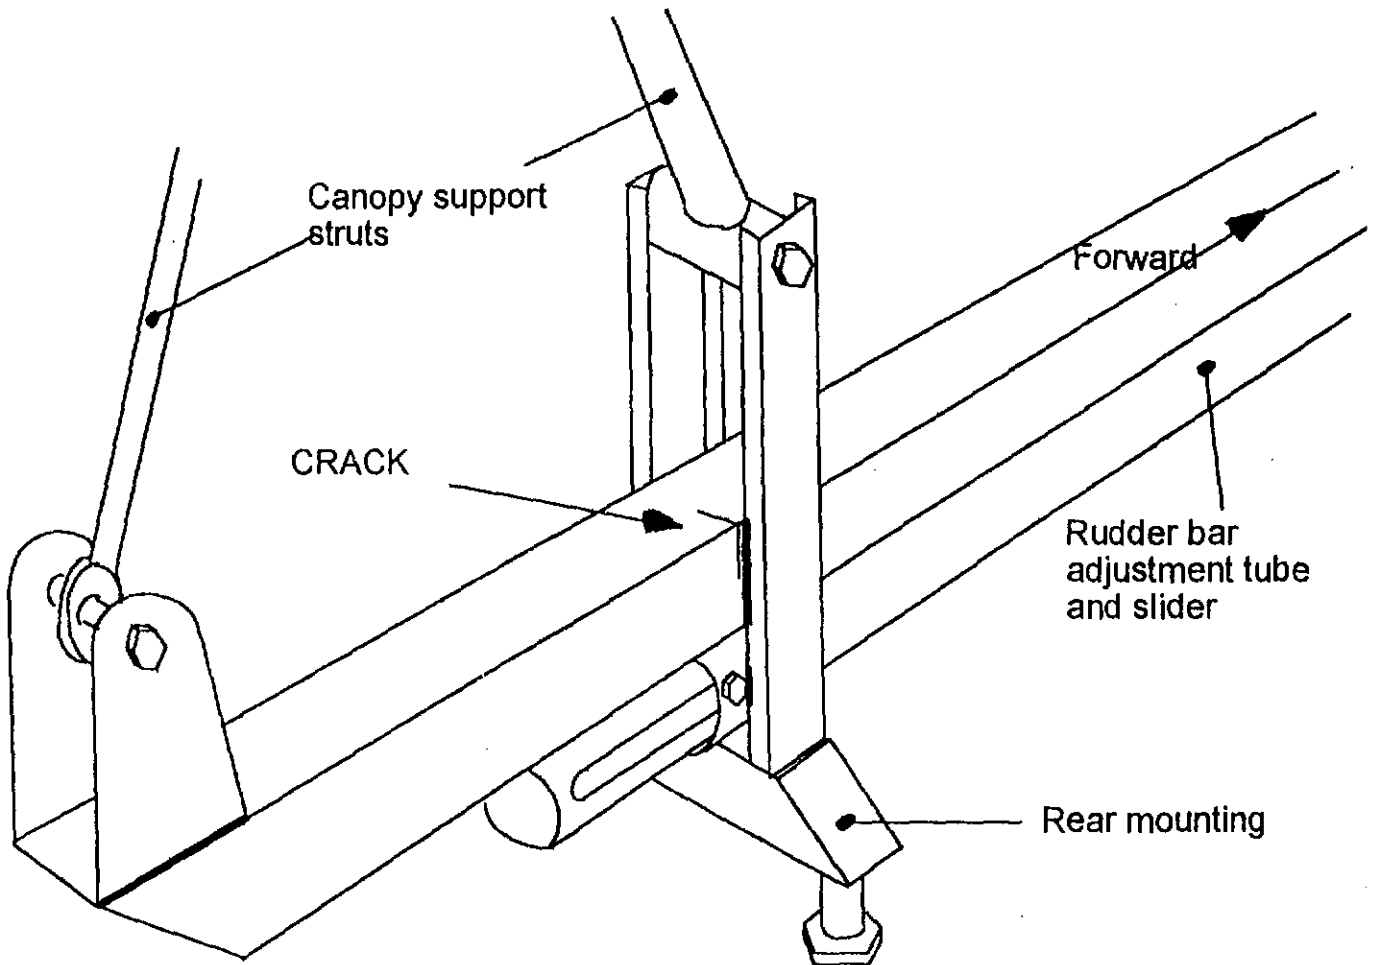
LS4 Rudder bar and canopy support brackets and mechanism.

- 1.11. LS4 - CRACKS in Rudder Pedal / Canopy Support Structure is illustrated herein. (Reported by Tom Muncaster).
 - 1.12. MT PROPELLERS. Latest list of A/D's (Feb 1999) herewith.

The crack appears to have started alongside the vertical weld and progressed upwards and around the corner of the square-section tube onto the horizontal face.

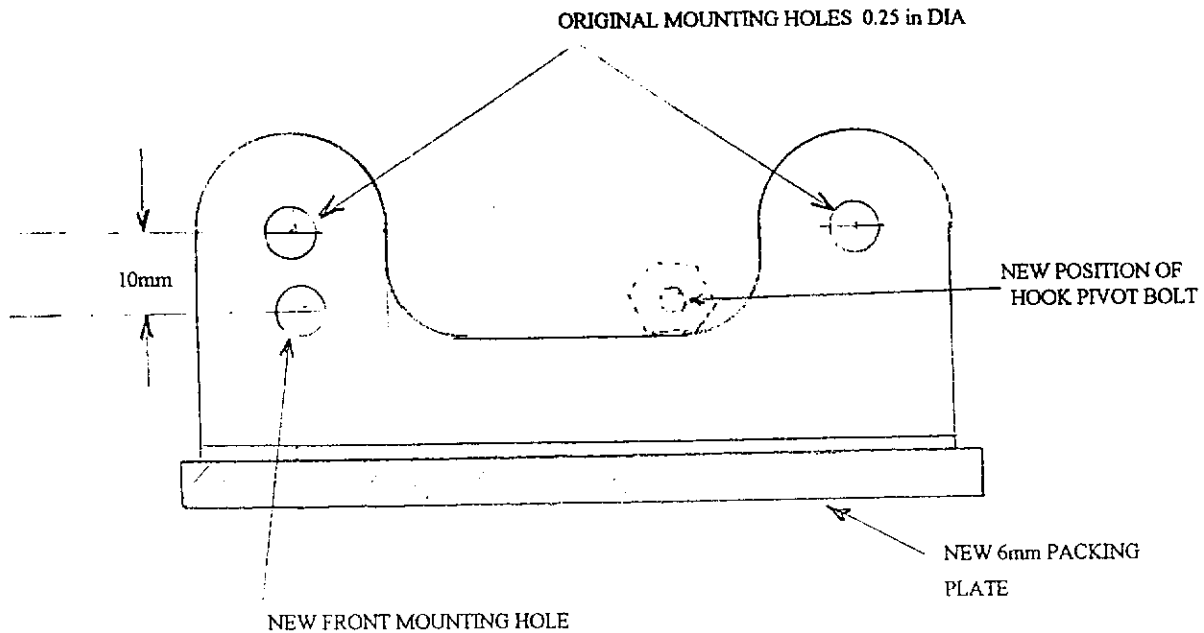
KESTREL 19/20 Hook Mod:

A sketch of the modified bracket is given below.

Test flights with the Kestrel 20 gave a much improved launch to 1200 feet at which height the cable release was pulled in the cockpit. There were no problems. The proposed modification was incorporated into the Kestrel 19 and test flights have shown a similar improvement to the winch launching performance.
