# BGA TECHNICAL COMMITTEE

## TECHNICAL NEWSHEET 7/8/99

### PART 1    AIRWORTHINESS MATTERS Please consult the BGA 1999 Red Pages .

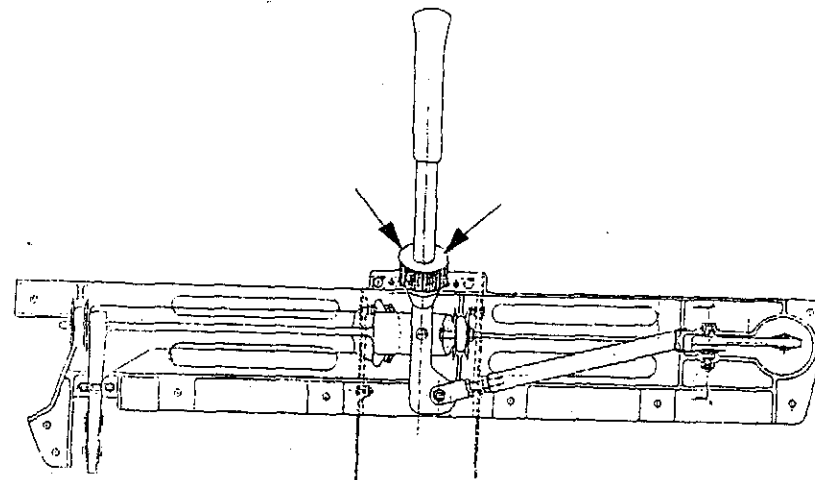
Single cases had been reported to GROB, where the fastening nut (knurled nut) was cracked. Previous investigations showed, that these damages may be caused by improper handling i.e. fastening the nut too tight. As a precautionary action an inspection or replacement of the knurled nut is mandatory.

1. The knurled nut must be checked for damage, especially for cracks on the upper side of the nut. If the nut is found damaged or cracked, the nut must be replaced immediately.

2. The inspection must be repeated before the first flight of a day, until the knurled nut is replaced.
3. The knurled nut at the rear control stick must be replaced for a new knurled nut made from stainless steel.

Replace with P/N 103-4205.03/2.
