BGA TECHNICAL COMMITTEE

TECHNICAL NEWSHEET 5/6/99

TNS 5/6/99.

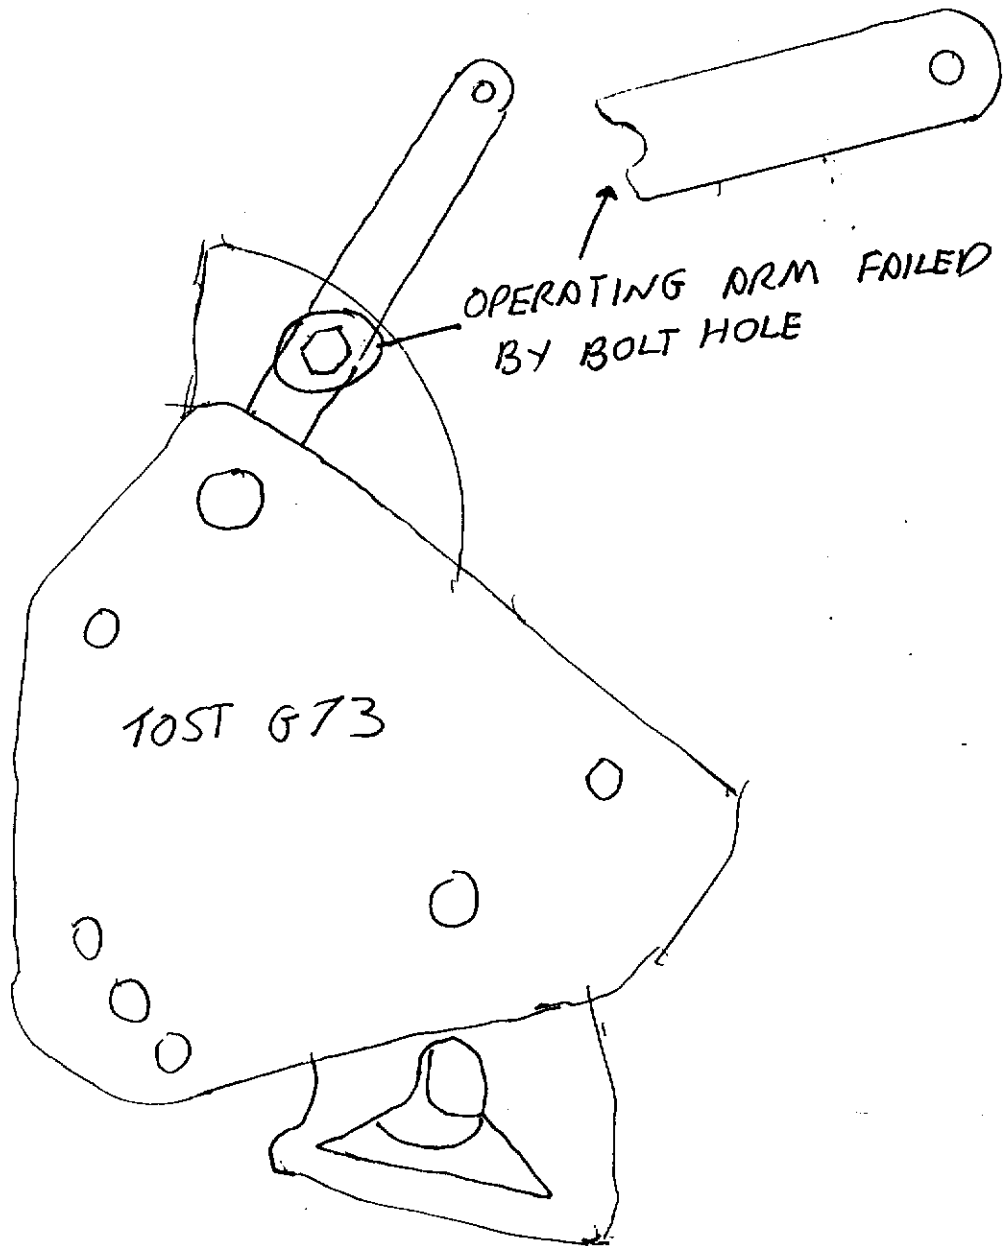
HOOK REMOVED FROM N K21

- PART 1 AIRWORTHINESS "AGGRO" Please consult the BGA 1999 Red Pages .
- 1.1. TOST HOOK FAILURE. Sketch from London Sailplanes illustrates failure of the operating lever on a KA21. (Overhauled Hook).

OVERHAULED HOOK FITTED ON THE 12/5/98

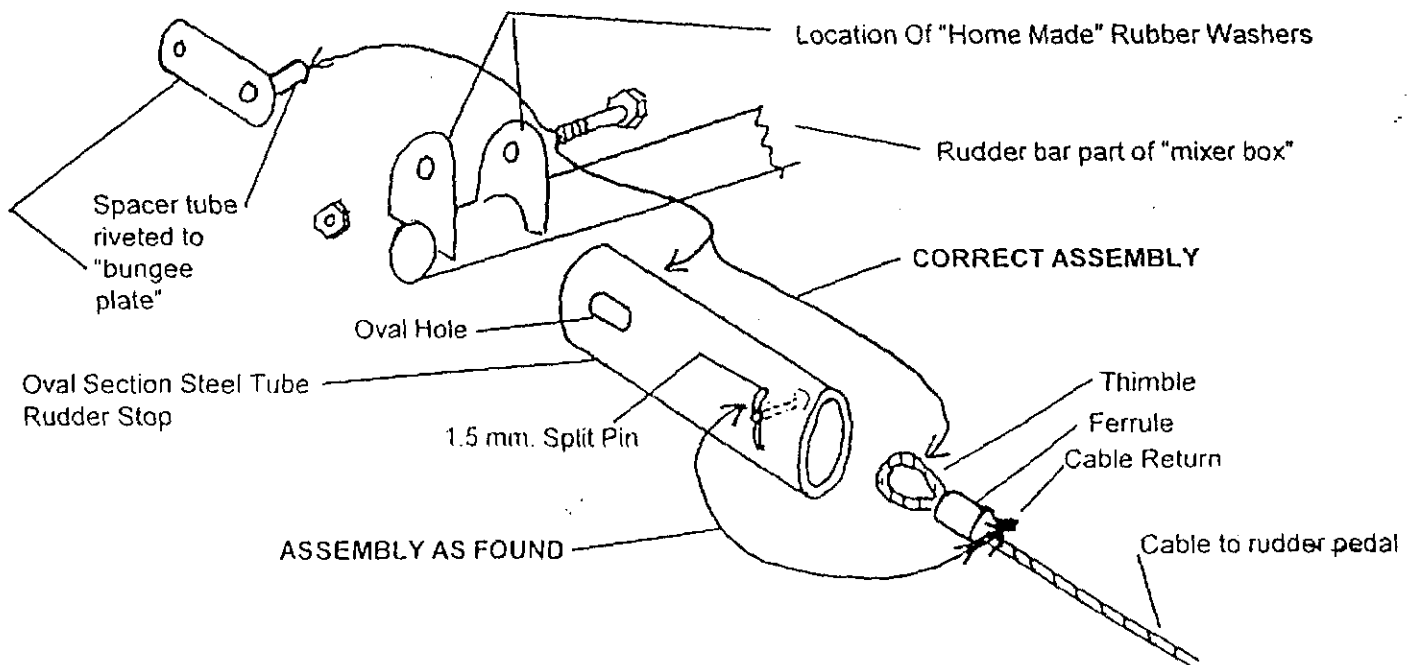
STD - AUSTRIA

- 1.2. STANDARD AUSTRIA Loss of Rudder Control as illustrated in report and sketch from Burn G.C.
 - 1.3. ASTIR'S - Sealing tape becoming detached, seriously impairs the performance of the flying controls. Applies to all types of gliders.

The retrieve crew observed when derigging the glider that the rudder cable was detached from the rudder bar at the control "mixer box"

In this instance the stbd. cable was loose from the oval tube, but the spacer and nut and bolt were still in place, as were the thimble and ferrule on the cable. There was however no 1.5mm split pin. Upon examining the port side assembly, Mr. Collins removed the split pin which instantly released the cable complete with thimble and ferrule. It appeared that the cable had only been held in place by the split pin lying between cable and return (after passing round thimble and through ferrule).

We surmise that at some time, rubber washers (apparently home made) had been fitted between the cheeks of the bracket and the oval tube to stop rattle, and the reassembly had been carried out incorrectly with the thimble NOT being placed over the spacer tube. Only the split pin stopped the cable pulling out of the oval tube.

It was impossible to see that the thimble was misplaced, since all of the cable end including the thimble were within the length of the oval tube.

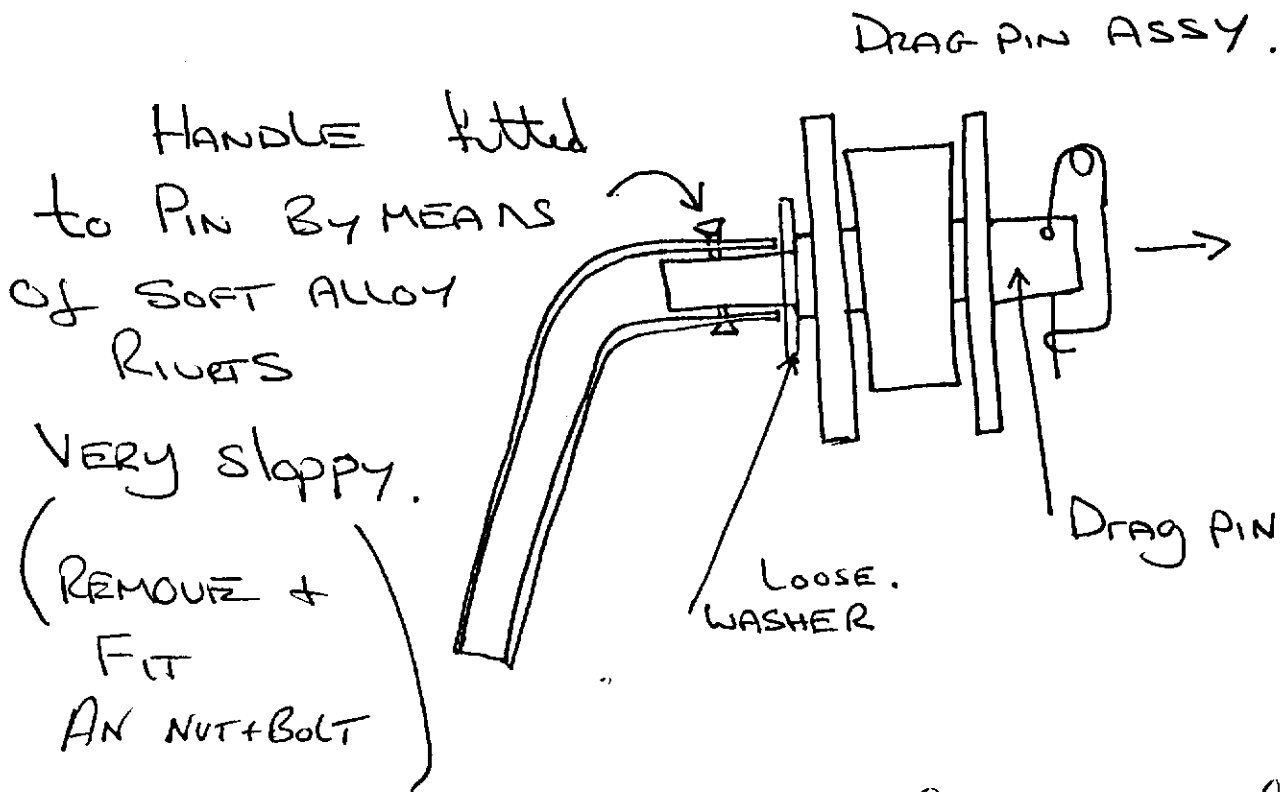
FAULT FOUND ON WA 28F
(ESPADON)
By P.M. JOHNSON 1/6/1134/ME

- 1.7. WASSAMER WA28F. Drag Pin handle incorrectly assembled, and therefore insecure. Sketch by G.M. Johnson I/C/1134/ME.
 - 1.8. IAR-SA BRASOV - latest list of A/D's for IS.28M2's dated March 99 - herewith.

IF HANDLE COMES AWAY FROM
DRAG PIN, WASHER FALLS OFF!
Which then ALLOWS PIN TO
COME OUT OF THE ASSY.

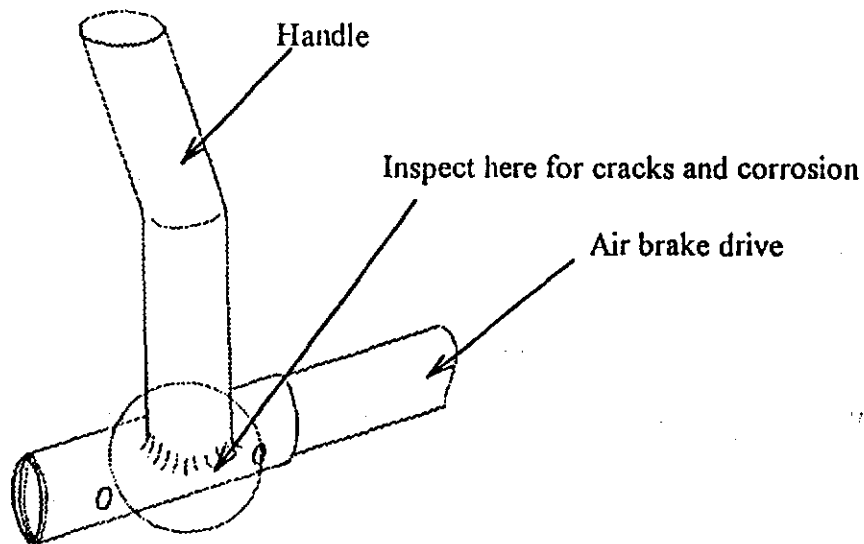
Sketch of affected area for closer inspection

BACKGROUND: The airbrake handle of an IS-30 (flown solo) broke away after the drive came out of the overcentre lock. The spoilers were sucked fully open leading to an accident as the brakes could not be closed.

The modification must be performed by a certified welder for aircraft. Corrosion is a problem at the handle of the airbrakes. Sweat is very likely to accumulate at the bottom of the handle leading to corrosion and cracks in the affected area. Thorough protection against corrosion after welding is essential for the modification of the airbrake handle.

ACTION REQUIRED: Before next flight inspect the airbrake handles for cracks as shown in figure 1. Remove any rust for proper inspection. Use a magnifying glass and if in doubt use dye penetrant. If any cracks are found the modification according to figure 2 must be performed prior to the next flight. Otherwise the modification must be performed before the next Form 2 inspection is completed.

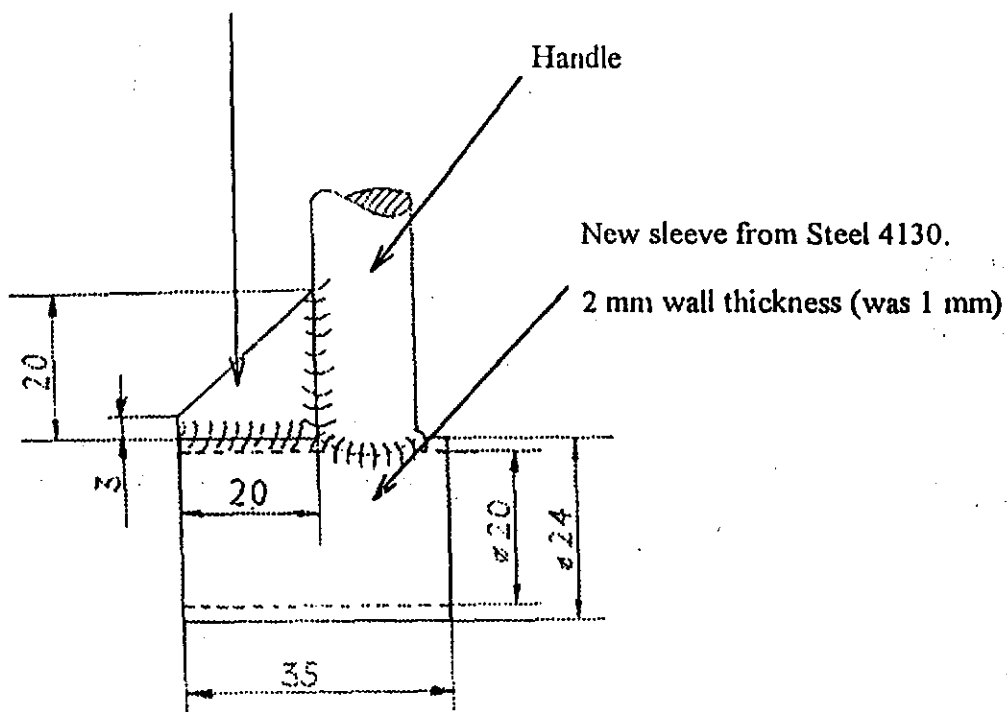
Sketch of modified air brake handle

The sketch is schematic. Particularly the gusset has to be fitted properly into the rounded corner at the handle.

○ Gusset from Chromium Molybdenum

Steel 4130 ($t = .060 \text{ inch} = 1.5 \text{ mm}$)

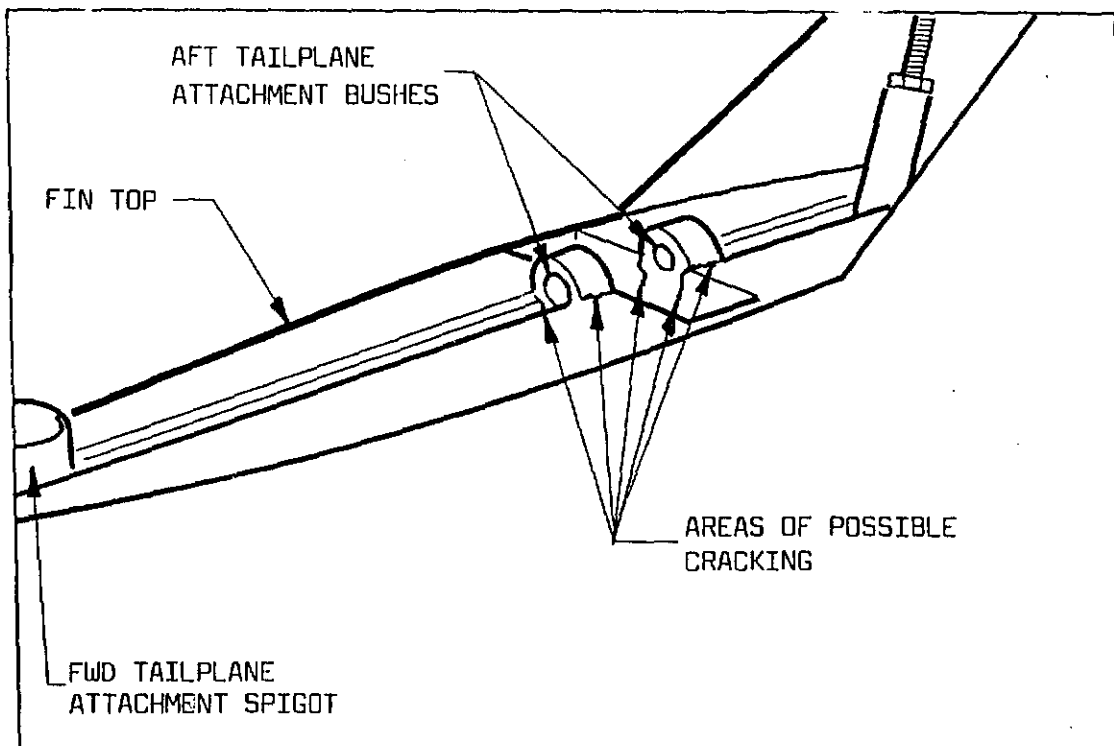
FIG 1

There have been cases reported of cracks having been found in the glass ropes which retain the fin mounted tailplane attachment bushes.

These cracks were found during repairs to a glider following a ground loop and could be an indication of further damage to tailplane mounting structure.

1. If applicable, de-rig tailplane from fin.
2. Clean area of inspection using acetone or equivalent.
3. Using a torch and a magnifying glass, check the structural integrity of the ropes securing rigging bushes to fin, ie there are no cracks in the areas shown on Fig 1. Additionally check the tailplane tang support structure within the fin for delamination etc. Should there be any doubt as to the existence of any cracks then place a bar (bush diameter is 7mm) in each bush in turn and carefully apply a twisting action on the bush, sufficient to disturb any crack that may be there. Ensure force used is not such to damage structure or bush bores.

4. Should the bush ropes be found to be satisfactory and the remaining structure is deemed to be sound, continue as paragraph 6.
5. Should cracks be found in the ropes around the bushes and/or structure is found to be unsound, then please supply to SAL, details of cracking/or other damage, stating whether glider was subject to any recorded ground loop incident, together with glider works number etc.
