# BGA TECHNICAL COMMITTEE

## TECHNICAL NEWSHEET 9/10/99

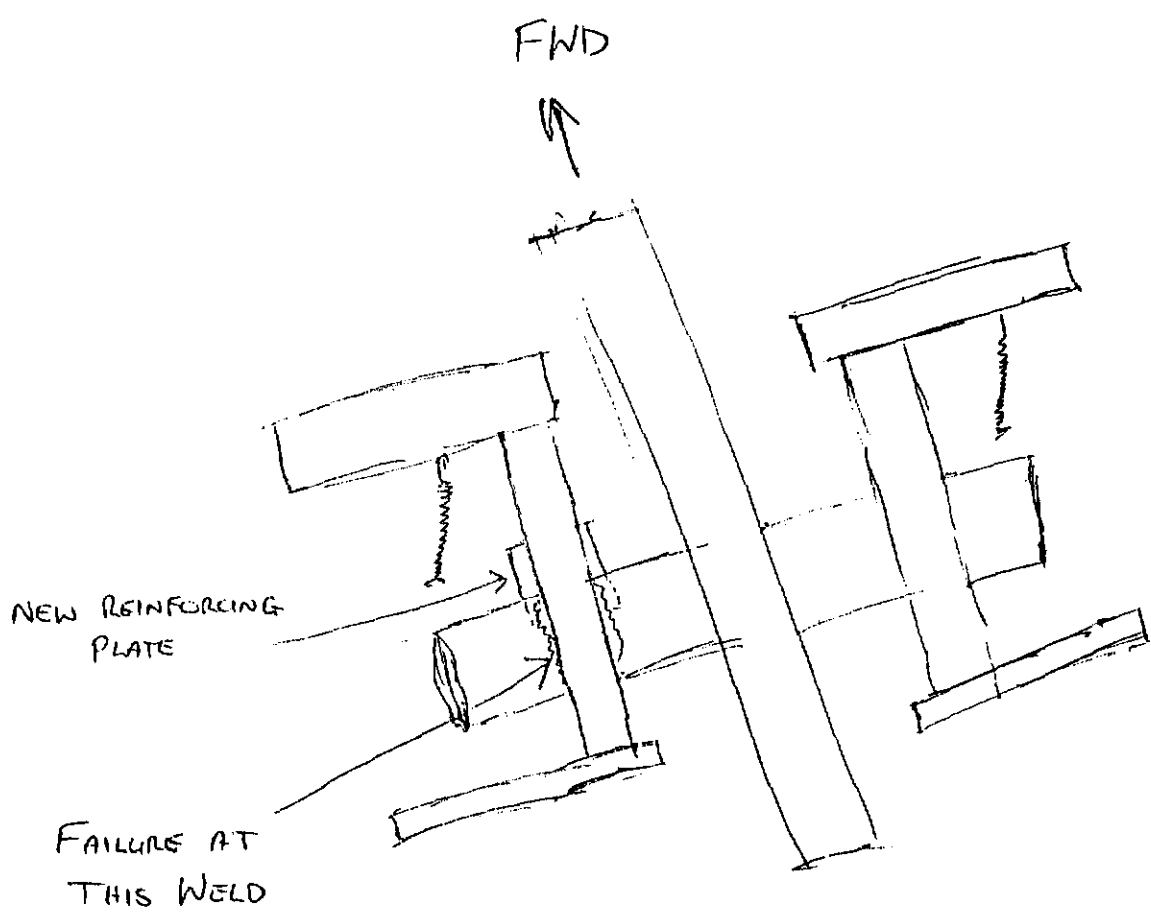
AS W 20 FL  
Rudder Pedal Failure

- 1.11.     **ASW 20FL - RUDDER PEDAL FAILURE IN FLIGHT.** Sketch from Colin Short identifies the failure. Inspect a.s.a.p.
- 2.0.     **GENRAL MATTERS**

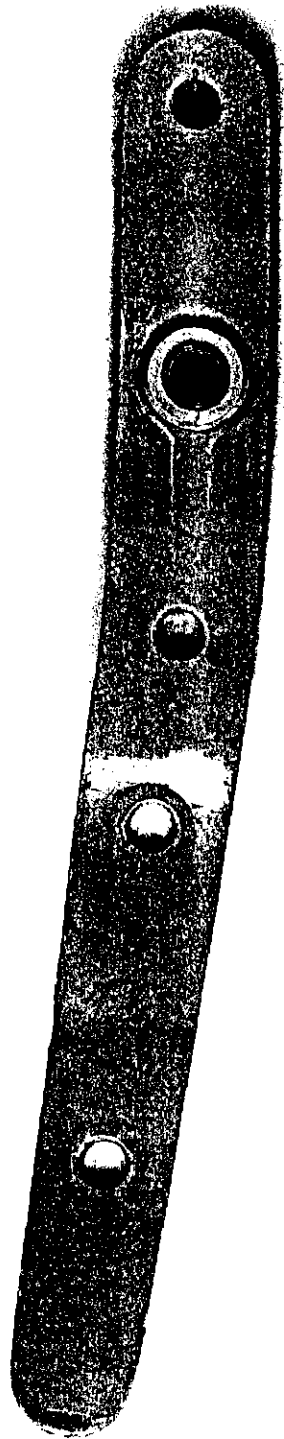
ELEVATOR DRIVE LEVER

- 1.10.     **KA13 (also KA7/8/18)** Elevator final drive levers supplied by London Sailplanes may have been manufactured in a "Soft" material, prone to bending under load. Inspect a.s.a.p. and replace if necessary. (Reported by Southdown G.C.).

MAY HAVE BEEN MANUFACTURED IN "SOFT" MATERIAL.

SUPPLIED BY LONDON SAILPLANES
