BGA TECHNICAL COMMITTEE

TECHNICAL NEWSHEET 01/02/00

MANDATORY BULLETIN

No. L13/085a

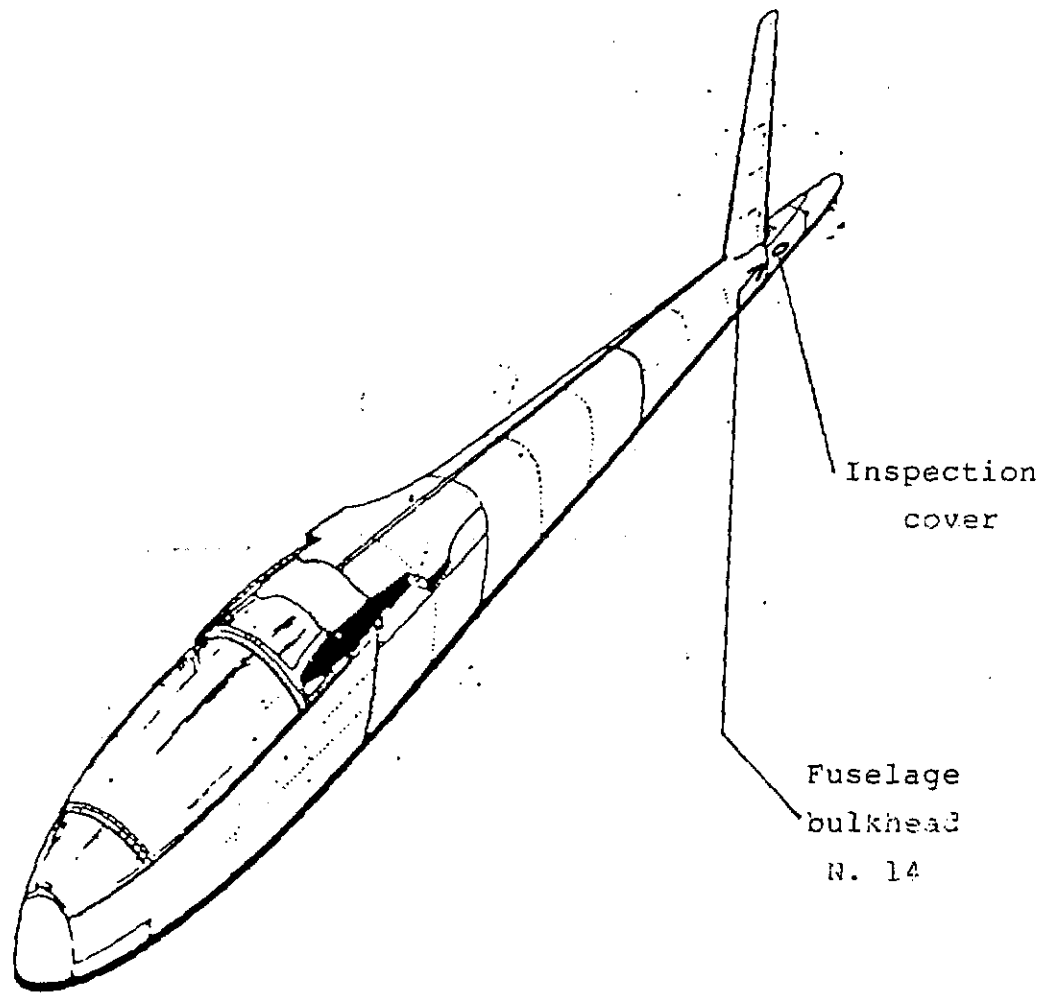
Fig. 1

Reason: On the L 13 BLANIK sailplane S/N 027226, the tail-fuselage attachment fitting P/N A 102 021 N made of 424253.11 material has been damaged in service.
The material of this component must be tested as instructed in this Bulletin.

1. Remove the oval cover located on the LH side of the fuselage, under the horizontal stabilizer.
2. Test the material of the attachment fitting P/N A 102 021 N as follows:
 - a) Conductivity measurement by means of eddy currents:
 - Recommended measurement frequency: 60 kHz
 - Probe diameter: not exceeding 15 mm
 - Measuring contact point: lower milled surface of the component, between the rivets (see Figs 1 and 2).

- 3.1 If the values measured during the check are within the permissible limits specified above, make a record in the sailplane logbook (see section H of this Bulletin). The sailplane operation can be continued without any limitations.
- 3.2 If the values measured during the check are not within the permissible limits, the attachment fitting P/N A 102 021 N must be replaced before the sailplane operation can be continued.
4. If the attachment fitting P/N A 102 021 N is to be replaced, the operator shall place an order with the manufacturer, stating the sailplane Serial No., number of flight hours, registration mark, and number of its repairs and / or overhauls.
5. The manufacturer will send to the operator the material required for replacement, together with a bulletin providing the work procedure.
6. After the check, reinstall the inspection hole cover.

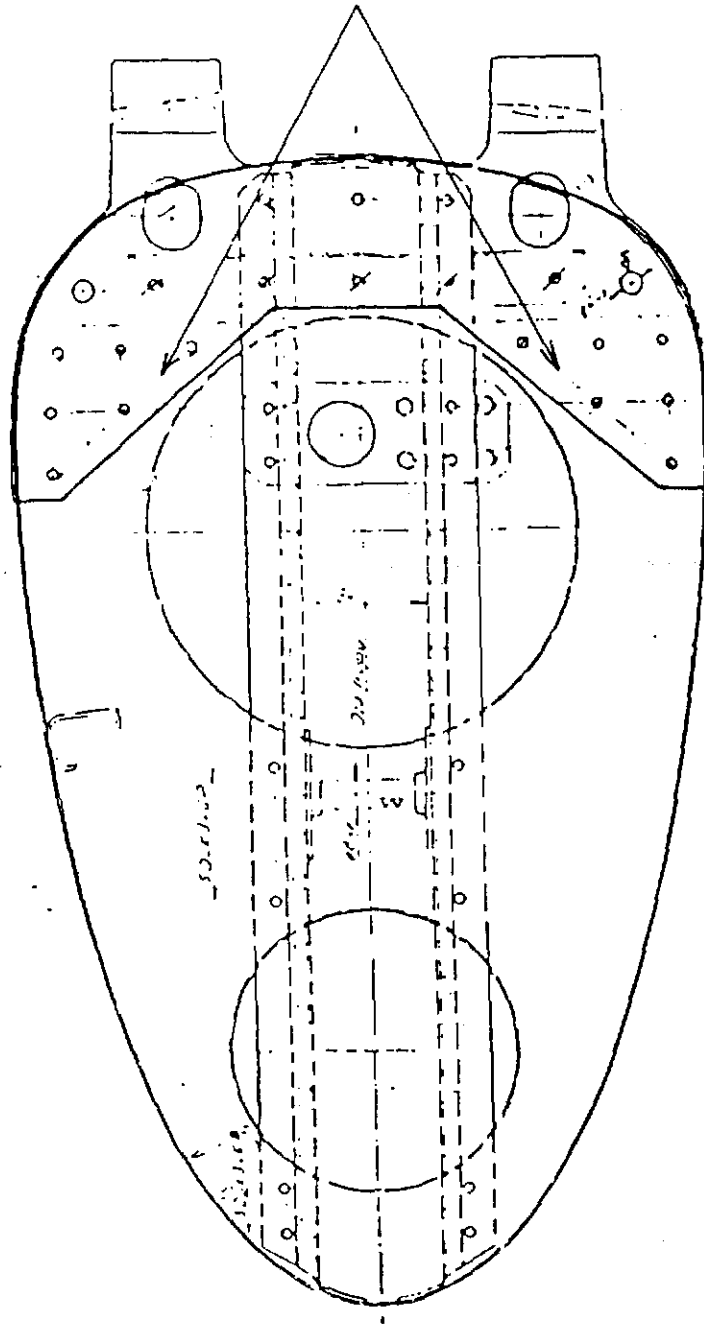
Fig. 2

Measuring contact point

Fuselage bulkhead N. 14 with attachment fitting P/N
A 102 021 N

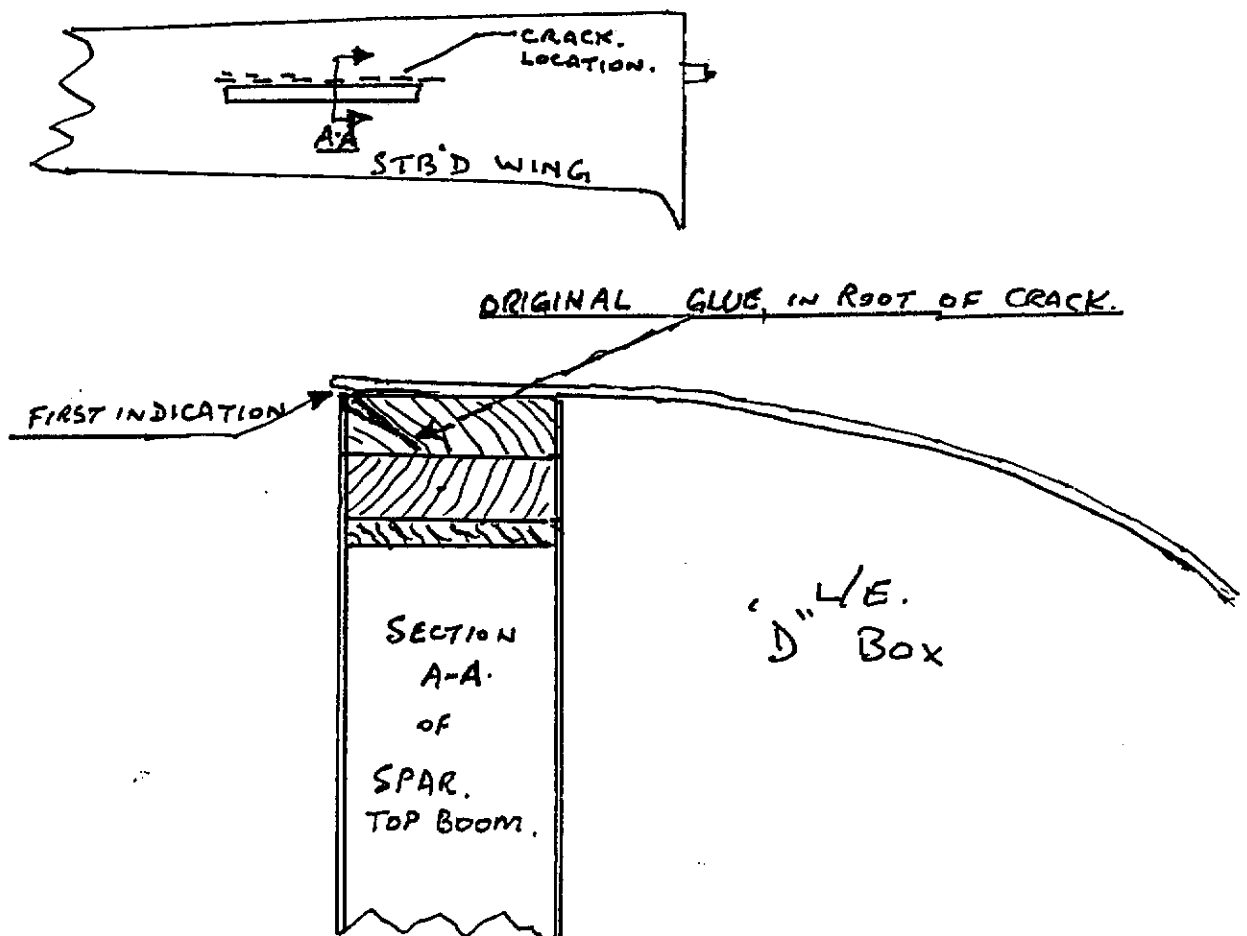
During the course of inspecting the above glider, it was observed that the port top airbrake paddle was approx: 1/4" below the top skin profile. Closer examination revealed a splitting of the top mainspar boom over a length of 30 inches immediately ahead of the airbrake slot under the D-box skin. A thin blade could be inserted 1/2" to 3/4" without resistance along the length of the separation in the spar boom.

Over the 10 years I have known the glider, it has been cared for and not abused. The starboard spar does not show any evidence of a defect. Inspection of a younger K6 E for any defect in the same area showed no problem.

There was some aerodux glue in the root of the crack, [see sketch]. This supports the possibility that the crack may have been there since manufacture. Ingress of water and consequent drying out or aging may then have precipitated the eventual opening up of the crack.
