BGA TECHNICAL COMMITTEE

TECHNICAL NEWSHEET 11/12/99

**Airworthiness
Directive
1999-340**

Flight Controls - Cracks in the aileron steel pipe spar around the welded in hinge bushings

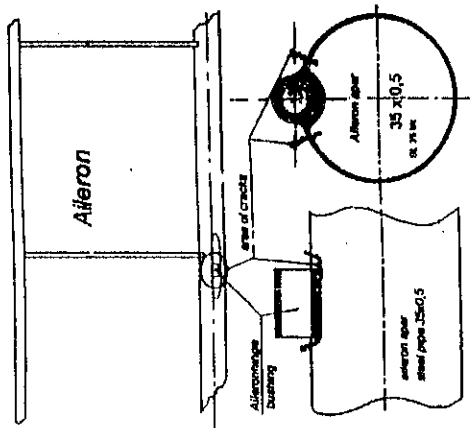
Reason: During inspection of a motorglider one aileron hinge was found to be broken out of the aileron steel pipe spar. On one aileron hinge bushing of another motorglider cracks have been detected around the hinge bushing weld seam (see following sketch)

- 1. Ailerons of affected motorgliders must be removed. Inspection of the welded seams of the aileron hinges and of the areas around the hinges is to be made with a ten-times magnifying glass. Therefore fabric and painting are to be removed 50 mm around the aileron hinge bushings on the aileron spar. If no cracks are found, paint the aileron spar steel pipe and repair the removed fabric. Following this inspection pay special attention during each maintenance inspection to point 6a of the manufacturer's check list SF 25 last edition.

- 2. If cracks are found aileron hinge bushings must be reinforced in accordance with the following sketch.
If cracks are detected around an aileron hinge bushing or if a hinge bushing is worn out, corrosion inspection of the inside of the aileron spar steel pipe is requested, because moisture may have appeared in period of time.
If corrosion is detected inside the aileron spar steel pipe please contact SCHEIBE Flugzeugbau GmbH for special repair instructions.
If one aileron hinge bushing must be reinforced all three hinge bushings on both ailerons of the motorglider must be reinforced. After reinforcing of the hinge bushings by a steel sheet joint (see the following sketch) special inspections according to point 6a of the manufacturer's maintenance checklist last edition will no longer be necessary.
