British Gliding Association – Technical Committee**Technical News Sheet 05/06/00****Part 1** **Airworthiness issues (all categories)**

Jim Hammerton
Chief Technical Officer

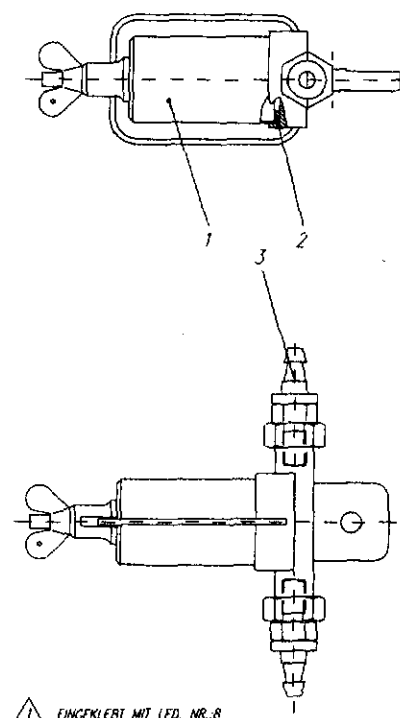
KRAFTSTOFFFILTER
 109B-6176

Background: *The rubber seal, installed in the fuel filter at the firewall, is no more available soon.*
Information: *Therefore in the future a new seal P/N 109B-6176.02 will be installed. This seal is usable for all types of fuel. A seal for the first, free replacement is enclosed to this Service Letter.*

Action: *Replace the seal as follows:*
- *remove the securing wire*
- *loose wing nut and remove the filter housing*
- *remove old seal and insert new seal*
- *install filter housing and tighten wing nut*
- *secure wing nut using securing wire*

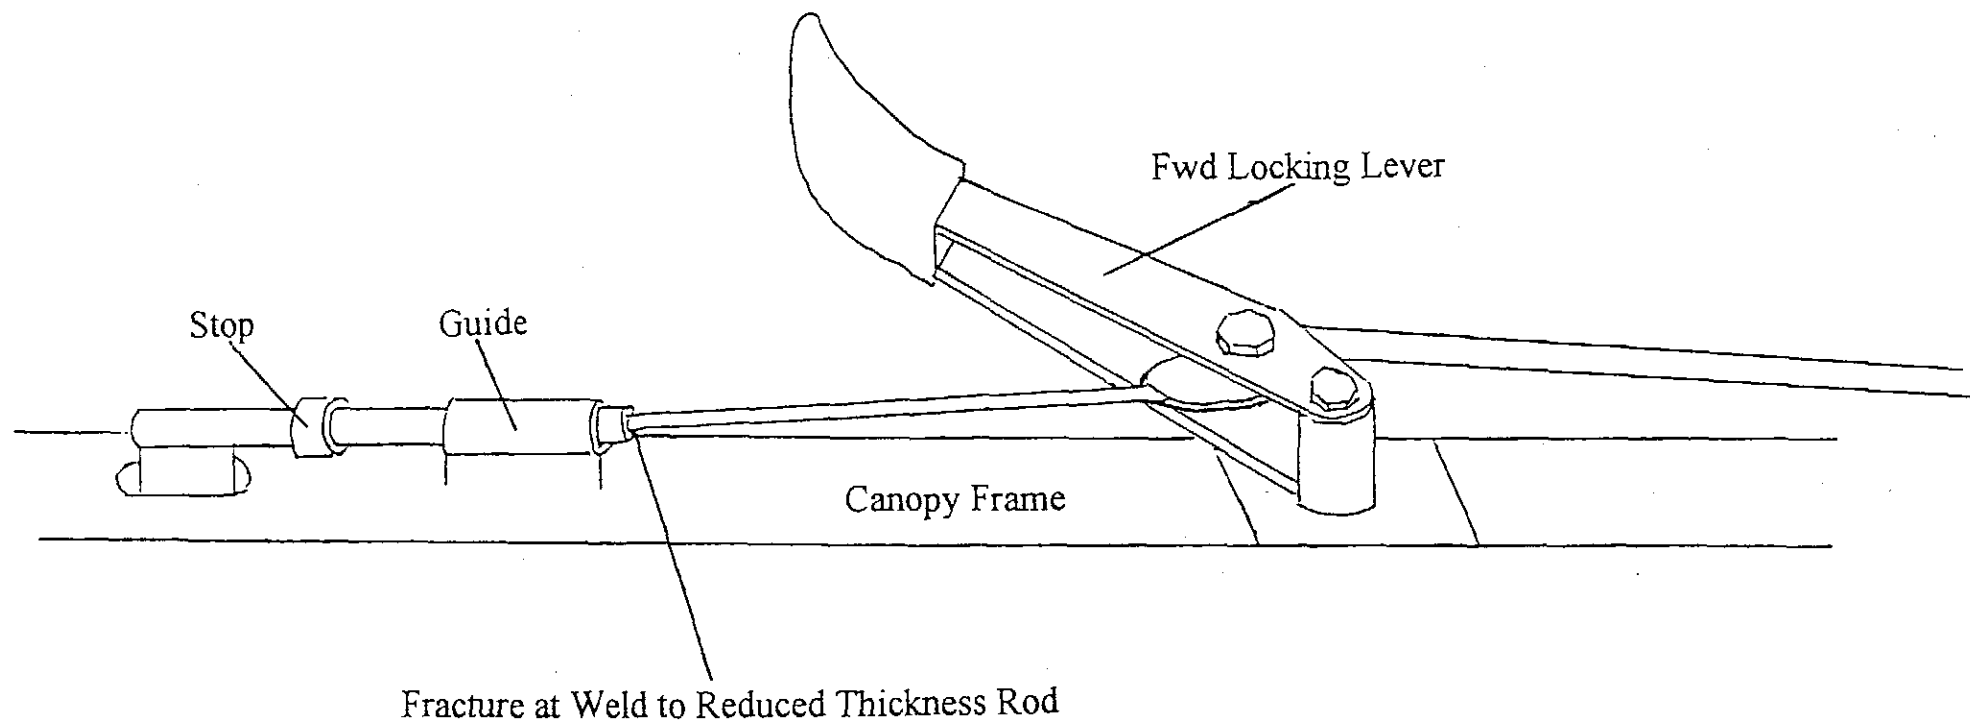
DUO DISCUS CANOPY LOCKING MECHANISM

- 1.12 **DUO DISCUS** Defect reported by RAF GSA
Canopy front locking mechanism failed resulting in inability to open to
open canopy. The operating rod fractured at the welded joint at the
diameter reduction. Drawing enclosed. Inspection is required A.S.A.P.
Note; Later aircraft do not have a reduced diameter operating rod.
