# BGA TECHNICAL COMMITTEE

## TECHNICAL NEWSHEET 3/4/00

TNS 3/4/00

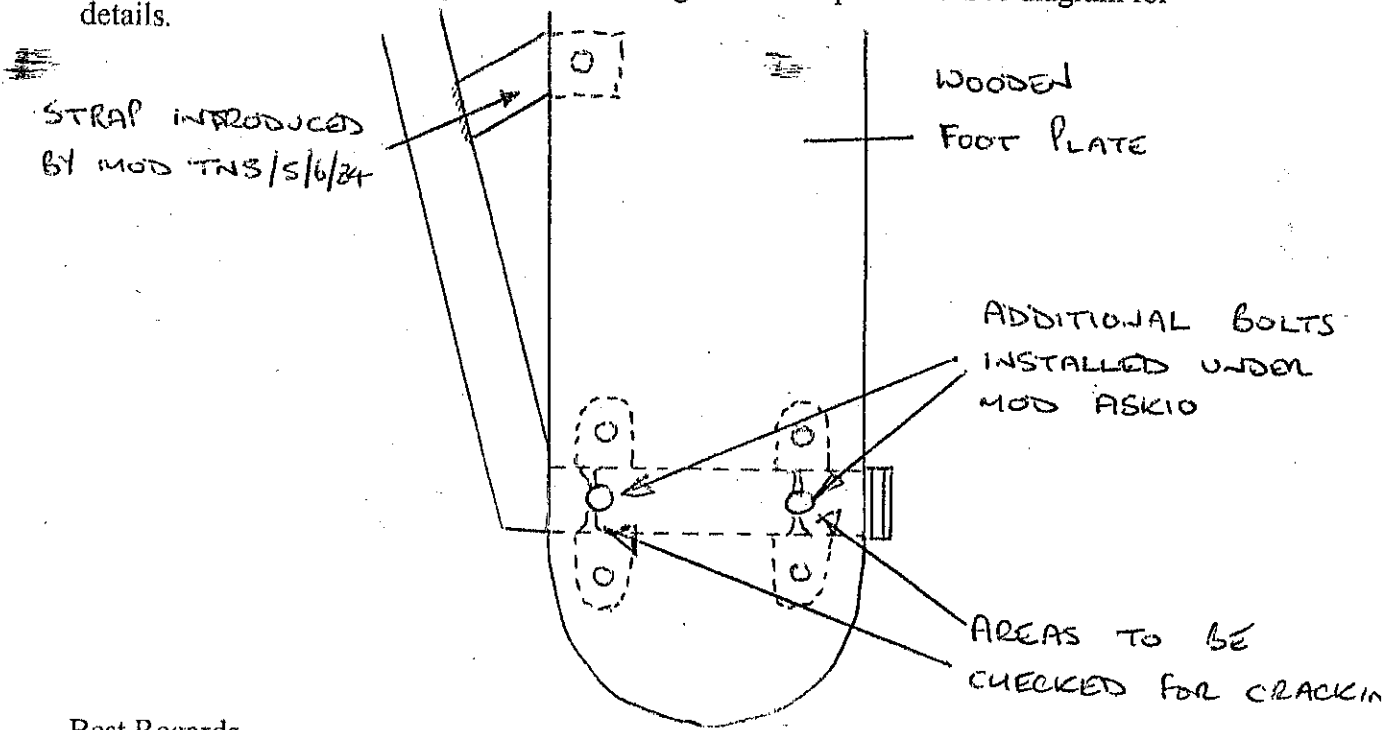
**FRONT RUDDER PEDAL FAILURE -- RAFGSA K 13 S/N 13615, BGA4581, R7**

The above defect was found during the pre flight checks of the flying controls and if had not been detected would have probably resulted in partial or total loss of rudder control..

The pedal tube was found to be totally fractured in the area where a hole had been drilled and bolt introduced to stop the foot plate twisting. I believe that this modification was introduced under Mod ASK10 by the RAFGSA and may affect other types such as Ka 7 and Ka 8. The mod approved by BGA TNS/5/6/84 introduced a welded strap which would appear to be a better method of preventing the foot plate twisting. I would suggest that any of the above types that have had holes drilled and additional bolts fitted to their rudder pedals be inspected for cracking as soon as possible. See diagram for details.

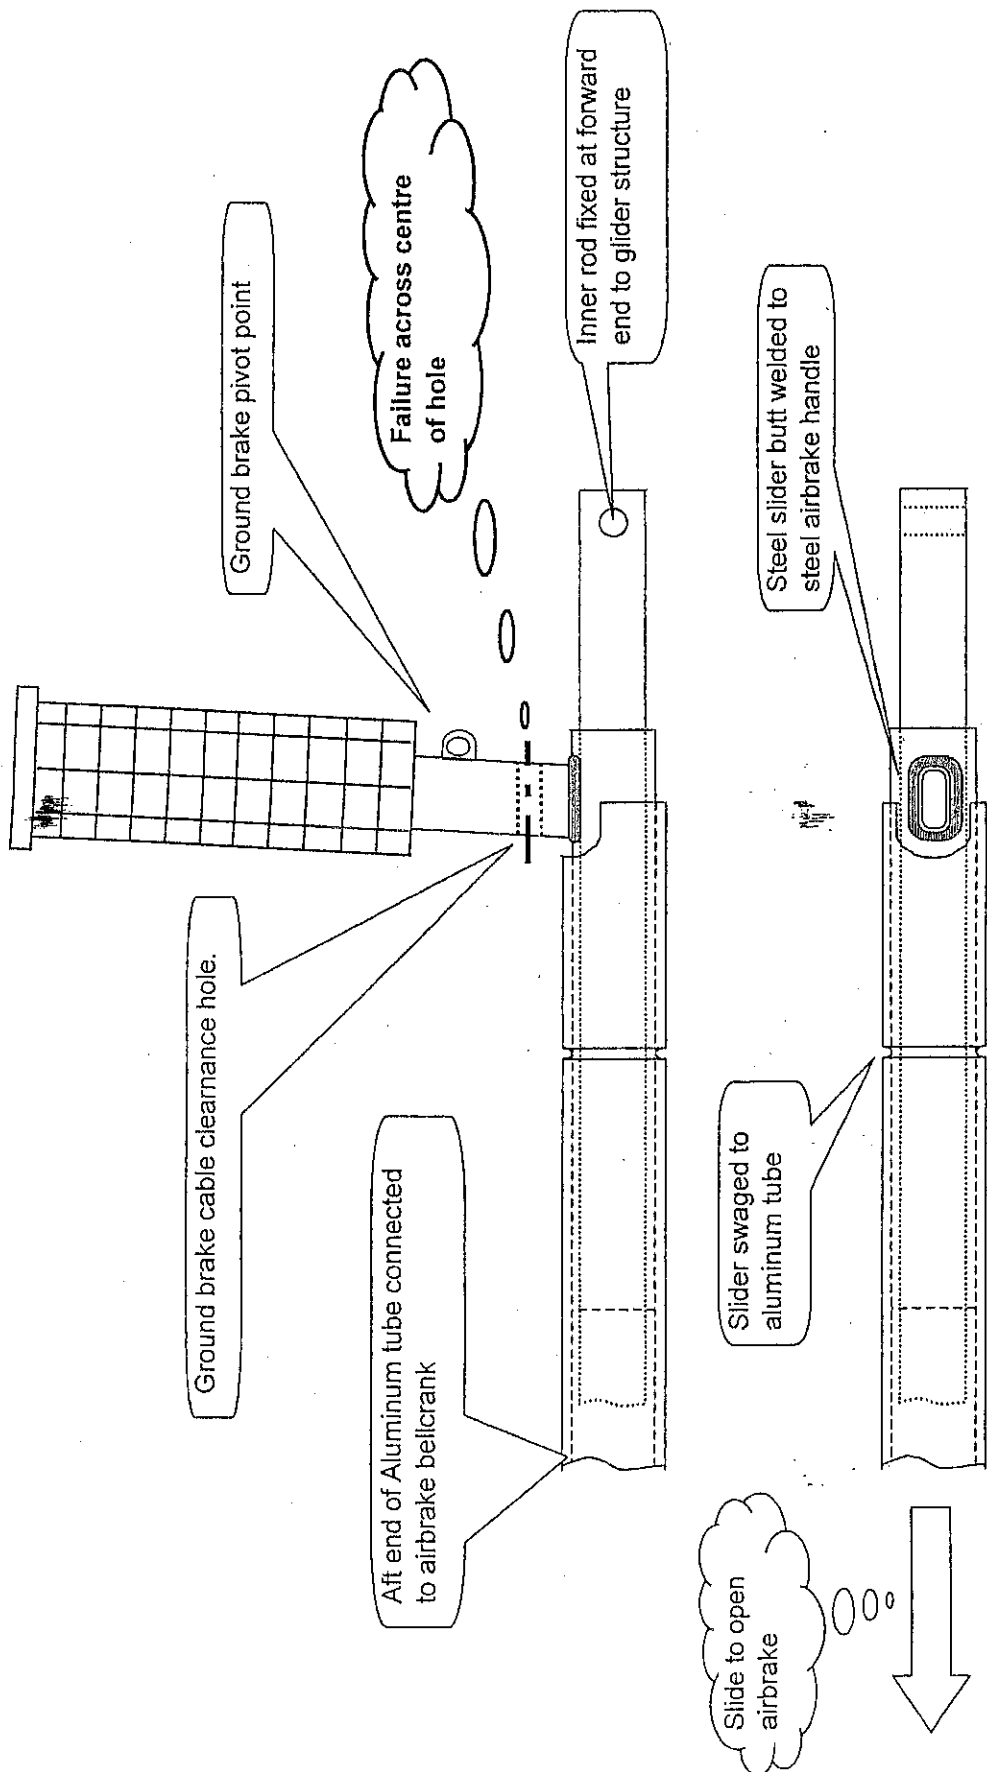
Junior HRG - Airbrake Lever Failure at SGU (Portmoak 20/02/00)

- ~~1.6.~~ JUNIOR AIRBRAKE LEVER FAILURE. Sketch from S.G.U. identifies the problem area.
- 1.7. LS3/LS4/LS6/LS7/LS8 SAILPLANES. LBA A/D EB 4/1 - B.16 requires action to prevent jamming of airbrakes.

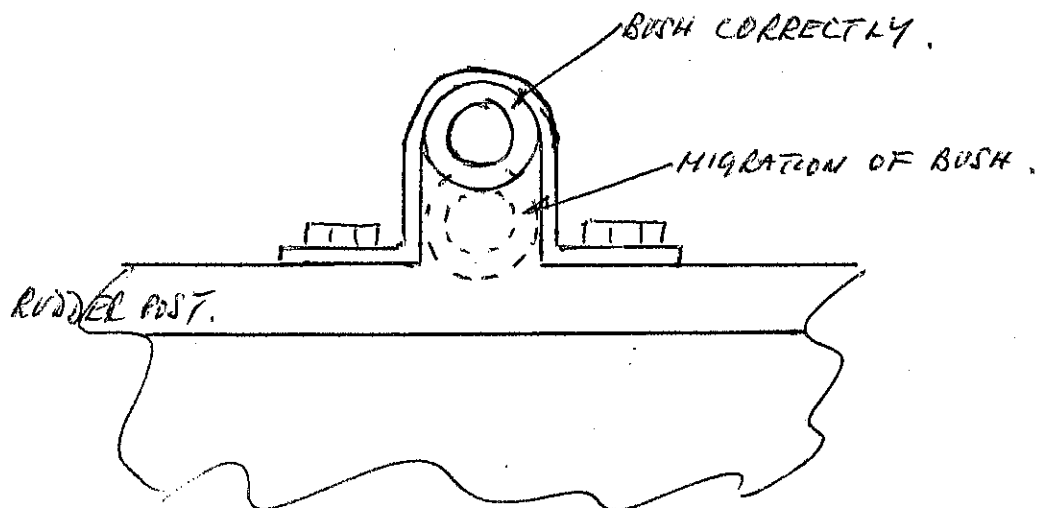
Fault found on rudder during annual C of A inspection.

Play at lower hinge suggested worn bush, however removal of the lower hinge capping revealed a more serious fault.

The bush which is normally retained in the 'U' shaped saddle by a weld top and bottom had come loose and moved rearwards by approx. 5 m/m, impacting on the rudder post. (At this stage it was thought that pilots pressing on both pedals together could have caused this to occur.!) )

The three hinge pins attached to the stern post were checked for correct alignment and the rudder offered up for refitting and at this stage it was found that the three bushes/saddles were not in alignment.

The three hinge system does not allow any scope for mis-alignment and stress probably caused the lower hinge (because it is in line with the pull of the rudder cables) to eventually break free and find it's 'true alignment' allowed by the void in the 'U' shaped saddle.

The rudder was removed and as the old bush was worn a new one was securely fitted.

Rudder fabric to access centre saddle made good and repainted as original.

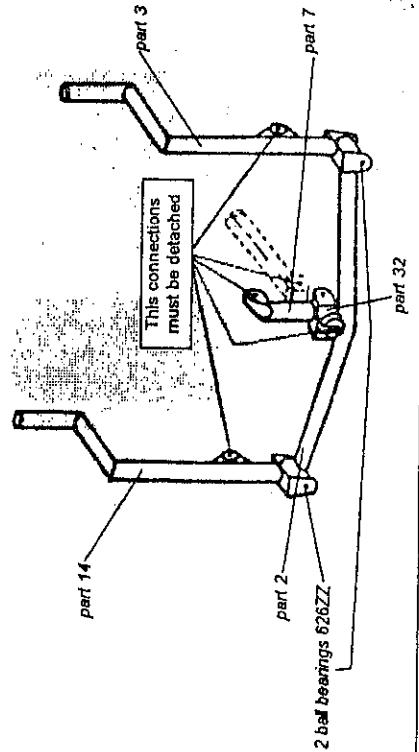
- a) Before the next flight, if a double-row self aligning ball bearing 14 C 6 is to be found in the control column parts 2, 3, 7 and/or 14 (see below sketch) or
- b) when the spheric slide bearings GE 8 E installed in accordance with TM 653-47 are worn out and must be replaced.

The spheric slide bearings GE 8 E according to TM 653-47 wear out very soon and are no longer obtainable.  
If these spheric slide bearings must be replaced, the complete control column (Parts 2, 3, 7 and 14 according to 653E-41-S10 and part 32 according to 653E-41-S10E1) must be modified according to 653E-41-S10 change d.

New slide bearing supports must be welded to the parts 2, 3, 7 und 14 (see below sketch) according to 653E-41-S10 change d and 653E-41-S10E1.  
The old Part 33 of 653E-41-S10 located between part 2 and 7 is to be replaced by the new part 32 according to 653E-41-S10E1.  
With the exception of the spheric ball bearing 14 C 8 at part 2 of 653-41-S10E1 all the other bearings are spheric slide bearings (1x SSCP 8 IH und 2x SSCP 6 IH). All the slide bearings are fixed with Loctite 270. Apply 2 new chime rings at each bearing.  
Replace the additional 4 ball bearings 626 ZZ at part 2 of 653E-41-S10.
