British Gliding Association – Technical Committee**Technical News Sheet 07/08/00**Part 1 Airworthiness issues (all categories)

- 1.1 **Centrair Alliance34 (and SF34b)**
BGA 007/08/2000 issue 1
BGA Mandatory inspection to lift flight restrictions. Details enclosed
- 1.2 **DG800B** TN873/19
Aircraft with Solo engine and spindle drive Stross ELT 10.
Powerplant control / extension-retraction switch unit modification.

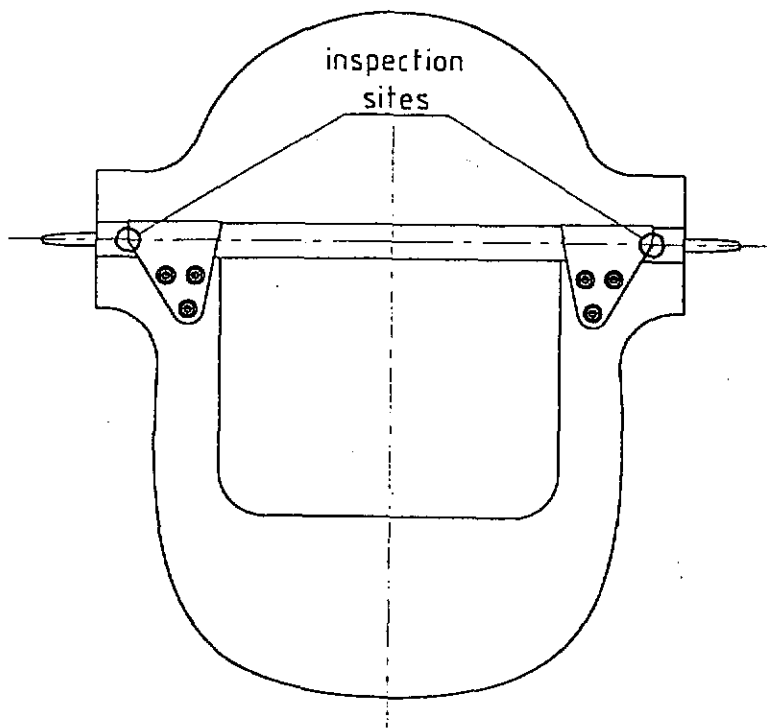
Front
bulkhead view

Bulletin issued due to first information on cracks detected in the front bracket console, mounted on front bulkhead fuselage.

Inspection to be held at sites indicated in the following sketch, both on front and back side of fuselage front bulkhead.

1. Preparatory action at sites specified in a sketch.
 - Wash-out paint from the surface, and de-grease the latter with acetone
 - Remove impurity from console surface with wire brush.
 - Pre-check the specified sites with aid of magnifying glass of 5x magnification, at least.
2. In case of doubts, employ the non-destructive magnetic-flourescent, penetrant-flourescent or penetrant-colour method accepted by Airworthiness Authority.

In case of finding on a console cracks above 3 mm, this plane should be withdrawn from operation, and producer is to be supplied by fax (No +48 33 812 37 39) with the following information:

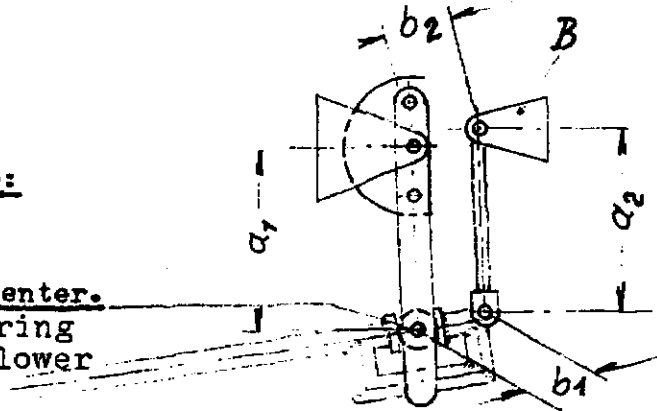
Must be in center.
or ballbearing
some what lower

$$a_1 = a_2$$

$$b_1 = b_2$$

A new bearing support
"B" is to be made with
adjusted measures if
the above dimensions
are not correct.

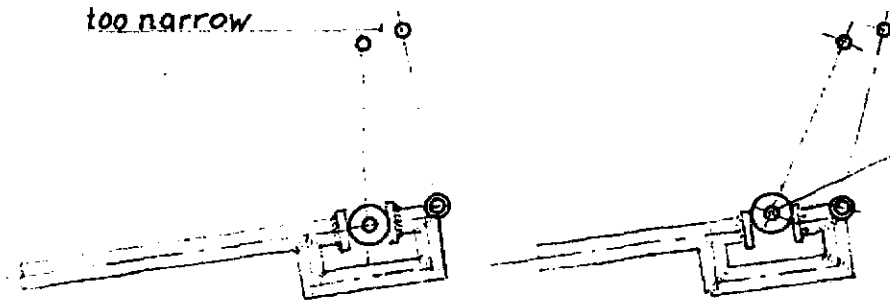
3. Parallelogram gearing not correct:

goes out at deflection
"push".

The inverse case can be, but is not so serious.
