British Gliding Association – Technical Committee

Technical News Sheet 11/12/00

British Gliding Association
Aircraft Inspection

Number:
011/12/2000

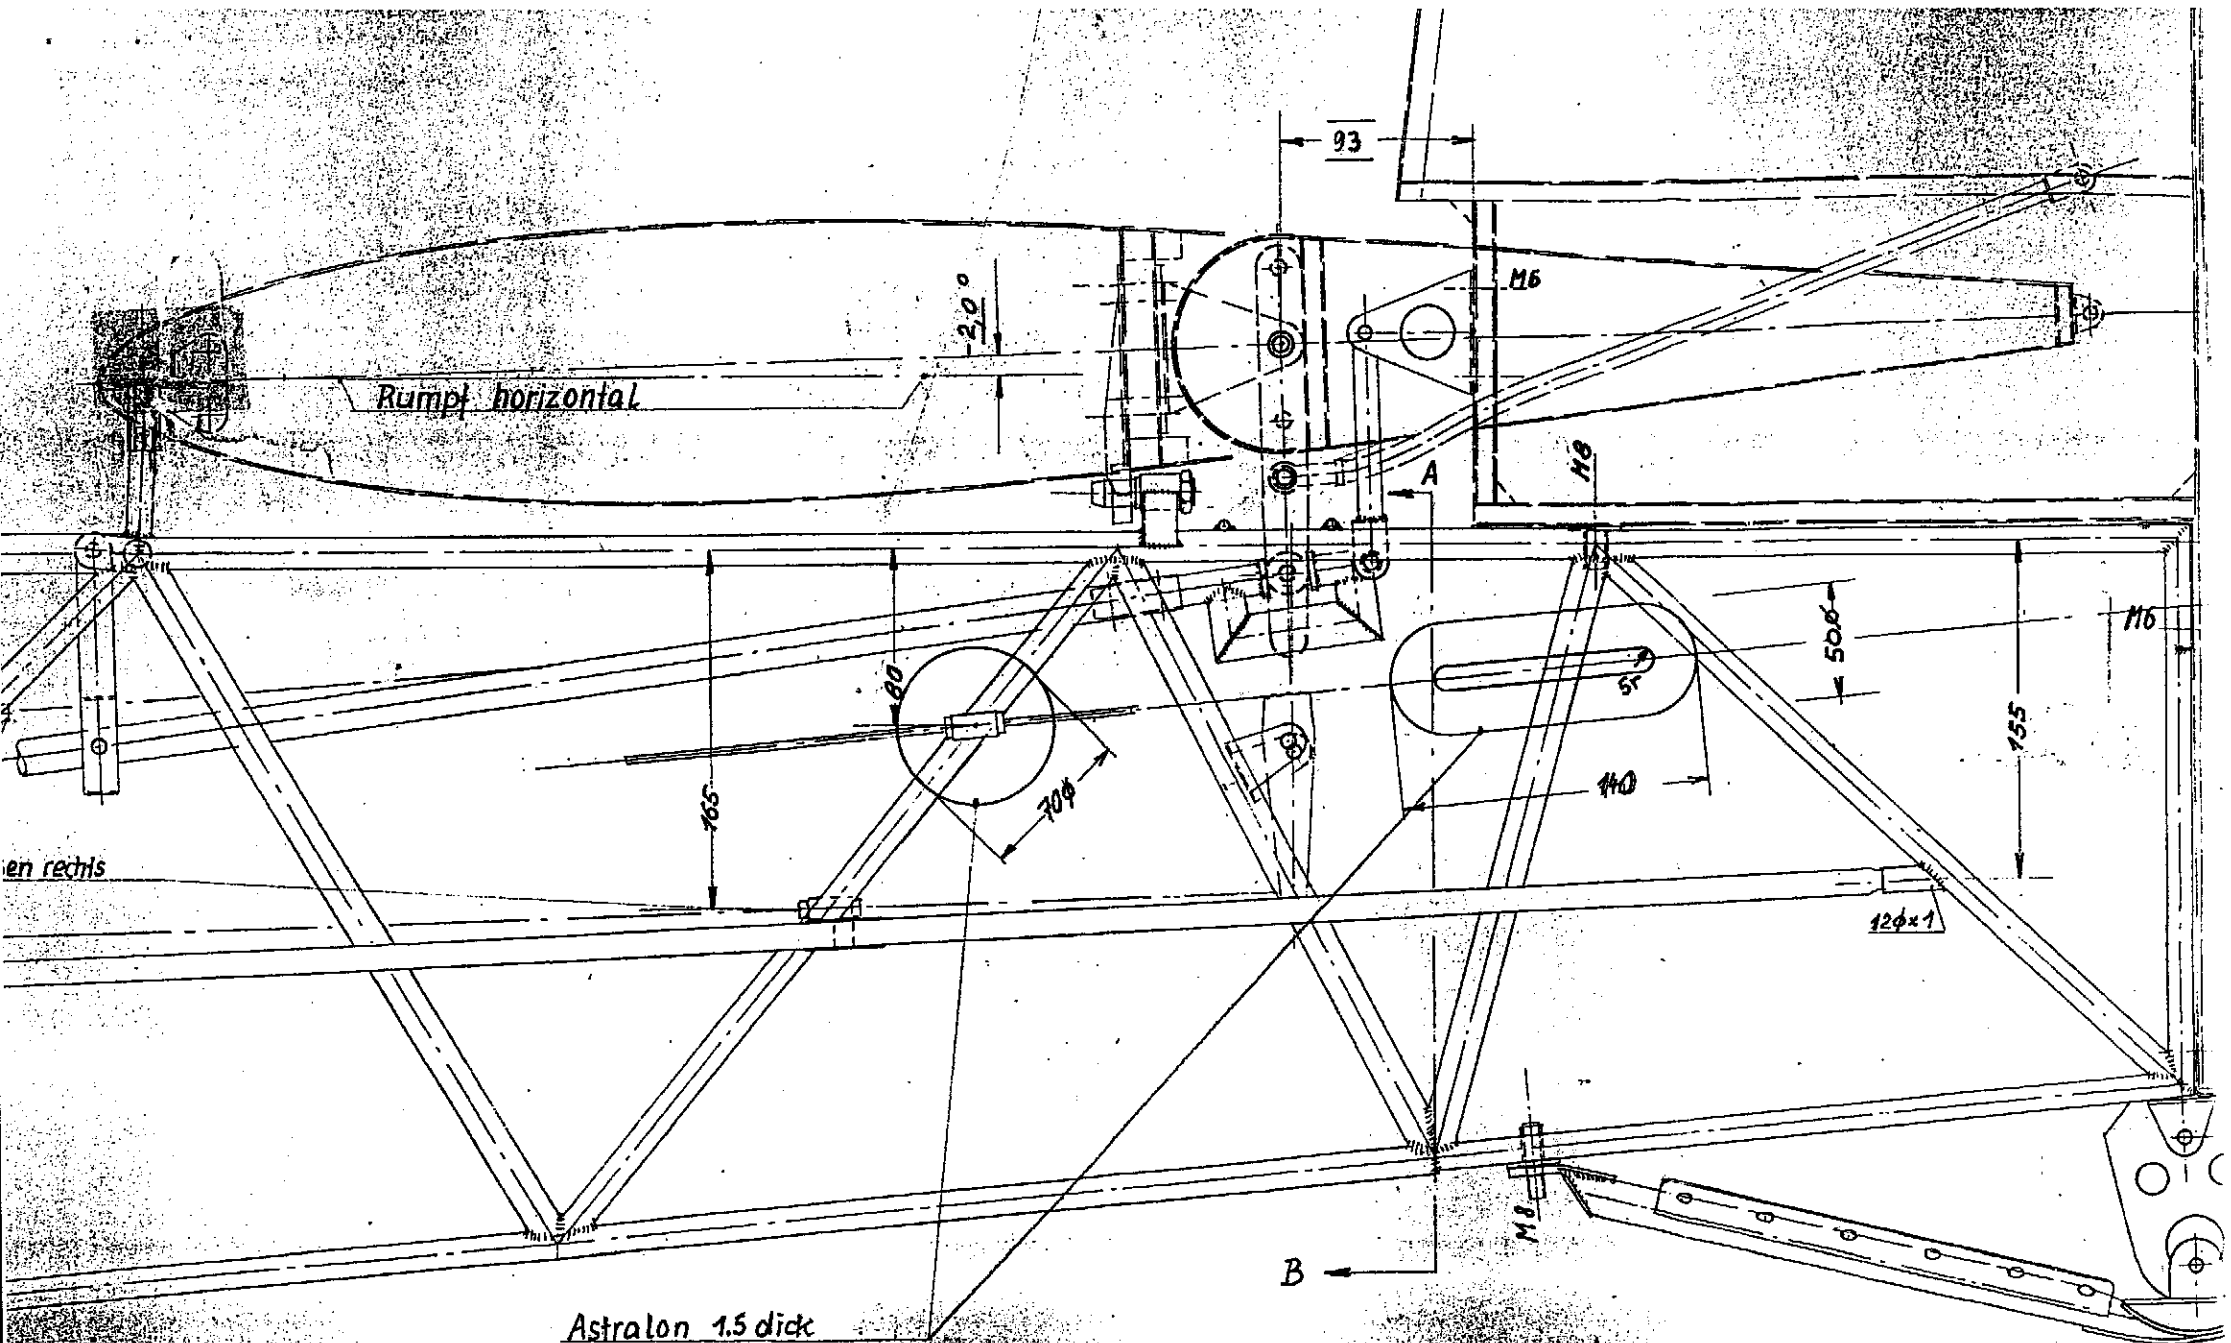
- Subject:** ASK 13 and ASK 18 Elevator Engagement
- Applicability:** Schleicher ASK 13 and ASK 18
- Accomplishment:** At next and subsequent C of A inspections and during inspections of rear fuselage.

- Reason:** Incorrect positioning of elevator linkage pivots or damage during rigging or following accident damage causing misalignment of elevator control arm ball bearing in drive rod and possible disconnection in extreme conditions.

- Instructions:** It may be necessary to remove one half of the elevator to accomplish this inspection.
Inspect the engagement of the elevator control arm ball bearing into the elevator control rod drive "U".
The engagement of the bearing must be at or slightly below the centreline of the "U" during all positions of elevator travel.
To correct an out of tolerance condition replace any worn or incorrect parts with genuine Schleicher items if condition still exists replace or modify link upper aft bracket. The K8 "Automatic Elevator Connection" drawing may be used as a guide.

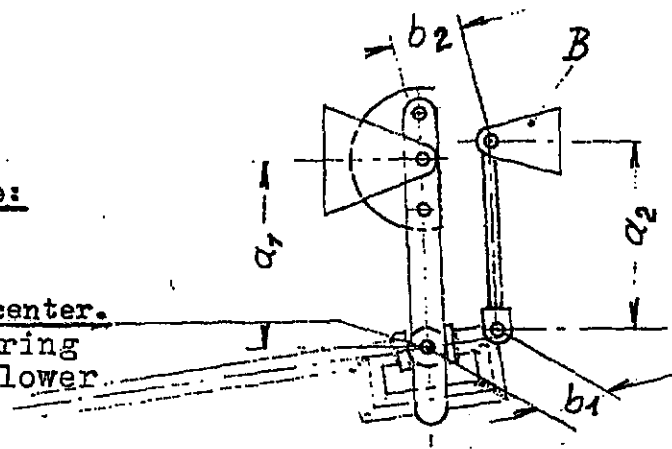
1. Correct make:

Must be in center.
or ballbearing
some what lower.

$$a_1 = a_2$$
$$b_1 = b_2$$

b2 may be wider until
4 mm, in no case
smaller. Check it with
a pair of compasses.
Therefore disassemble
one half of elevator.

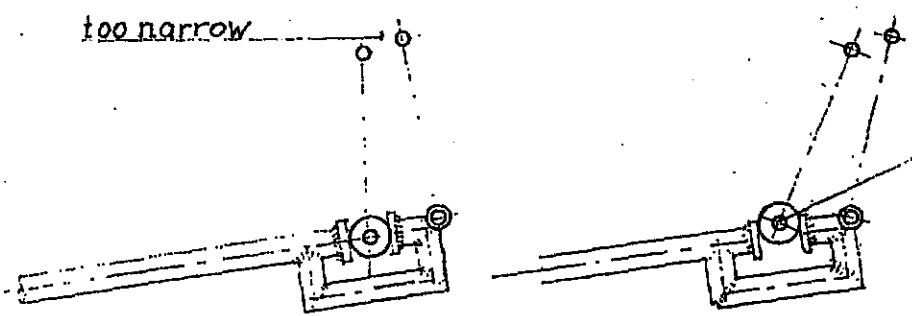
3. Parallelogram gearing not correct:

goes out at deflection
"push".

The inverse case can be, but is not so serious.

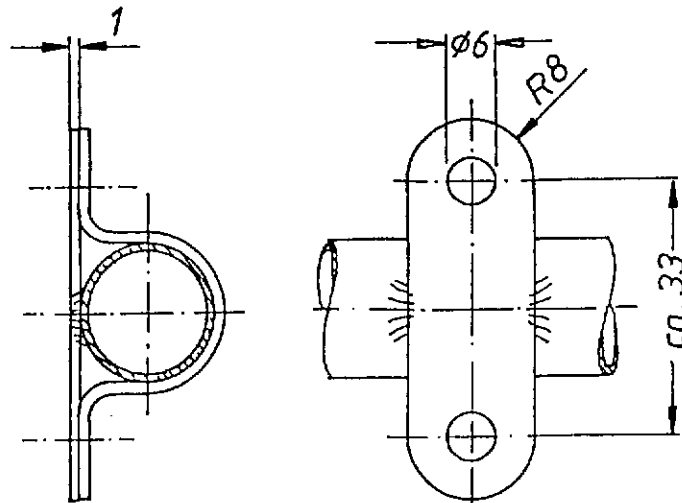
Fig. A2

ad A2) In case of extreme overloading the rudder pedals the attach collars of the pedal boards may bend. As a result also the full deflection of the rudder can become restricted.

- ad A2) Checking the rudder pedals:
With the rudder neutral the pedals left and right must be evenly adjusted. Check the pedal board angle versus the pedal (dimensions see drawing L-216.42-U01). The angle must meet the specified dimension.
Engage the pedal adjustment into its foremost position and check full deflection of the rudder.
Where pedals or attachment collars are bent, these can be either repaired or replaced by new ones.
In order to impede the bending of the pedal boards it is optionally recommended to weld an additional butt strap onto the attachment collar (see Fig.A2).

Reinforcing the attachment collars for pedal boards at the pedal assembly. Material: 1.7734.4

Welding procedure WIG to spec DIN 1912, welding wire material: 1.7734.2

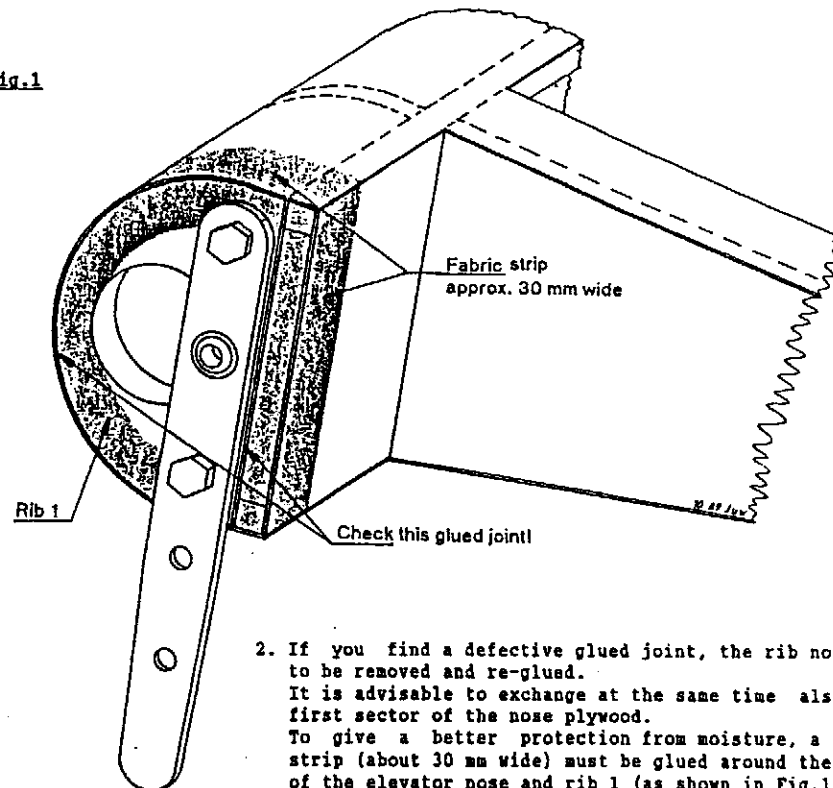
Fig.1

Loose glue joints on rib 1 of the elevator

- If you find a defective glued joint, the rib no.1 has to be removed and re-glued. It is advisable to exchange at the same time also the first sector of the nose plywood. To give a better protection from moisture, a fabric strip (about 30 mm wide) must be glued around the edge of the elevator nose and rib 1 (as shown in Fig.1).
- The above action under points 1. and 2. must be repeated every three years during the annual re-inspection. This copy of the Technical Note must be inserted in the Flight and Operations Manual of the respective glider as an annex and a corresponding entry must be made into the "Amendments to the Manual".

<p><u>Action:</u></p> <ol style="list-style-type: none"> 1. Remove elevator. Check that the glued joint between rib 1 and the leading edge plywood and the elevator spar respectively is in good condition (see Fig.1). Before doing so check whether the LTA 72-7 of Feb.9, 1972 was already previously accomplished (this is not applicable to K9, K11 and ASK 18); if yes then the fabric strip first carefully has to be detached in order to be able to check the glued joint.

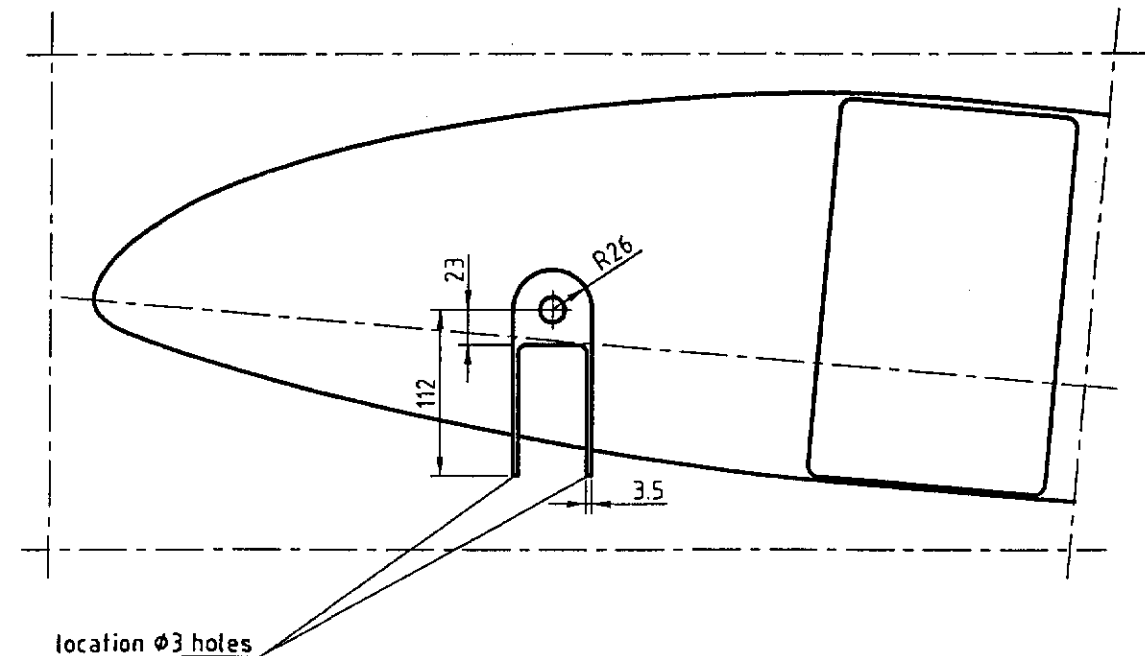
Bulletin issued due to cracks detected in console of the mounted to fore bulkhead fuselage front fitting.

Front fitting replacement must be made on each plane of SZD-50-3 "PUCHACZ" model on which, in inspection, a crack of length exceeding 3 mm has been found.

- Make a cut-out in fuselage skin, in accordance with following drawing.
- To facilitate marking of cut-out contour, make a hole with 3 mm diameter drill in fuselage skin from inside, close to bulkhead.

PDPS "PZL-BIELSKO"	MANDATORY BULLETIN No BE-049/SZD-50-3/2000 „PUCHACZ”	Page: 3 of: 4
<ul style="list-style-type: none"> - Re-bore the tubular rivets fastening front fitting to bulkhead. - Remove the bored rivets and sleeves. - Separate the fitting from bulkhead, and take the former out through the cut-out made (in case of problems with removal, enlarge the cut-out appropriately) - Remove glue joint remains from bulkhead and repair eventual damages. - Insert the new, Producer delivered fitting and assemble wings to verify correct wing & fitting positioning. - On gaining wings and fitting correct position in accordance with openings in bulkhead, mark the holes in consoles of fitting. - Take-out the fitting and enlarge openings acc. to markings made. - Prepare a contact surface between bulkhead and fitting for gluing. - Cover the bulkhead/ fitting contact surface with AEROSIL + resin composition (resin system according to Technical Service Manual must be used) - Embed new fitting and assemble wings, to verify verify correct wing & fitting positioning. - Reame lower openings both on R.H and L.H. side of bulkhead to 16 mm H7 size. - Insert the Producer supplied special, long bolts in openings, bolt head inside. - Put on washers from bulkhead aft side on both bolts and, on tightening castellated nuts, secure these with cotter pins. - Disassemble wings and reame remaining openings, then install the remaining bolts repeating procedure of three preceding items. <p>Two shorter bolts to be installed in openings closest to fuselage plane of symmetry.</p> <ul style="list-style-type: none"> - Repair the cut-out in a rib at fuselage-wing junction from outside, following the Technical Service Manual. - Remove the split angles (ones connecting bulkhead to fuselage skin) from inside in the area of cut-out made, and laminate new ones of 2 x 92125_x fabric, 60 mm wide.
