BGA ENGINEERING

NEWS

Number 6, May 2001

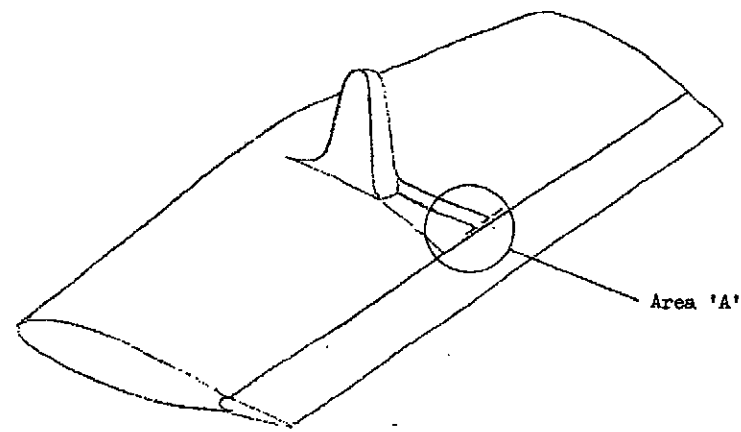
FIG 1 Area of Cracking on Vega T-Plane

1.3	Inspect the tailplane centre hinge pin mounting rib at the section just forward of the hinge pin as detailed in Fig 6. If cracks or damage are found a repair entailing the fitting of a new 'reinforced' rib will be required. The repair scheme is detailed in Section 4 and should be undertaken by S.A.L. or an approved repair shop. If the section does not show signs of cracking a reinforcement cloth will be required as detailed in Section 5. Alternative means of repair for minor cracking may be carried out with the agreement of SAL.	
	Note - Use Epikote 162/Epikure 113 resin system throughout.	
ISSUED BY:	<i>B. Miller</i>	Date 22nd Sept 82
for and on behalf of	SLINGSBY ENGINEERING LIMITED Kirkbymoorside, York YO6 6EZ, England. Tel. 0751 31751 Telex 57911	Page 1 of 7

CONSEQUENTIAL LIMITATIONS	If cracking is found on the tailplane central hinge the repair will require a new central tailplane rib (T65A-30-15) which must be fitted by S.A.L. or an approved repair shop before next flight.	
ACTION	- Inspection to be carried out as follows :

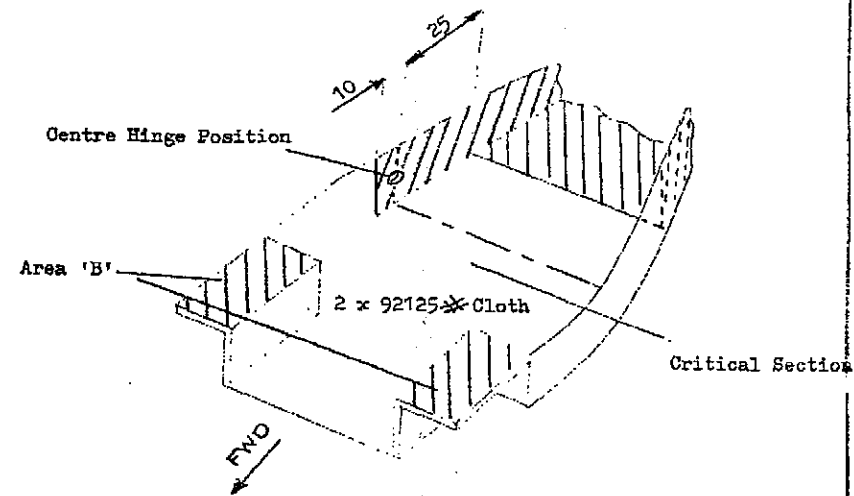
FIG 2 Reinforcement of Elevator-Tongue

1.1	With the tailplane/elevator assembly removed from the aircraft examine the glass reinforced plastic operating tongue of the elevator which projects forwards into the tailplane. The lips of this channel shaped tongue must be unbroken and continuous to the point where it merges with the elevator proper. Check the tongue for lack of stiffness in the vertical sense by attempting to bend the tongue with the fingers. If any degree of cracking, damage or abnormal flexibility is found it must be rectified before further flight in accordance with a repair detailed in Section 2.	
	The preceding action must be carried out following a heavy landing or ground loop in addition to any other required inspections.

Only layup cloth on the inside of the tongue on the area NOT shaded.

(c)	Layup 2 layers of woven roving cloth (2 x 92125XX) over the area detailed in Fig 2.	
3.1	If the pivot bearing 04 DU 04 is worn it may be replaced as follows (refer Fig 3).

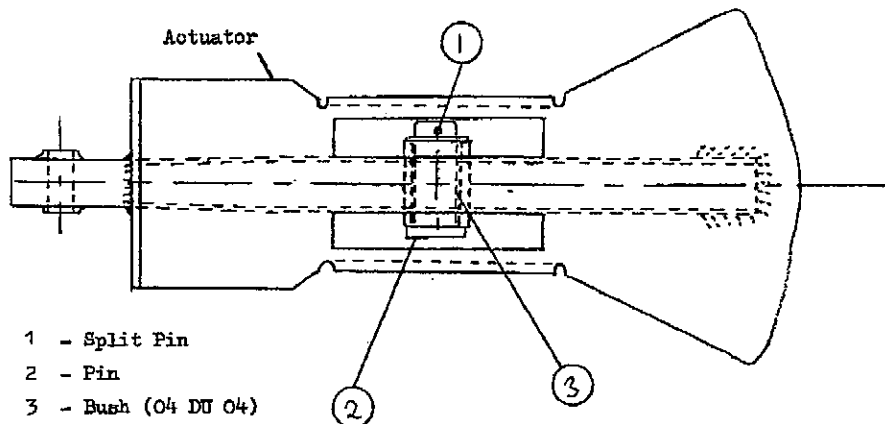
FIG 3 Actuator Pivot Bearing

1.2	Inspect the pivot bearings (04 DU 04) for the elevator rocker arm assembly, on the top of the fin for wear. Any wear found in excess of 0.01" in the fwd & aft direction must be rectified before further flight. Fitting of the bearing is detailed in Section 3.

(c)	Remove pin (Item 2).	
(d)	Disconnect the pushrod on the fwd end of the actuator (similar to above).	
(e)	Drift the bush from the elevator actuator assembly and replace with new bush (04 DU 04), available from S.A.L.

(f)	New split pins must be fitted when reassembling.	
4.1	Replacement of the central tailplane rib with reinforced rib only available from S.A.L. will be carried out as follows (Refer Fig 4).

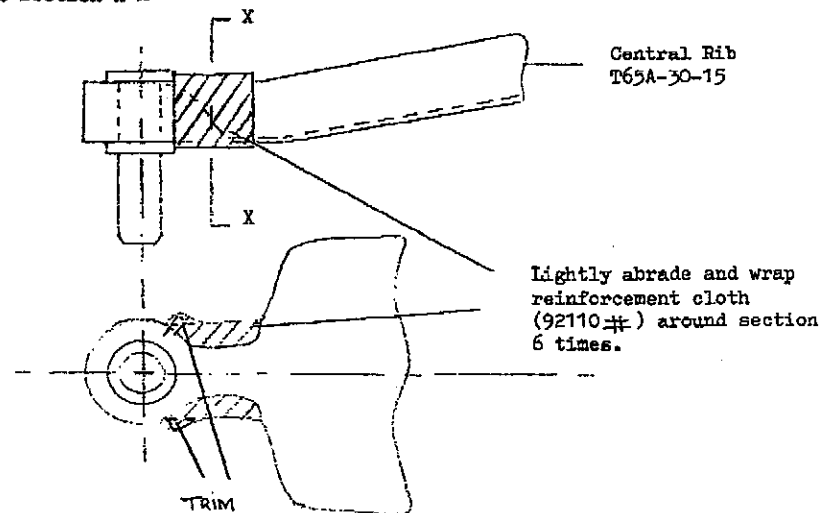
FIG 6 Reinforcement Cloth on the Centre Tailplane Hinge

Inspect Section X-X

- (k) Cure for 8 hours at 56°C.
- 5.1 If the central elevator hinge on the tailplane is not cracked, reinforcement will be added as follows :-
- (a) Remove the tailplane/elevator assembly from the aircraft.
