# BGA ENGINEERING NEWS

Number 7, July 2001

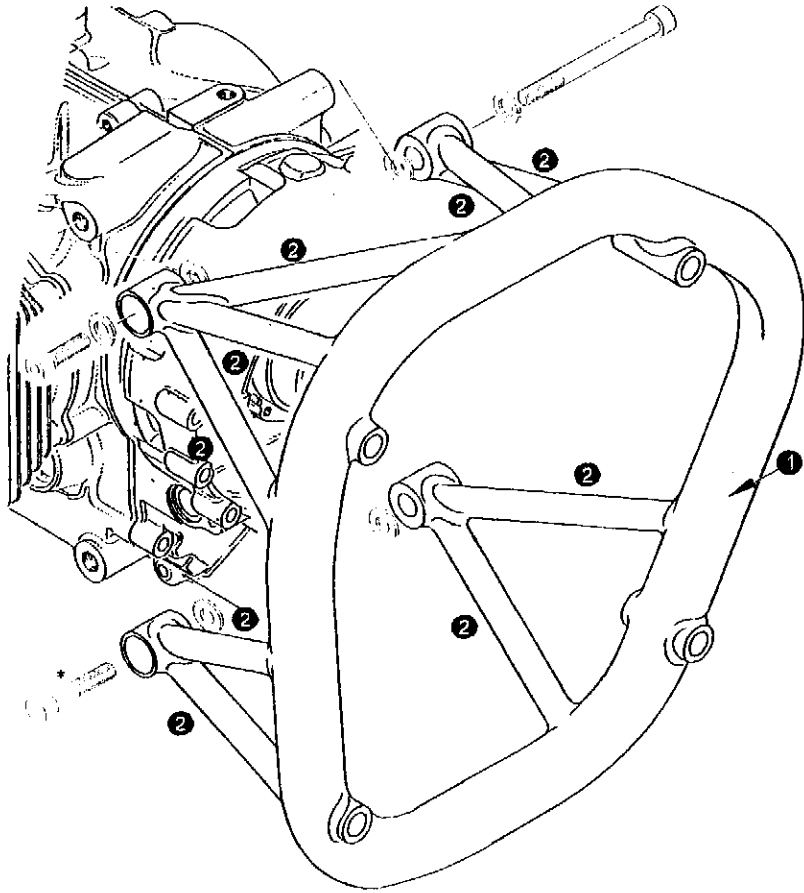
Bild / Fig. 1

One or more of the following could result in formation of cracks on the engine suspension frame part no. 886 567:

- Unapproved and untested modifications
- Improper carburetor synchronization
- Unsuitable idle speed (too low)
- Unsuitable engine suspension / non-neutralized vibrations
- Propeller balance out of tolerance
- Friction torque in the backlash range of gearbox not within tolerance
- Lack of maintenance
- Ground contact

Vibrations, impacts, forces etc. could cause cracks on the engine suspension frame part no. 886 567.

- If cracks are detected replace the engine suspension frame in accordance with the relevant Maintenance Manual 914 F. That is also effective ROTAX 912 engines.

◆ NOTE: If absolutely necessary, and if only one of the circular tube or struts are not cracked by more than 50%, a ferry flight is permitted. A complete fracture replacement without delay will be necessary.

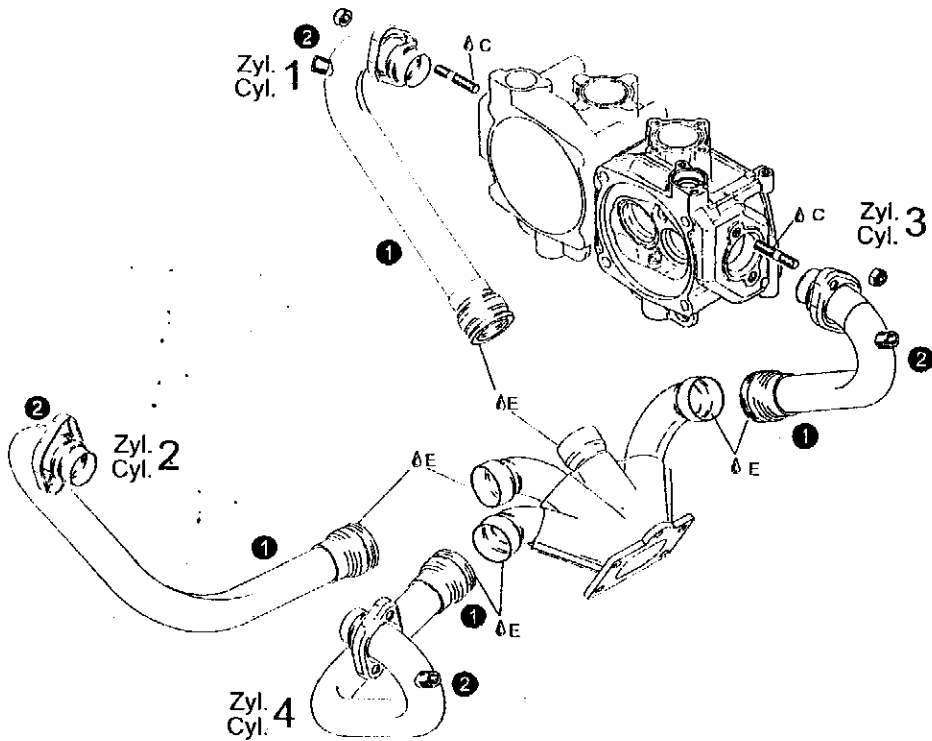
One or more of the following could result in formation of cracks on the exhaust bends:

Vibrations, impacts, forces, thermal strain etc. could cause cracks on the exhaust bends.

◆ NOTE: Scrutinize the exhaust bends for exterior traces of smoke, cracks and other faults especially about the EGT-terminals (2). See fig. 1.

- If cracks are detected replace the exhaust bend in accordance with the relevant Maintenance Manual.
- Reconnect negative terminal of aircraft battery.

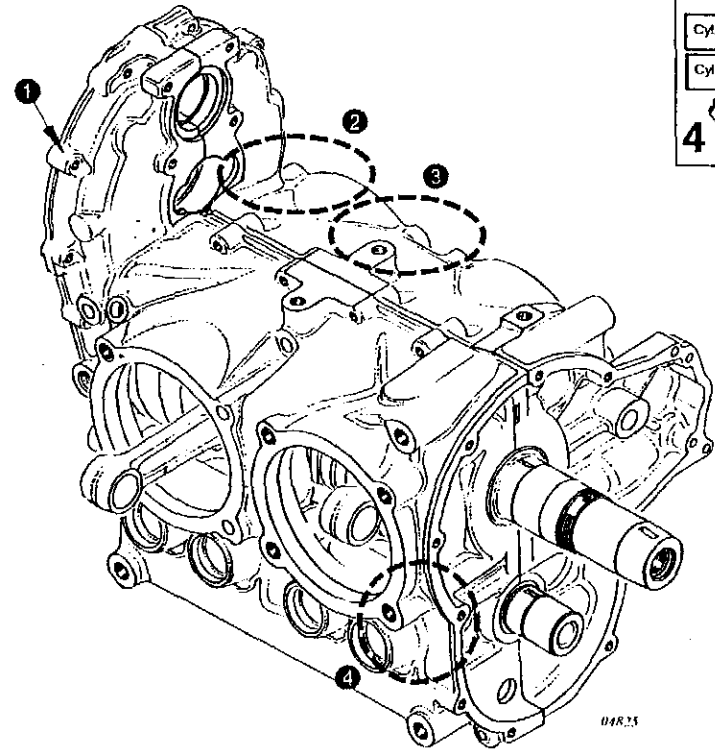
One or more of the following could result in formation of cracks on the crankcase:

Vibrations, impacts, forces, thermal strain etc. could cause cracks on the crankcase.

- Inspect the crankcase (1) and engine suspension in accordance with the relevant Maintenance Manual.
- ◆ **NOTE:** Scrutinize the crankcase for cracks especially in the area of cylinder 1 upper side (2), between cylinder 1 and 3 upper side (3) and cylinder 4 lower side (4). See fig. 1.  
 For those engines using cooling air baffle inspect for oil leaks in area (2) and (3). If leaks are found, then further investigation to determine the cause of the oil leak is required. If the exact origin of the leak can not be determined i.e. governor, then removal of the cooling air baffle may be required. Alternative methods of inspection may be used, i.e. bore scope, to inspect the areas without removal of the shroud.

- ◆ **NOTE:** If absolutely necessary, and if only a small amount of oil leakage is found, a ferry flight to a maintenance facility is permitted. At a massive oil leakage replacement of engine without delay will be necessary.

- If cracks are detected the nearest ROTAX<sub>e</sub> Authorized Distributor (see also our official ROTAX-Web-Site: [www.rotax-aircraft-engines.com](http://www.rotax-aircraft-engines.com)) has to be informed and if necessary the engines has to be removed from aircraft and must be returned to a ROTAX<sub>e</sub> Authorized Distributor.

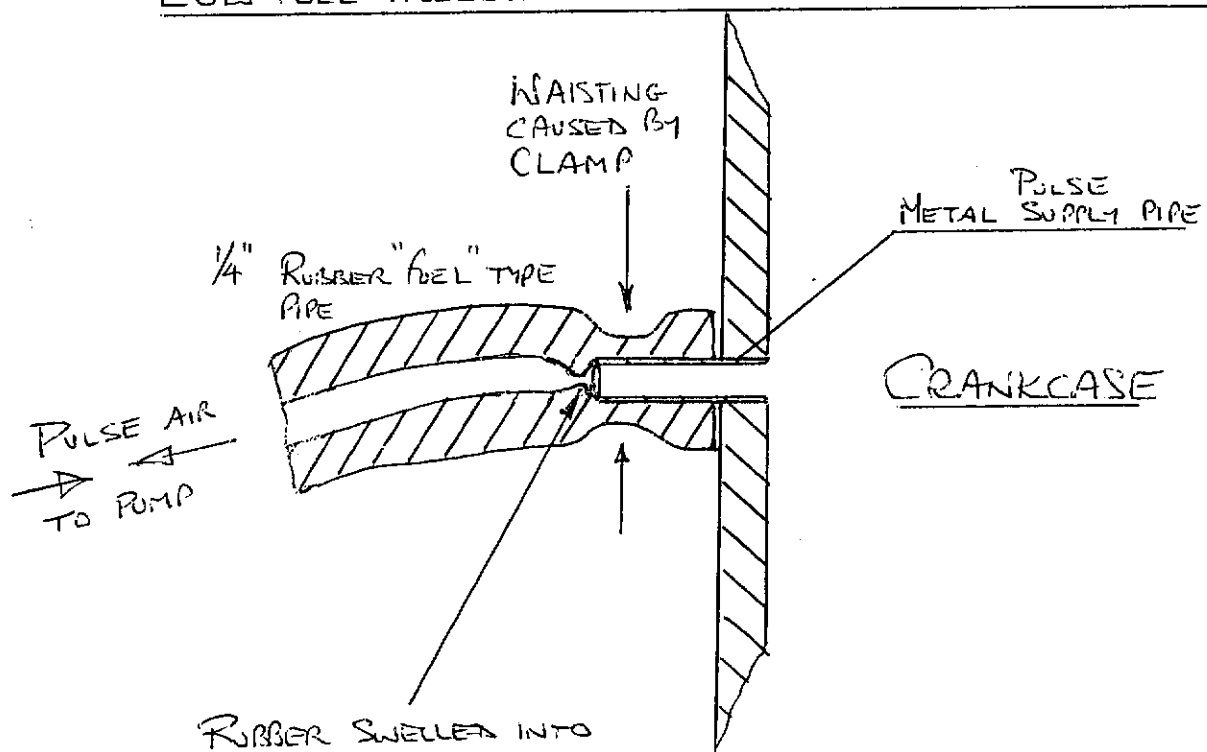
## LOW FUEL PRESSURE OBSERVED ON FUEL PRESSURE GAUGE

RUBBER SWELLED INTO PATH OF AIR OUT OF PULSE PIPE WHEN SQUEEZED FOR LONG TIME BY CLAMP TOO CLOSE TO THE END OF METAL SUPPLY PIPE.

## RESTRICTION BY CLAMP CAUSED LOW FUEL PRESSURE

### SUGGESTIONS
