British Gliding Association – Technical Committee

Technical News Sheet 02/02

British Gliding Association Aircraft Inspection

- Subject:** Wing spar corrosion – continued airworthiness inspections
- Applicability:** Elliots of Newbury Olympia 460 series with metal reinforced main spars

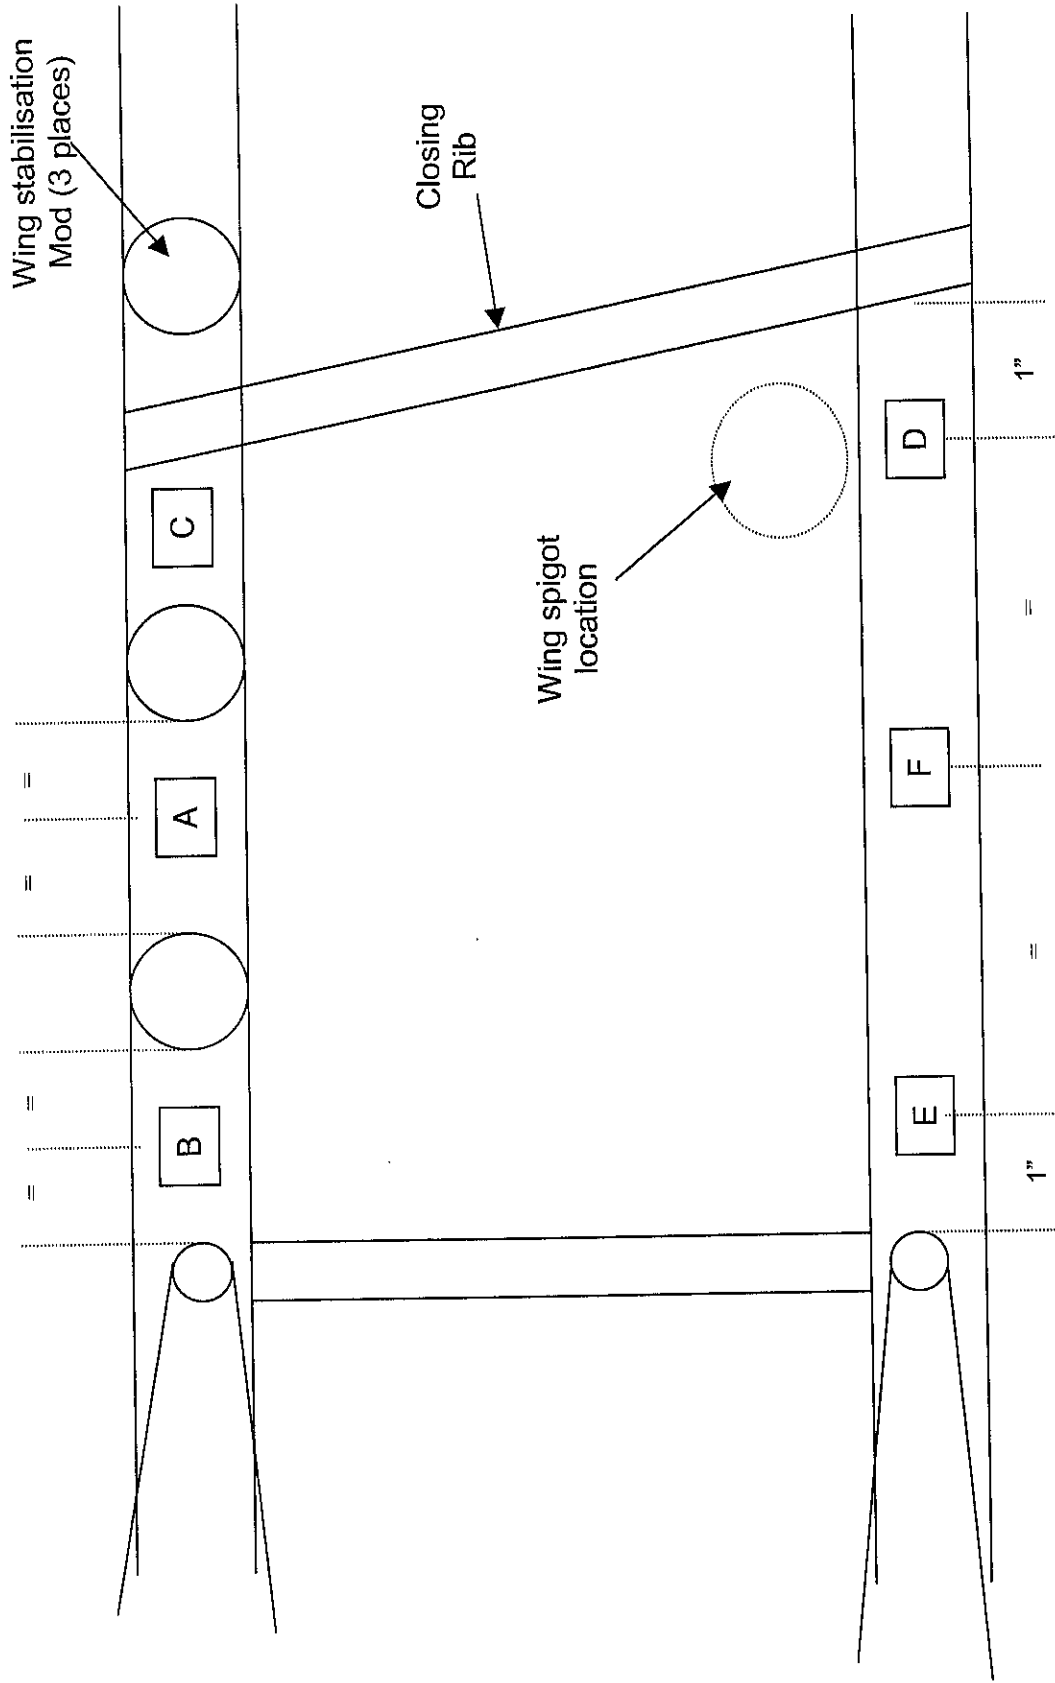
Olympia 460 Wing measurement locations

7. With a micrometer (preferred) or a digital vernier gauge, measure the width of the spar booms, on the centre line of the boom at positions (A) to (F) as detailed below (see sketch for positions)

8. **Top boom** – position (A), between the two visible 2BA bolts of the mandatory modification.
 9. **Top boom** – position (B), between the inboard 2BA bolt and the joint plate.

10. **Top boom** – position (C), between the closing rib and the middle 2BA bolt of the mandatory modification. See note.
 11. **Lower boom** – position (D), 1 inch from the closing rib

12. **Lower boom** – position (E), 1 inch from the spar joint plate.
 13. **Lower boom** – position (F), at a point midway between point (D) & (E)
- Note:** depending on the layout of the stabilization modification it may not be possible to measure position (C) if this is the case a note should be made in the log book when recording the measurements

14. **Record** the positions and measured widths and the temperature in the logbook.

15. The width of the spar, at the various measurement locations, should be compared to previous measurements (after the initial measurements). **If the measurements are increasing, then corrosion in the bond lines should be suspected and a very careful inspection undertaken.** Allowance should be made for the normal dimensional changes brought about by change in water content of the wood and temperature. It is desirable to let the wings stabilise at room temperature before taking the spar width measurements, and note the temperature in the logbook.

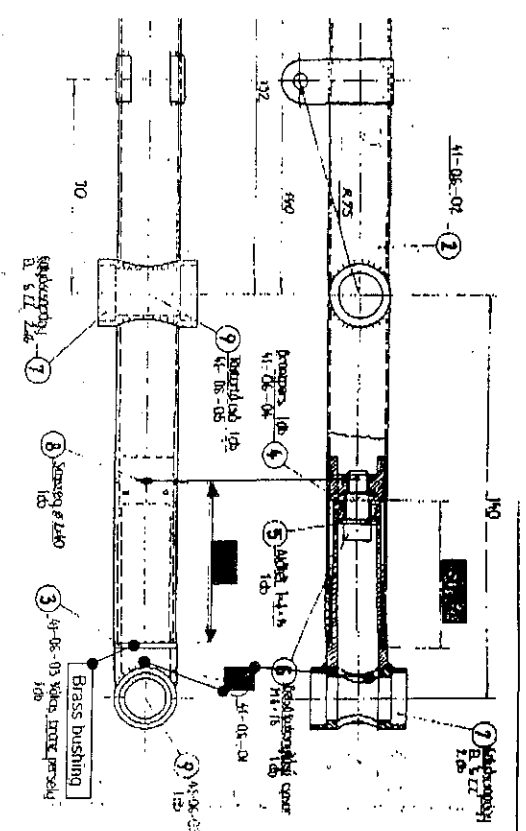
picture 2: detail

Reason: A Routine check has showed, that socket head screw M8x18 DIN 912-8.8 (part 6 of following picture 1) was broken. These socket head screw connects upper- and lower part of the rear control stick. If connection by socket head screw M8x18 DIN 912-8.8 failed between both parts of the control stick - controllability of the glider is endangered.
 At the affected glider the socket head screw M8x18 DIN 912-8.8 was drilled improperly at a wrong position (see position 8 of following picture 1). Socket head screw was drilled additional 2x at same distance to the screw head 90° misplaced (Ø 3mm and Ø 2mm). Through that the pretended cross-section of the thread was important lessened.

3. Check for correct drilled split pin hole in the control stick and the socket head screw like picture 1 and 2.
 4. If split pin hole is drilled correct, installation of part 1 into the control stick, secure with a split pin and install the completed control stick in the rear cockpit.

5. If split pin hole is not drilled correct after picture 1 and 2, holes in the control stick must be closed by WIG-welding from a certified WIG-welder. After that holes must be drilled after picture 1 and 2. Renew socket head screw M8x18-8.8 DIN 912; lubricate brass bushings. Drill split pin hole (Ø 2mm) only if controlstick is completed and install the split pin. Take care that part 1 rotates easy in the control stick.
