British Gliding Association – Technical Committee**Technical News Sheet 11/12/01****Part 1** Airworthiness issues (all categories)

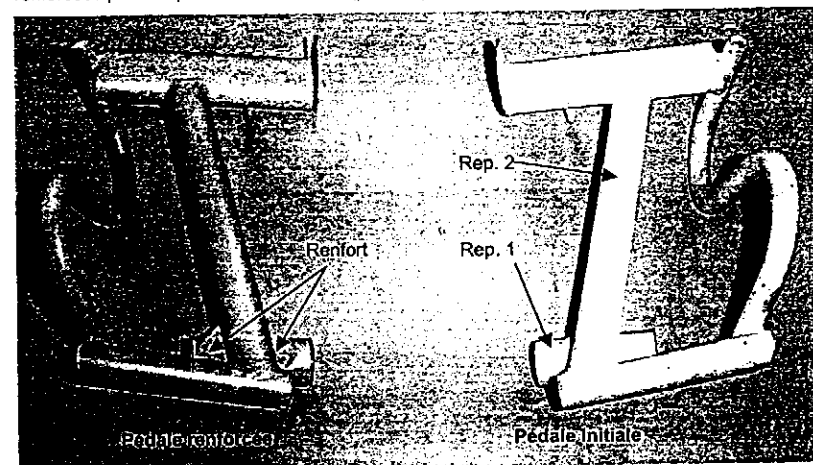
En cas de surcharge, un risque d'apparition de crique peut survenir au niveau de la soudure entre le tube d'articulation et le tube vertical des pédales de palonnier (constaté sur un planeur accidenté ayant des pédales de même type que le planeur CENTRAIR 101 "Pégase").

1. Contrôler sous un mois l'état de la soudure entre le tube d'articulation (repère 1) et le tube vertical (repère 2) sur les 2 pédales de palonnier afin d'y déceler un éventuel début de crique. Ce contrôle doit être fait par ressuage (pénétrant Ardrox 996P2 et révélateur 9D1 par exemple) après décapage local de la peinture. En cas de découverte d'amorce de crique, le remplacement de la pédale est impératif avant tout nouveau vol.
2. Remplacer sous un an maxi et au plus tard lors de la prochaine visite annuelle les pédales non renforcées par des pédales réf. \$Y185A (pédale gauche) et \$Y196A (pédale droite).

Une notice explicative est disponible à SN CENTRAIR pour le démontage et remontage des pédales, et installation et réglage des câbles de direction (document 101BE1650)

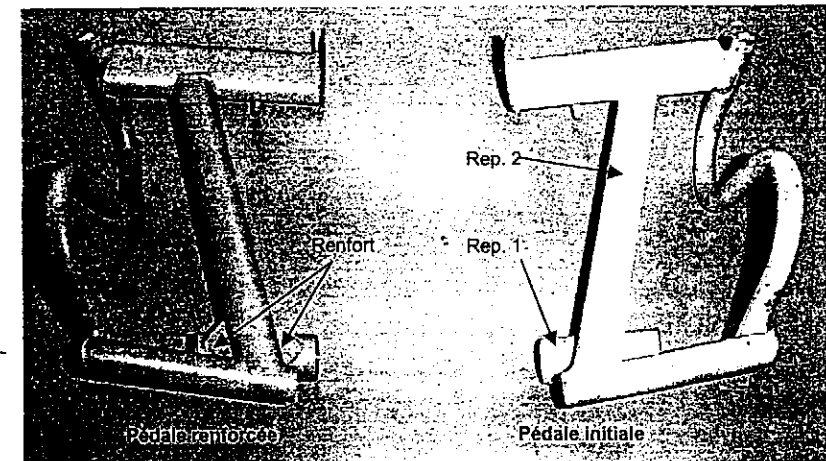
En cas de surcharge, un risque d'apparition de crique peut survenir au niveau de la soudure entre le tube d'articulation et le tube vertical des pédales de palonnier (constaté sur un planeur accidenté ayant des pédales de même type que le planeur CENTRAIR ASW20F ou FL).

1. Contrôler sous un mois l'état de la soudure entre le tube d'articulation (repère 1) et le tube vertical (repère 2) sur les 2 pédales de palonnier afin d'y déceler un éventuel début de crique. Ce contrôle doit être fait par ressuage (pénétrant Ardrox 996P2 et révélateur 9D1 par exemple) après décapage local de la peinture. En cas de découverte d'amorce de crique, le remplacement de la pédale est impératif avant tout nouveau vol.
2. Remplacer sous un an maxi et au plus tard lors de la prochaine visite annuelle les pédales non renforcées par des pédales réf. \$Y185A (pédale gauche) et \$Y196A (pédale droite).

Une notice explicative est disponible à SN CENTRAIR pour le démontage et remontage des pédales, et installation et réglage des câbles de direction (document 101BE1650)

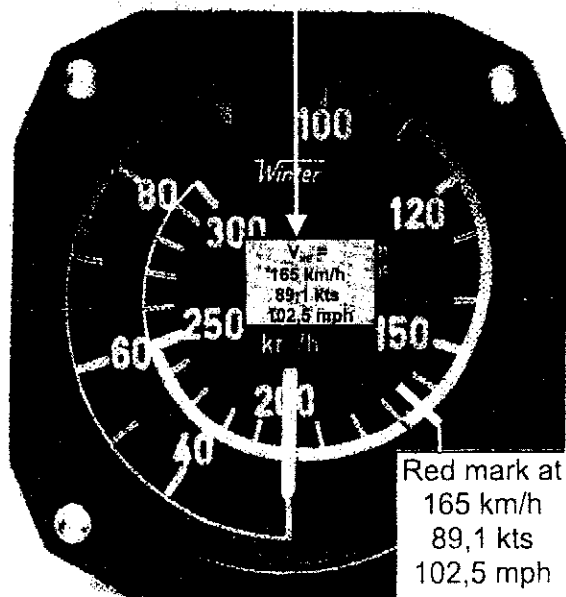
Red mark at
165 km/h
89,1 kts
102,5 mph

Flutter appearances of the elevator in the upper flight speed range - Reduction of V_{NE}

During flight operation of a sailplane model GROB G 102 Club Astir IIIb flutter appearances of the elevator in the upper flight speed range occurred because of presently unknown causes. Since the same design is used at the G 102 Standard Astir III and the G 102 Club Astir III these models are also affected by this problem. To make the operation with reduced maximum speed V_{NE} possible, the temporary operation of the gliders until the final modification is permitted.

- 1.8.1 Apply a red mark on the airspeed indicator at 165 km/h (89,1 kts, / 102,5 mph)
- 1.8.2 Apply the following red placard (according to airspeed indicator calibration) to the airspeed indicator:

Apply a red mark on the airspeed indicator to reduce the maximum V_{NE} to 165 km/h (89,1kts / 102.5 mph). The actions must be done in accordance with the Technical Notes of the manufacturer.
