**British Gliding Association – Technical Committee****Technical News Sheet 04/02****Part 1 Airworthiness issues (all categories)**

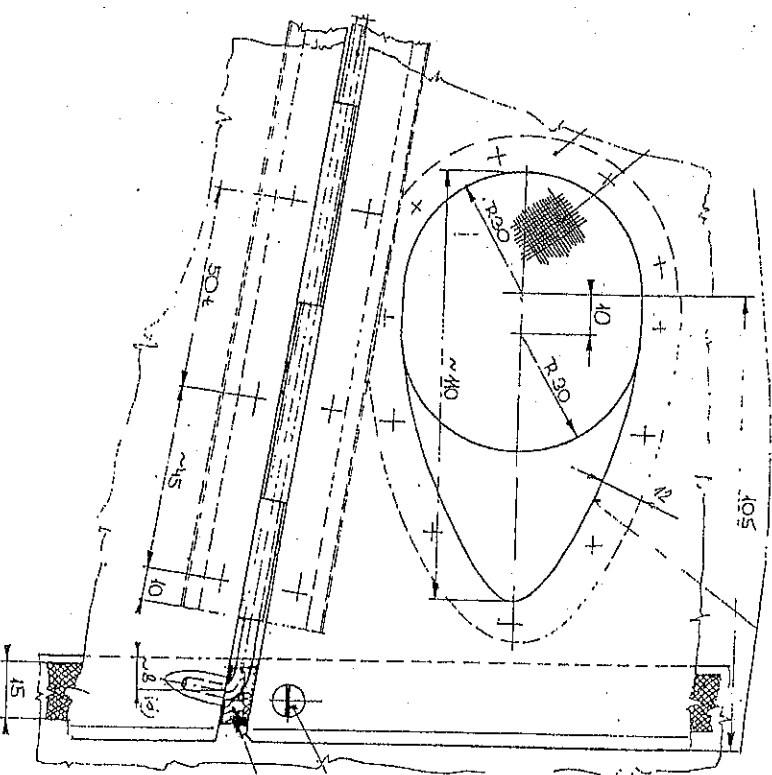
Sheet	1	Total sheets	1
-------	---	--------------	---

Reason: Possibility of intrusion of impurities into the carburettor, because of the non-protected engine inlet, which can lead to the engine failure.

1. Drill out the inlet hole baffle on the upper engine cover.
2. Adjust the strainer shape according to the inlet hole with the allowance of 12 mm.
3. Set the baffle with strainer to the original position.
4. Drill and joggle holes for rivets.
5. Rivet. Pack out snap heads of rivets with packing.
6. Write down the bulletin accomplishment into the operation documentation.
