British Gliding Association – Technical Committee**Technical News Sheet 04/03****Part 1** Airworthiness issues (all categories)

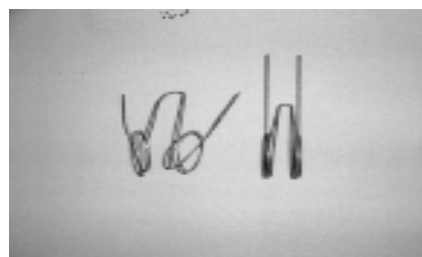
3.1

Release Hook Springs

The picture shows an attempt by someone to manufacture a spring for an Ottfur release hook – the result is obvious!

This type of home-made engineering is very dangerous especially on a critical component and considering that the genuine item only costs £1.50 including P&P we sometimes wonder why?
