British Gliding Association - Technical News Sheet

<u>Issue 1-2006</u>	<u>Date: 2 March 2006</u>
----------------------------	----------------------------------

British Gliding Association Aircraft Inspection

Number: 042/07/2004	Issue: 3
------------------------	-------------

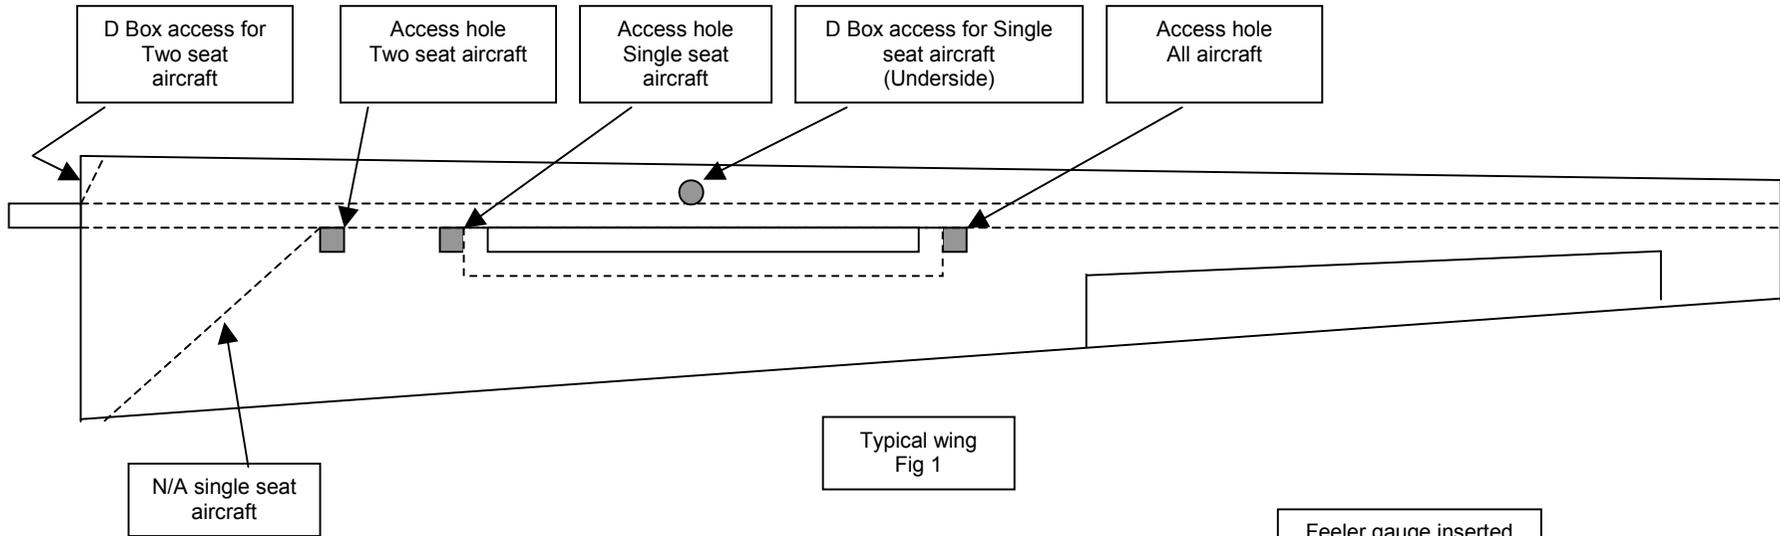
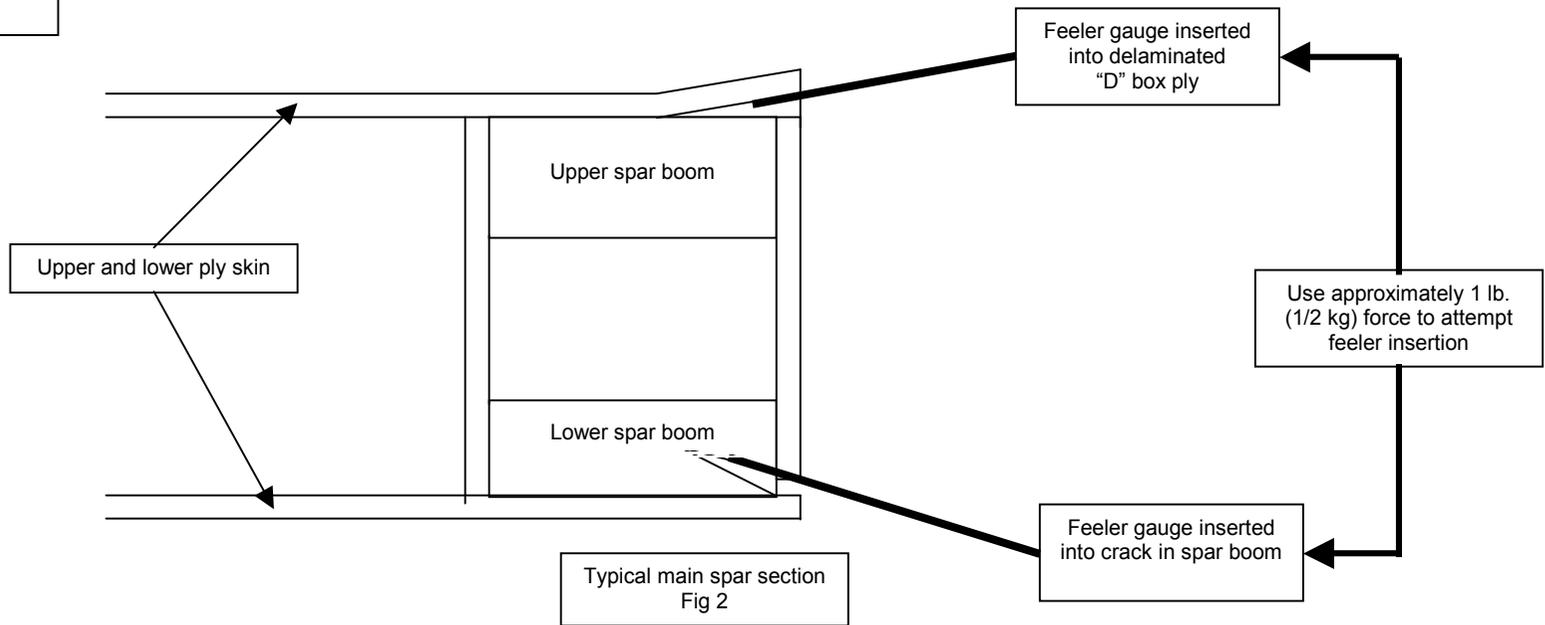
Single seat aircraft: Adjacent to the rear face of the main spar immediately inboard and outboard of the air brake box. See fig 1.

Two seat aircraft: Adjacent to the rear face of the main spar immediately outboard of the air brake box and at the drag spar intersection with the main spar. See fig 1.

Using a 005/010" (0.12/0.25mm) feeler gauge, try to insert into the glue joint parallel to the wing top surface. See fig 2.

Check for cracks running into the spar booms by trying to insert the feeler at 45° to the spar. Apply a force of approximately 1 lb. (1/2 Kg) See fig 2.

If the feeler gauge can be entered more than 3/16" (4mm) or any evidence of glue failure is observed the aircraft must not be flown. All the fabric must be removed and a complete aircraft structural survey carried out. An inspection report must be submitted to the CTO for further instructions.
