British Gliding Association - Technical News Sheet

Issue 1-2009

Date: 30/03/2009

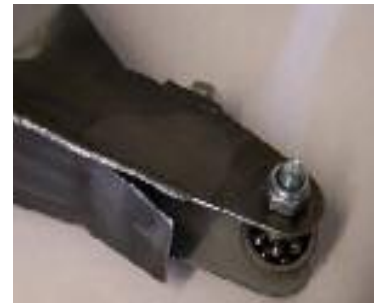
6. **Schempp-Hirth Duo Discus** **(Advisory)**
Reported by Stuart Clay, Lasham.
Automatic Airbrake self connecting coupling cracked possibly due to over zealous rigging. Applicable to other automatic connectors.

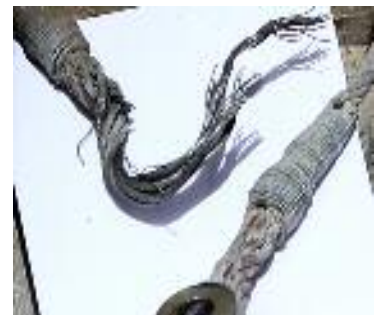
7. **LAK 12 Glider Cable Inspections** **(Advisory)**
Report from New Zealand
Highlights the need for careful inspection of cables especially spliced ends and corrosion over long periods of time.
Applicable to other gliders with spliced cables.
