British Gliding Association - Technical News Sheet

Issue 2-2010

Date: 10/05/2010

Airworthiness Information

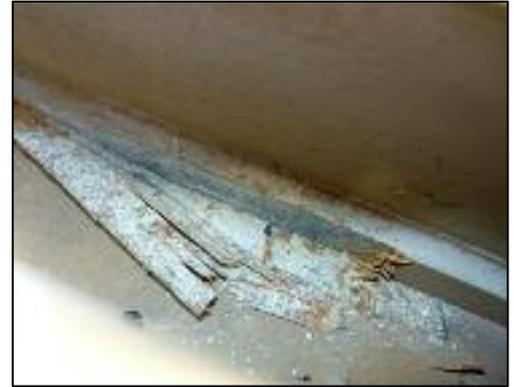
Reported by Ian Bannister, BGA Inspector

Spar corrosion found on wing spar during routine inspection.

Note; AD 005-09-97 and TI 109/51 issue 3 applies for 5 year repeat inspection.

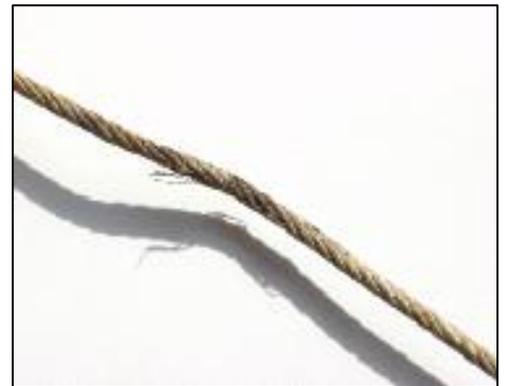
Reported by Stu Hoy of Anglia Sailplanes

Further cases of severely corroded control cables continue to be found.

Remember that cables must be inspected thoroughly, paying particular attention where the cables are in areas liable to contain water (guide tubes, conduits etc.) It may be necessary to "slip" cables for inspection. Cables that are rusty will have lost a significant amount of strength and are not airworthy.
