**Issue 4-2010**

**Date: 01/09/2010**

## Airworthiness Information

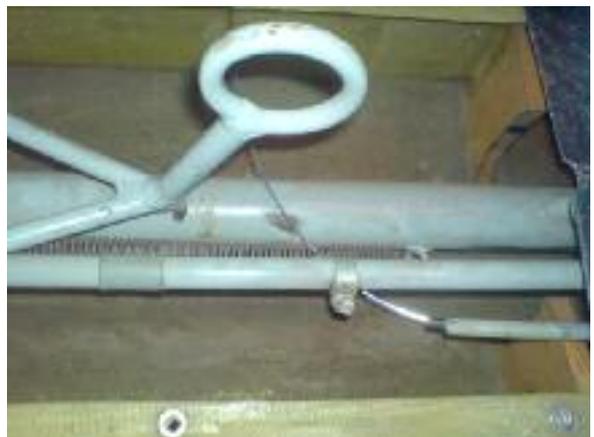
The GFA has published an airworthiness alert. The trim rod pictured (smaller of the two) was found bent and could possibly cause fouling of the aileron control rod (larger rod). Incorrect removal technique is suspected. To remove the rod it is necessary to first remove the rear rudder pedal assembly otherwise the rod may become bent trying to force it out of the gap.
