Issue 1-2011

Date: 28/02/2011

Airworthiness Information

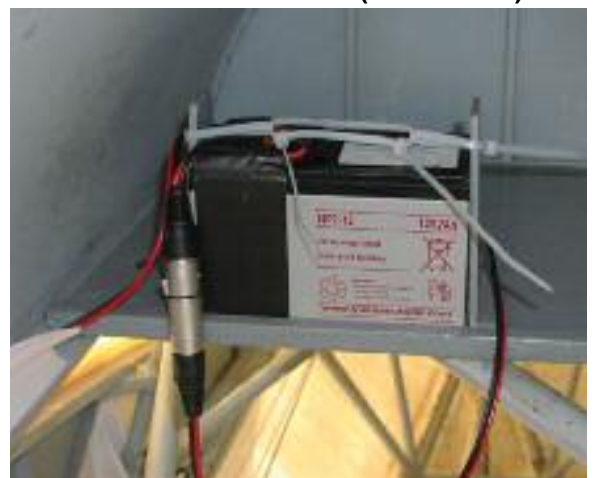
- 5 **Schleicher ASK 13 Battery Box** **(Information)**
Reported by John Giddins, Hinton Aviation.
The battery was secured in place with cable ties to attempt to repair a broken side support. This battery could have been lethal in an accident.

Note: Design requirements for battery boxes and other equipment are specified in Alexander Schleicher Technical Note 02-2008. It is very important that these requirements are understood and in particular crash worthiness are maintained.
