Issue 3-2011

Date: 4/7/2011

Airworthiness Information

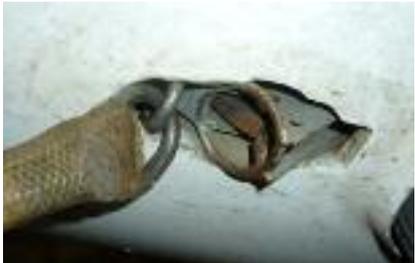
- 2 **Alexander Schleicher ASK 21 Aero tow hang up.** **(Information)**
Reported by John Firth, Burn Gliding Club
The small aerotow ring was inadvertently placed in the gap forward of the release hook and a successful launch was carried out. The problem is that during use the large ring of the Tost two ring set touches the underbelly forward of the nose release and gradually wears a hole in the area forward of the release unit. If this is worn large enough the small ring can be inserted.

Note: a proper lay up repair will be required in accordance with repair data to ensure it can withstand continued wear.
- 3 **DG 500 Rudder Stop Missing** **(Information)**
Reported by Roger Andrews, Long Mynd.
A rudder stop bolt became detached from a DG 500 causing a restricted elevator and damage to the rudder because of rudder over travel. A before next flight instruction was issued to check all stops and a total of seven reports of loose stops were received. It is recommended to secure the stops with low/med strength Loctite to prevent them coming loose but to allow future adjustment.
Caution: the rudder stop uses a thin "Shear" nut to lock the bolt, the thread on this nut is easily stripped. Please exercise caution when tightening the nut.
