Issue 5-2010

Date: 02/11/2010

Airworthiness Information

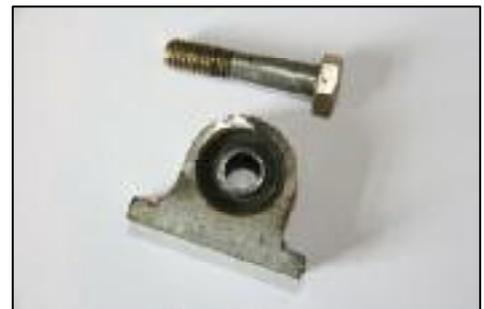
- 3 DG 800B Worn Spindle Drive Forward Mounting (Advisory)**
 Reported by Tony Hoskins, South East Aircraft Services.

Pilot reported vibration at full power on climb, investigation showed worn mount and bolt. Replacement cured the problem.

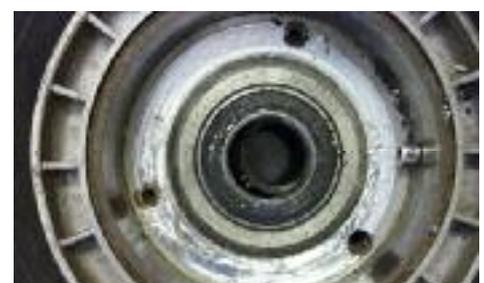
- 4 Grob Astir CS Main Wheel (Advisory)**
 Reported by Steve Saunders, Fenland Gliding Club
 One split hub retaining bolt sheared causing damage to wheel and brake assembly. Old wheel has 3 retaining bolts the replacement has 5 retaining bolts.
 If changing this wheel it is recommended to install the latest version with 5 bolts.

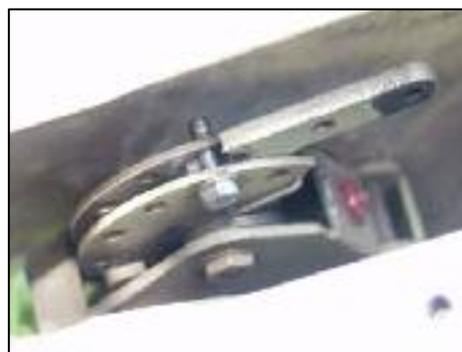
- 10 Dittel FSG 2T VHF/AM Transceiver AD 2010-0186, SB FSG 2T-1.06 (Mandatory)**
Incorrectly installed capacitor
http://ad.easa.europa.eu/blob/easa_ad_2010_0186.pdf/AD_2010-0186_1
- 11 OTTFUR CW300 Release Unit (Advisory)**
Reported by Stu Hoy, Anglia Sailplanes
- Operating arm fractured preventing release.
Cause not known but possibly too much force being repeatedly applied to release knob. Highlights the importance of careful inspection and testing.
