**Issue 4-2012**

**Date: 02/11/2012**

## Airworthiness Information

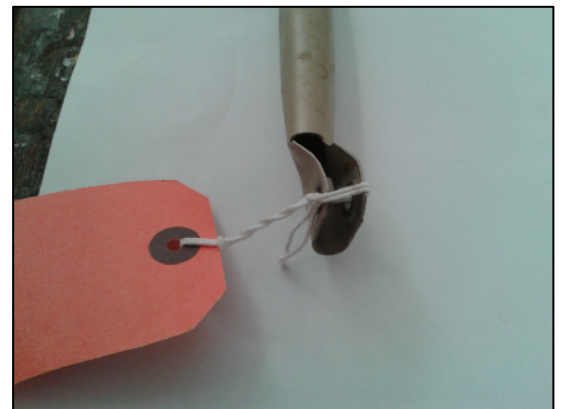
Airbrake control rod end collapsed.

It is suspected that the cause was overloading during high speed air brake deployment during spin/spiral dive recovery.

Symptoms are air brakes could not be fully closed.

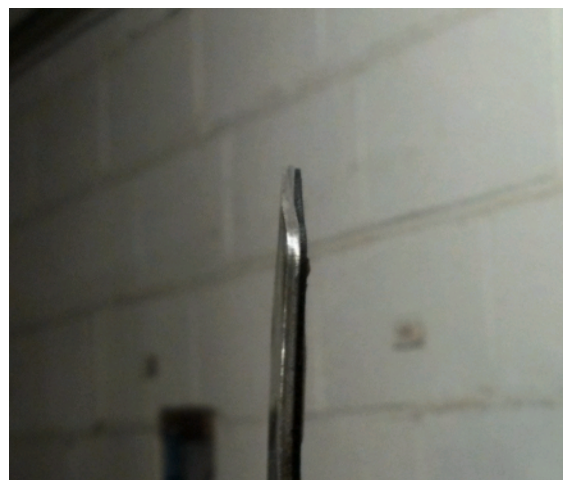
Fuel leak into engine bay when primer was operating.

The cover plate was observed distorted probably due to over tightening of the cover screws onto a soft rubber gasket/diaphragm.
