**Issue 1-2012**

**Date: 01/03/2012**

## Airworthiness Information

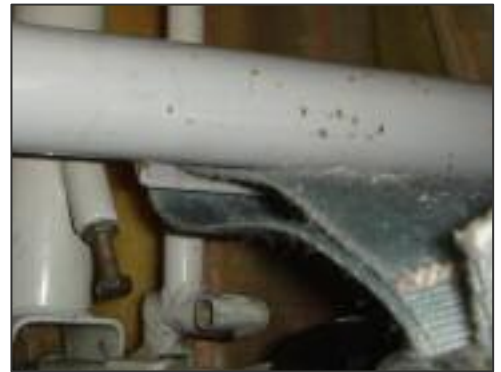
Reported by Tim Dews, Airborne Composites  
Crotch seat harness found incorrectly fitted. The belt was looped around the location strap instead of the main tube. There was a similar issue on Astir gliders a few years ago.

Please ensure that persons installing seat harnesses are aware of the correct position of the belt.

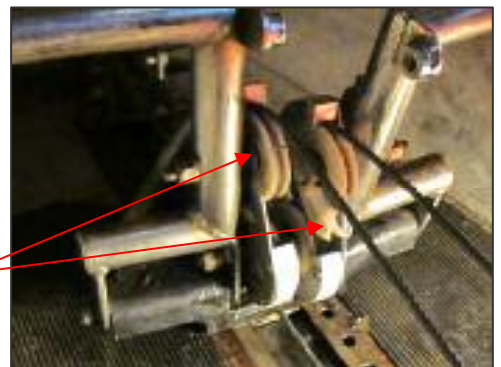
Reported by John Giddins, Hinton Aviation Services  
Nylon rudder cable pulleys found broken. If undetected this could cause the rudder cables to jam.

Cracked and  
broken

Note; it is recommended that these nylon pulleys are changed for aluminium pulleys.

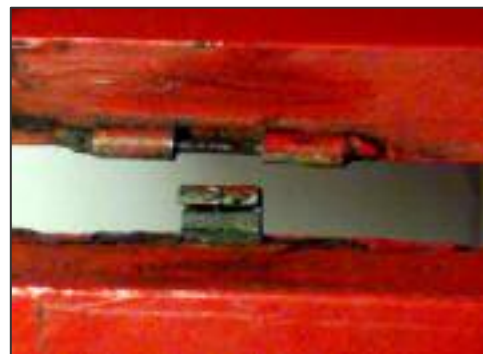
Elevator tab hinge worn and unrolled.

Please be aware of worn rolled hinges when they become worn they tend to unroll and could cause detachment.

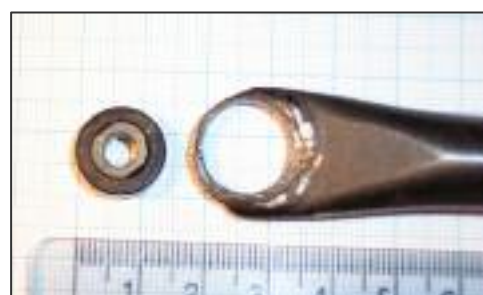
Air brake handle telescopic rod became detached from forward mounting due to spherical bearing coming out of staked retainer.

The trimmer control has a similar arrangement.

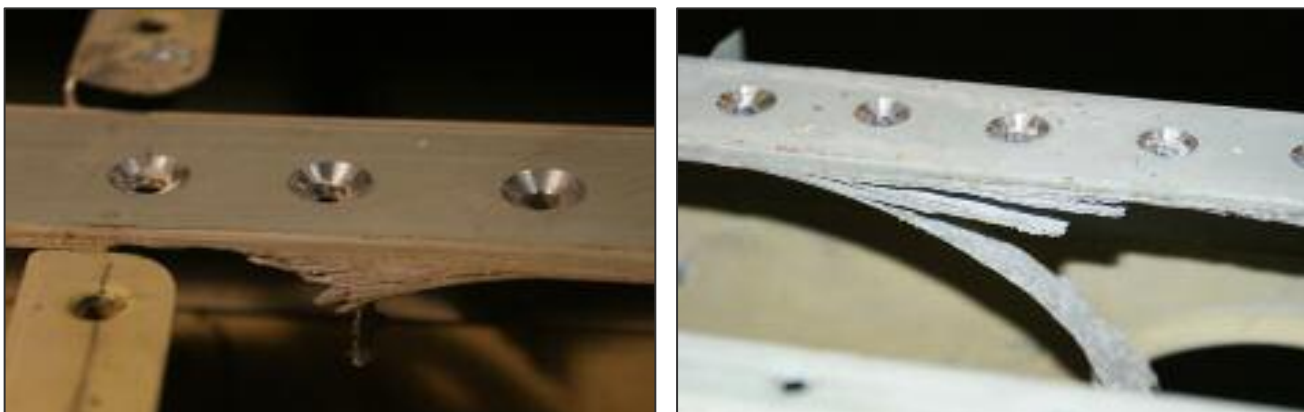
Highlighting the need for careful inspection of the entire length of metal spars during annual inspections. The pictures are of an IS28 glider with corrosion so severe it made the aircraft uneconomical to repair. The main area of corrosion was not visible from normal inspection access panels. As these gliders become older a full inspection is even more important. In many cases special inspection equipment may be required to effect a thorough inspection. Wing skin in photographs removed to reveal extent of corrosion. More than 50% of the thickness of the spar is corroded away.
