Issue 2-2012

Date: 30/05/2012

Airworthiness Information

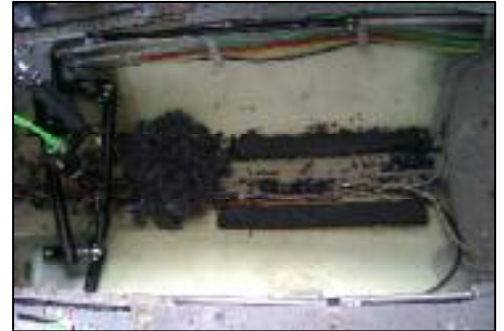
1 DG LS8

Mouse nest found under seat.

It is very difficult to stop this kind of infestation especially if the glider is laid up for any period of time. During inspections check for damaged wire and flexible pipes.

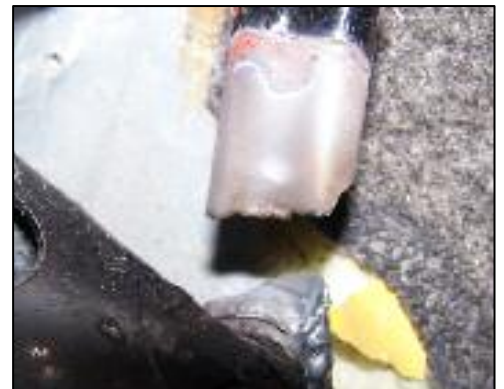
2 Grob G102 Astir

Landing gear handle broken in flight.

Thin handle welded to shaft and can weaken in time with heavy use. Check carefully during inspections.

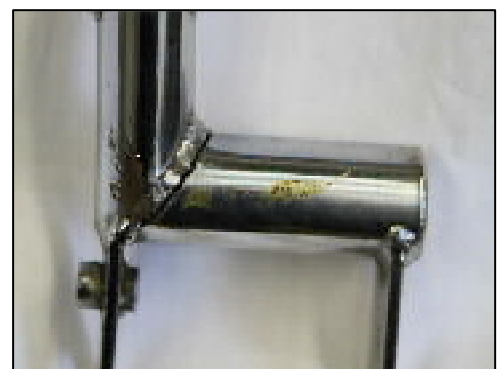
3 Grob G103 Twin Astir

Rudder pedal found cracked. Typical edge of weld crack. Chrome plating will hide crack until well developed.

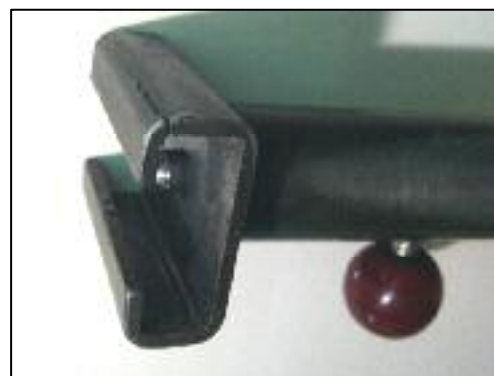
4 Grob G109**(Advisory)**

3 of the 4 rudder pedals found cracked at attachment to adjusting bar.

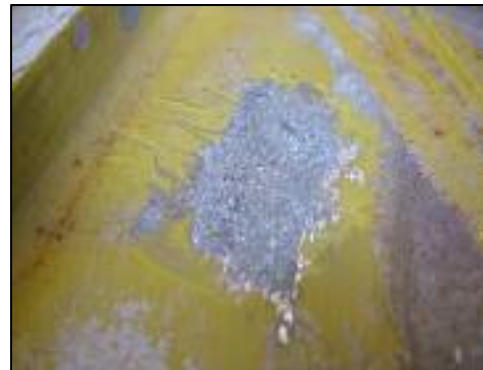
7 Pilatus B4**(Advisory)**

Exfoliation corrosion found on wing spar web root area. Possible water contamination. Not known if wing is serviceable following corrosion removal. After removing any substantial corrosion, seek advice from Type Certificate holder re serviceability.

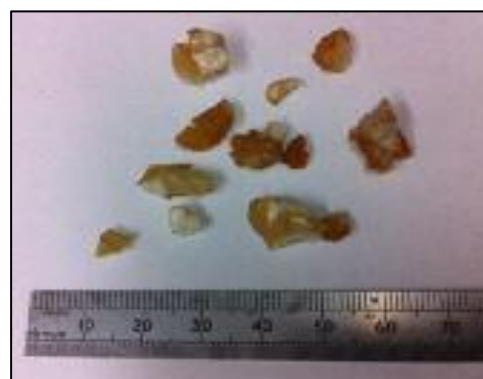
9 Schleicher ASH 25E**(Advisory)**

Debris in fuel tank. What appears to be resin pieces were found in the fuel tank. The most likely origin is excess resin spew from manufacture that has broken off over time. Possibility of debris causing a fuel restriction.

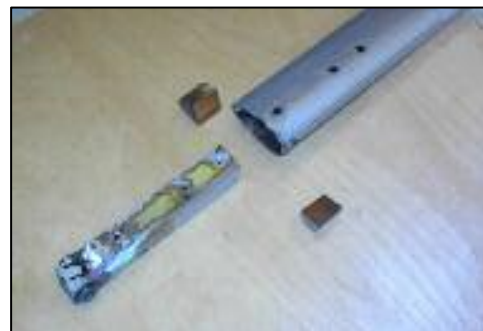
10 Slingsby T31**(Advisory)**

Wing lift strut end fittings corroded inside tubular strut. Possible cause dissimilar metal corrosion due to inadequate protection. Only a very small amount of corrosion was visible prior to removal and might easily be dismissed. Look for signs of previous work. All parts should be painted properly and assembled with yellow jointing compound. Applicable to other Slingsby types.

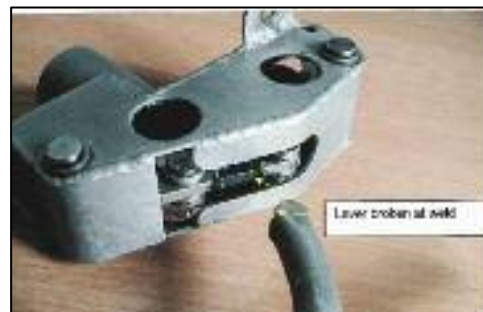
**11 Slingsby Vega****(Advisory)**

Canopy catch operating lever broken off. Possible incorrect previous repair.

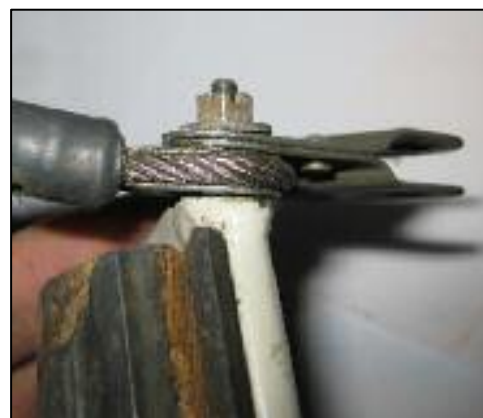
**12 SZD 50-3 Puchacz****(Advisory)**

Rear rudder cable attachment to ruder pedal split pins broken/missing and poor cable retention when distorted by pilots shoe.

Assemble with forward cable link on outside to capture cable (as shown) and only use good quality stainless steel split pins.

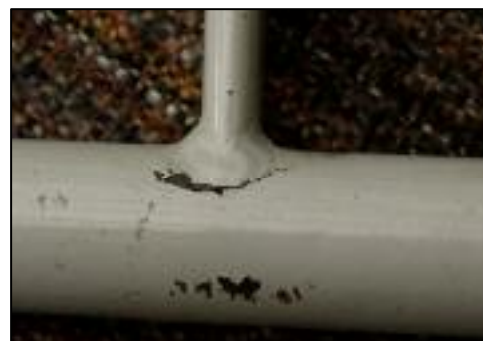
**13 SZD 50-3 Puchacz****(Advisory)**

Air Brake torque tube cracked. Known problem and inspection required by AD.

The kind of crack is typical of this type of design and applicable to many types. Investigate any paint cracks.

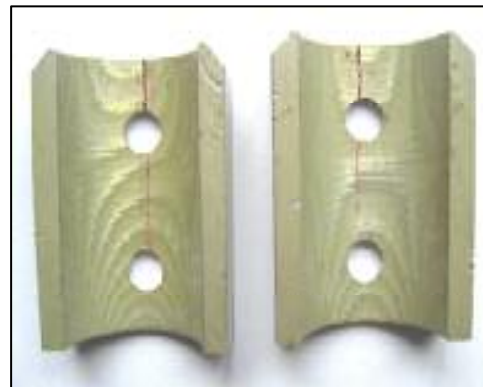
14 SZD 50-3 Puchacz**(Advisory)**

Control stick mounting blocks cracked. Known problem and inspection required by AD.

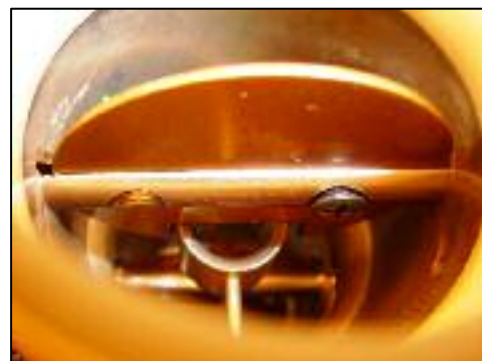
**Engines****15 DG 500MB Carburettor Choke Butterfly****(Advisory)**

The redundant choke butterfly on Mikuni carburettor was found with one screw missing and the other loose. The aircraft is fitted with a Solo engine and it is possible that this carburettor is used on many other types. The issue may be high engine vibration and ineffective screw peening.

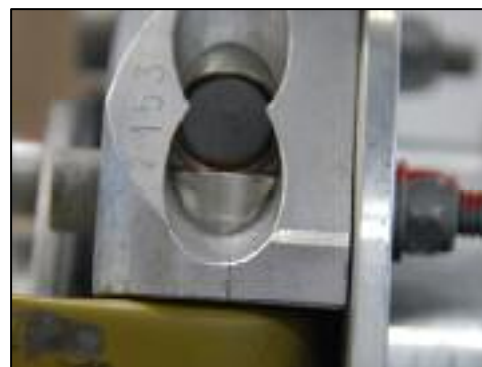
Propellers**17 Ingrid Oehler Propeller (Schempp-Hirth Duo Discus T)****(Advisory)**

Folding propeller blade mounting block found cracked. Please report any further occurrences.

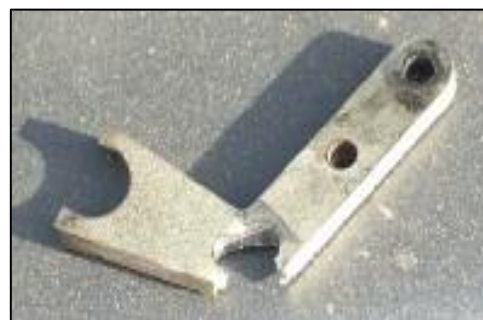
20 **OTTFUR CW 300 Release** **(Advisory)**

Broken operating lever. This appears a similar failure as reported in TNS 5-2010. Please check at next opportunity and report any further failures to BGA.
