**Issue 6-2011**

**Date: 21/12/2011**

## Airworthiness Information

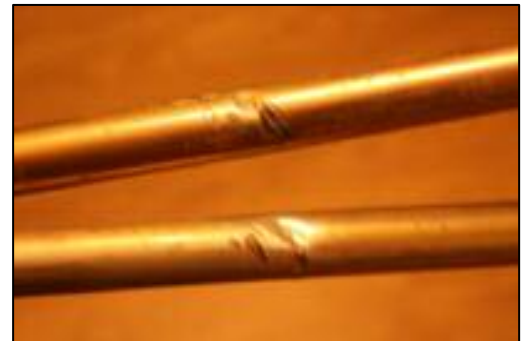
### 1 **DG 200**

Two gliders found with damaged airbrake drive rods. The damage is caused by the undercarriage arm end striking when raised or lowered. Careful adjustment is needed.

(Rather disappointingly, one of the rods had been turned over to hiding the damage!)

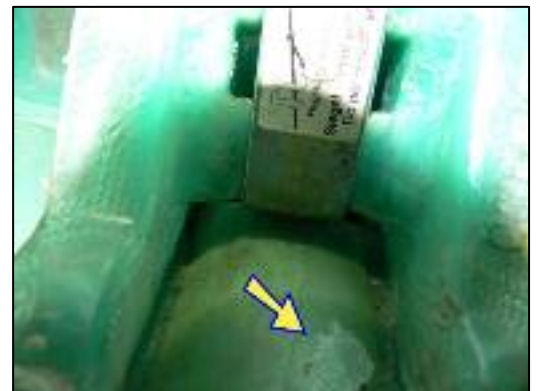
### 2 **DG500**

Stone or debris damage to the main wheel shroud.

The shroud over the main wheel is fairly thin and damaged easily by the wheel picking up a stone or possibly a cable ring set.

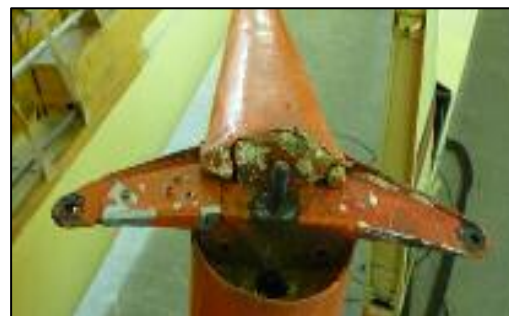
- 4 Scheibe SF26** **(Information)**  
Reported by John Gilbert, Essex Sailplnes.

Unsatisfactory repair found on SF26 Rudder control bell crank. No corresponding log book entry. Please remember that all repairs must be carried out in accordance with approved procedures and to the correct standard.

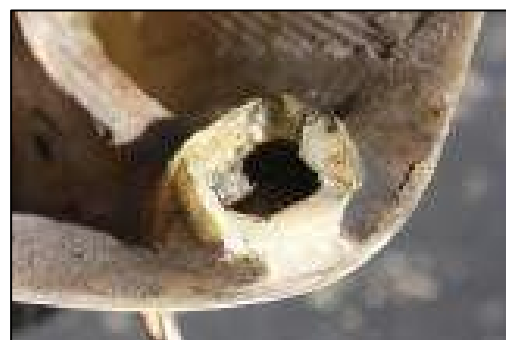
- 5 SZD 50-3 Puchacz** **(Information)**  
Reported by Darren Smith, PNGC.

Rudder detached from aircraft during landing roll. The problem was found to be the GRP "cup" supporting the lower rudder hinge had broken. A fleet inspection in this area was initiated.
