Issue 5-2012

Date: 19/12/2012

Airworthiness Information

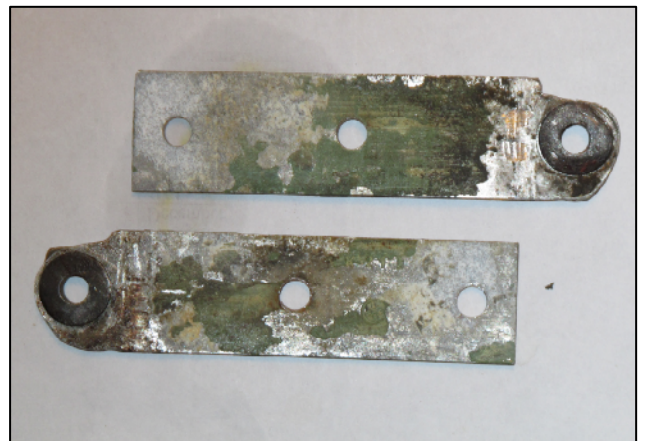
- 3 Slingsby T21 Sedburg (Information)**
Reported by Eric Munk, The Netherlands.

Tail plane lower strut carry through member in fuselage, severe exfoliation corrosion of alloy end strut attachment plates where attached the wooden cross member and stringer attachment. In some areas the plates had lost 20% of their thickness.

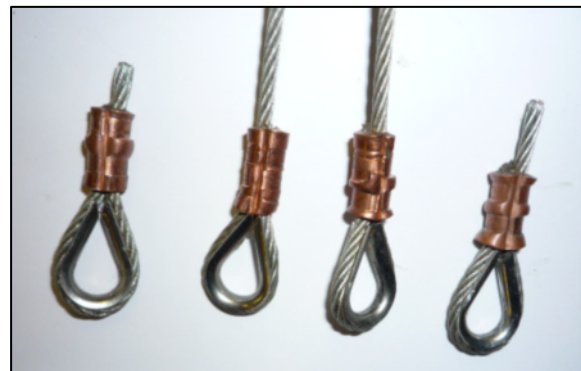
The picture shows a rather motley selection of control cable crimps found on a glider, including too few swages, over swaging, badly formed swages and no cable protrusion. FAA AC 43.13.1B Chapter 7, section 8 gives guidance and the correct procedure for the inspection and repair on control cables. This guidance **MUST** be followed when making up cables using American spec cable and crimps. BGA AMP Leaflet 4-7 also provides guidance.

All the pictured swaged ends should have been rejected!
