**Issue 3-2013**

**Date: 01/07/2013**

## **Airworthiness Information**

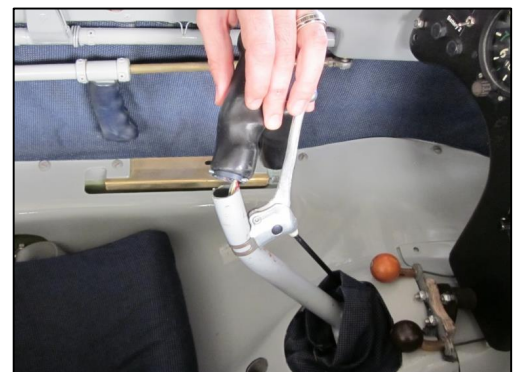
- 3 ASW 20 (Applicable to all types) (Advisory)**  
Reported by John Giddins, Banbury Gliding Club  
A recent modification had been carried out to a control stick to install a handle containing controls for the navigation system involving shortening the stick. Ensure that if a stick really needs to be shortened only the minimum is removed leaving enough to allow proper engagement of the handle grip. In addition it is usual to centre drill to allow the retaining grub screws to locate.

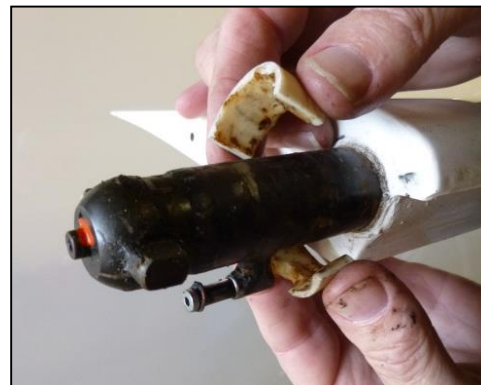
**4 DG500/20 and /22**

The flap operating torque tube bearing shells disbonded and could cause a jam. The shells are covered by a rubber gaiter. It is recommended to inspect these for security annually.

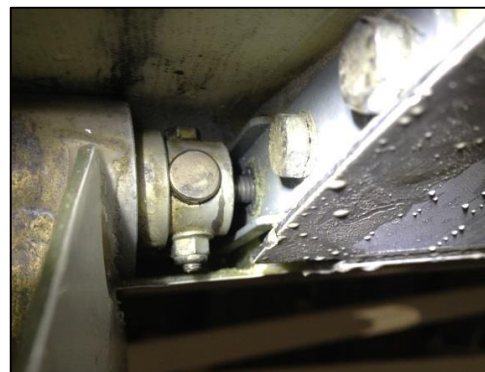
**5 Duo Disc Elevator Drive**

Reported by Stuart Naylor, Highland Gliding Club  
An elevator drive plate bolt had become unwound preventing de-rigging the tail plane. If these bolts are removed always tighten fully and using a new lock washer. Do not use lock-tite.

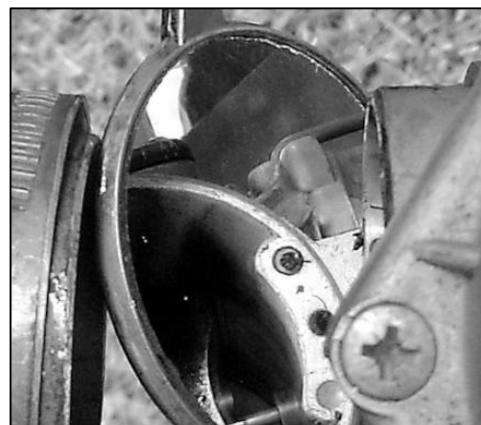
**7 Engine Intakes**

A recent incident on a Micro-light aircraft where the engine was running roughly and would not idle. The engine had ingested flies and the body of a fly was lodged firmly in the slow running jet.

This highlights the importance of maintaining air filters in good condition.

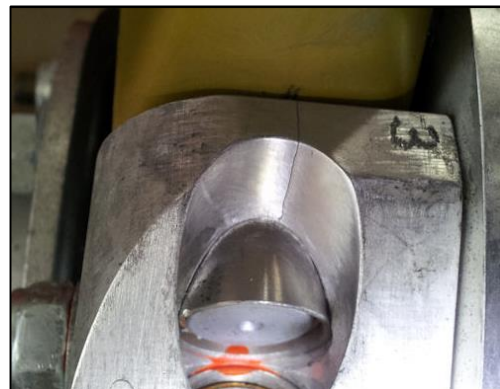
### 8 Duo Discus T Propeller Hub

The recent inspection of propeller hubs required by AD 2013-0012 was carried out.

Two cracked retaining lugs were found. The cracked hub was very difficult to see at first. Cleaning with fine wet and dry paper to remove the surface contamination revealed the cracks.

This was a modified hub and had only been used for 18 hours.
