Issue 4-2013

Date: 02/09/2013

Airworthiness Information

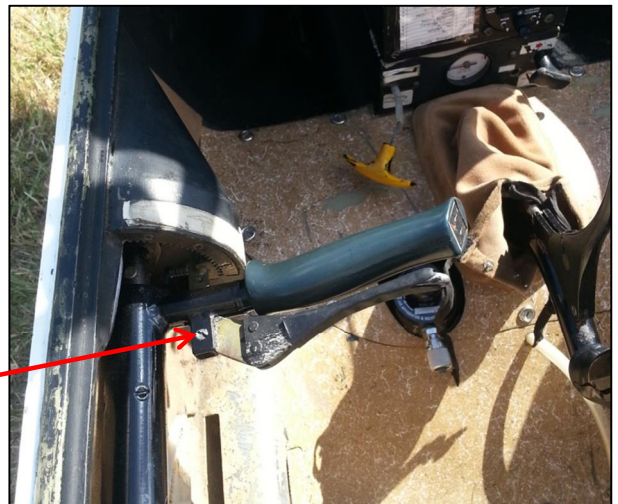
1 **Slingsby Vega**

Flap disengagement lever pivot bolt missing preventing disengagement of the flap lock preventing alteration of flap settings. It is recommended to check tightness of the pivot bolt/nut and secure with thread lock.

Apply thread lock and check tightness

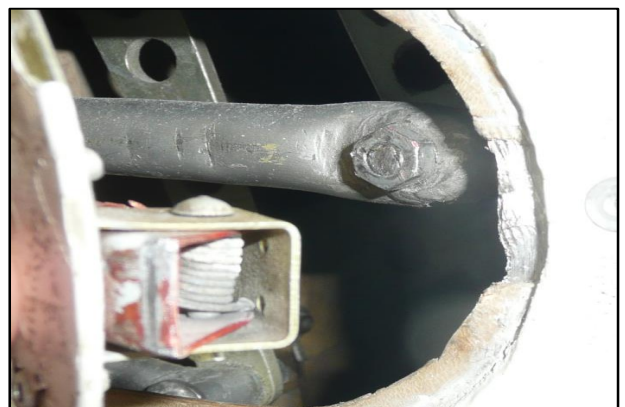
3 **SZD Pirat**

Airbrake control restriction caused by installing a catch on an access panel when closed interferes with the air brake control rod. This type of panel is used on many older gliders and care must be taken when repairing or modifying.
