# Technical News Sheet

**Issue 5-2013**

**Date: 07/11/2013**

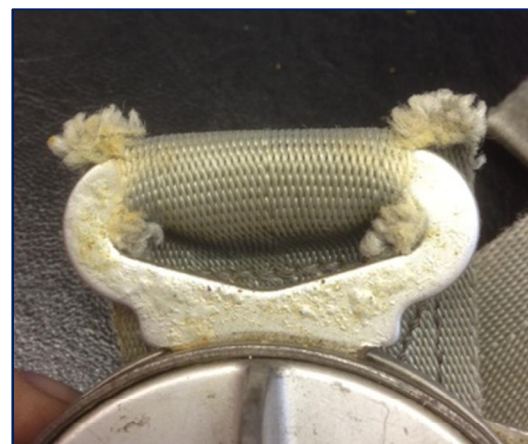
- 10 Seat Harnesses**  
 The picture shows a glider seat harness found in use. Obviously suffering from excessive webbing wear and corrosion of the buckle.  
 The BGA Maintenance Programme allows for seat harnesses to remain in service subject to on-condition inspections.  
 On Condition means that the item must be inspected and its condition assessed in accordance with the appropriate instructions. For seat harnesses use AMP Leaflet 4-8.
